**PHASE 2, STRUCTURAL ASSESSMENT**

**CITY OF NORTH PORT  
WORK AUTHORIZATION 8, PHASE 2  
PROJECT WM16HD**

**Prepared for: The City of North Port**

**September 30, 2016**

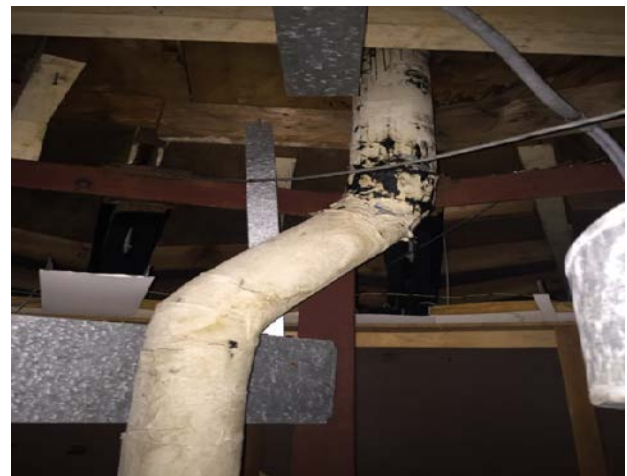
**Picture 16**  
Building 3 - Cyclorama Steel Collar & Support for Bar Joists

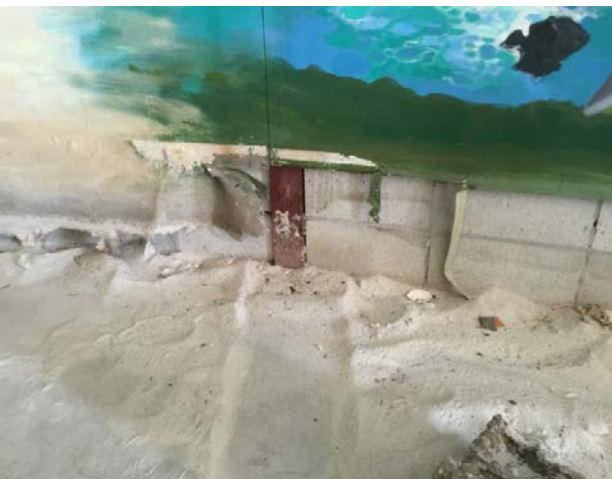
**Picture 17**  
Building 3 - Cyclorama Steel Column in Wall

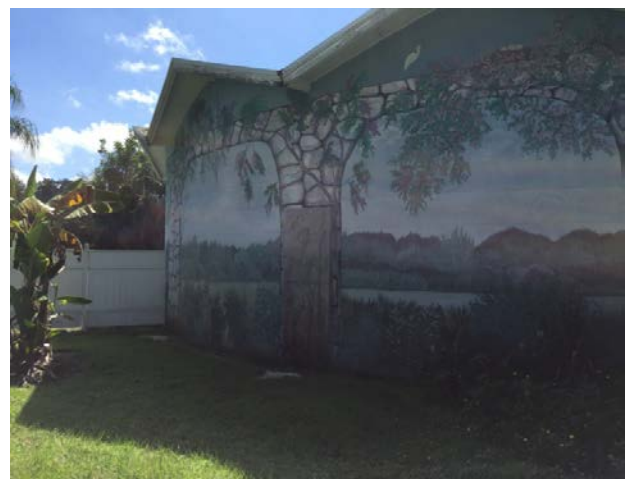
**Picture 18**  
Building 3 - Cyclorama Stucco

Eight-inch CMU walls are in good condition with the exception of some isolated damaged areas that appear to have resulted from impact. These areas may be repaired with minor effort. The walls should be cleaned and prepared for new stucco. The existing coating is a skim coat of stucco and any new application will be required to have a similar texture to maintain historical relevance. Repairs such as coatings and material protection applications will be required to be verified for use in a historic application.
