**PHASE 2, STRUCTURAL ASSESSMENT**

**CITY OF NORTH PORT  
WORK AUTHORIZATION 8, PHASE 2  
PROJECT WM16HD**

**Prepared for: The City of North Port**

**September 30, 2016**

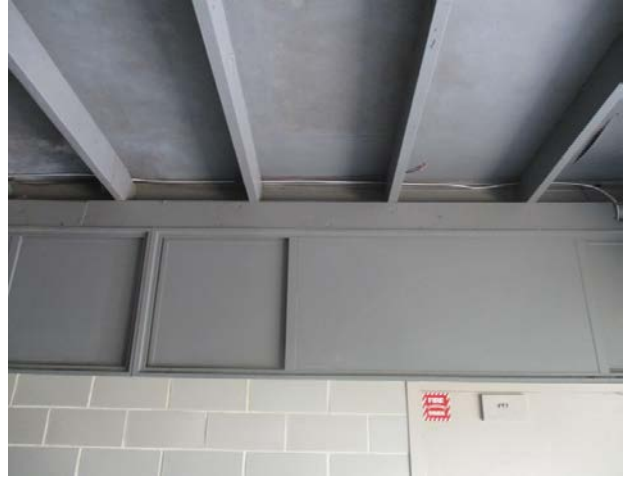
**Picture 8**

Building 1 - Breezeway with Wood Fill Where Glass Existed

- 9 Replace all aluminum window frames and glass above 4 inch block. Includes areas now covered with wood.
- 10 Replace all aluminum frames and windows at corners of building

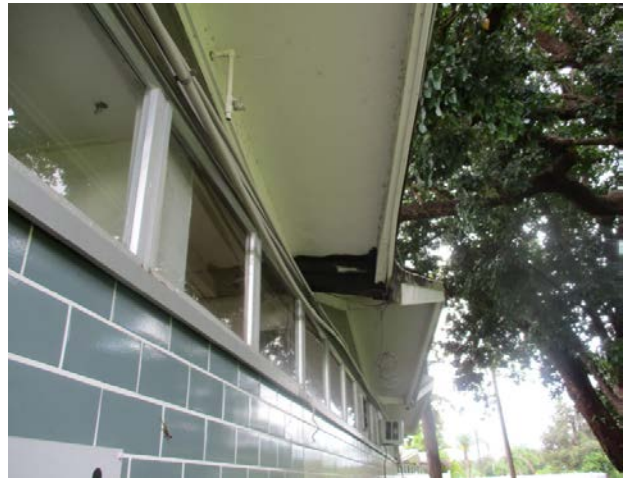
**Picture 10**

Building 2 - Type 1 & 2 Windows with Aluminum Frame

- 9 Replace all aluminum window frames and glass above 4 inch block. Includes areas now covered with wood.
- 10 Replace all aluminum frames and windows at corners of building

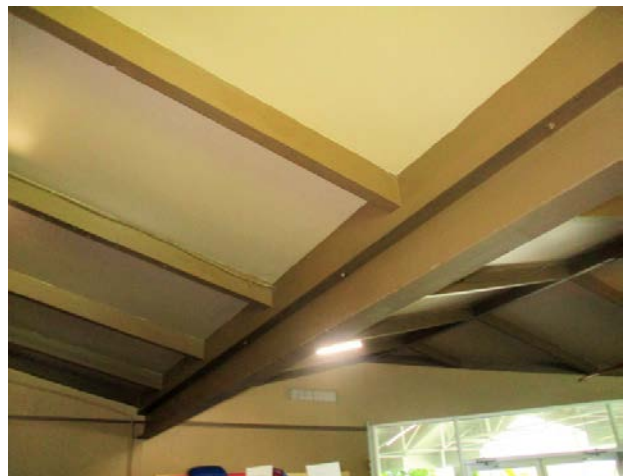
**Picture 12**

Building 1 - Typical Beam, Girder & Roof Deck Configuration
