Atwater Park is the only developed park in eastern North Port. One of the park's boundaries is shared with Atwater Elementary School while the rest of the edges are shared with the backyards of single-familyhome lots, many of which are currently undeveloped. This park has many accessible features from grills and tables to the pavilions to companion seating at the ballfields. The main issues at this park are restroom door force is too high and/or closes too quickly and lack of adequate signage for the unisex restrooms.

The City of North Port is part of a local government which requires compliance with Title II of the Americans with Disabilities Act (ADA). Changes to the park district would allow for equal opportunity to participate in programs and activities, effective communication, and program accessibility. Access of programs and activities can be achieved by removal of physical barriers, modification of policies, practices and procedures that discriminate against a person with a disability and relocation to an accessibility facility. In existing facilities, the ADA does allow the relocation of a program from an inaccessible facility to an accessible facility until all access ba

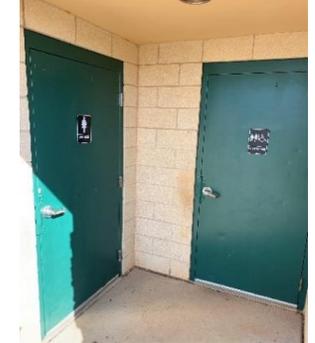
<p>The women's restroom door has an opening force too high at 15 lbs.</p>	<p>FAC 553.504(6)</p>	<p>Adjust the closer so the door opening force is no heavier than 8.5 lbs. to open and takes a minimum of 5 seconds to close or provide an automatic door opener at the door.</p>	<p>3</p>	<p>2</p>	<p>\$ 105.00</p>

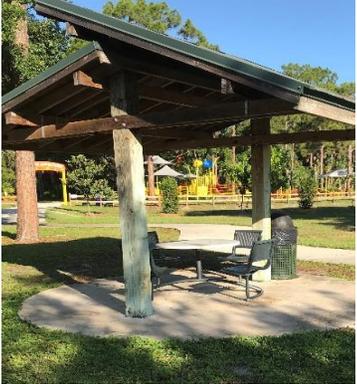
<p>The picnic shelters provides one picnic tables but none are accessible.</p>	<p><b>Proposed</b> Outdoor Developed Areas Guidelines ADAAG 245 &amp; 1011</p>	<p><b>Picnic Table Recommendation:</b> At least 20% of picnic tables, but no less than two, be of an accessible design, connected to an accessible route. Provide picnic tables that have a clear floor space of 30 inches minimum by 48 inches minimum, a table top between 28 inches minimum of 34 inches maximum and a minimum 27 inches knee clearance. The knee clearance should go 17 inches to 25 inches under the top. Relocate or purchase two accessible picnic tables and locate them on an accessible surface.</p>	<p><b>2</b></p>	<p><b>3</b></p>	<p>\$ 1,570.00</p>		
<p><b>Men's Restroom</b></p>

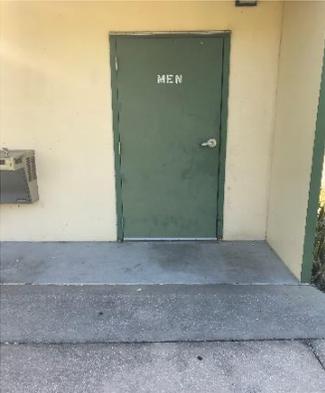
<p>The men's restroom has a door opening force too high at 10 lbs.</p>	<p>FAC 553.504(6)</p>	<p>Adjust the closer so the door opening force is no heavier than 8.5 lbs. to open and takes a minimum of 5 seconds to close or provide an automatic door opener at the door.</p>	<p>3</p>	<p>2</p>	<p>\$ 105.00</p>

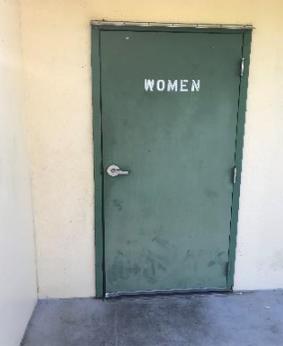
<p>The women's restroom at the soccer field door has an opening force too high at 10 lbs. and closes too quickly at 3 seconds.</p>	<p>FAC 553.504(6)</p>	<p>Adjust the closer so the door opening force is no heavier than 8.5 lbs. to open and takes a minimum of 5 seconds to close or provide an automatic door opener at the door.</p>	<p>3</p>	<p>2</p>	<p>\$ 105.00</p>

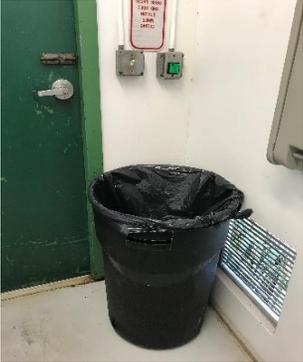
<p>The automatic door button is blocked by the trash cans in both restrooms.</p>	<p>ADAAG 308</p>	<p>Relocate the trash can to the outside of the restroom to provide a reach range no higher than 48 inches AFF for a forward reach over an obstruction no deeper than 20 inches or a side reach of 48 inches AFF over an object no deeper than 10 inches. The new location should not have the hand dryer protrude into the accessible route.</p>	<p><b>3</b></p>	<p><b>2</b></p>	<p>\$ 520.00</p>

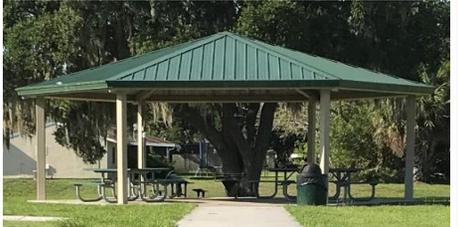
<p>The picnic shelter provides two picnic tables but none are accessible.</p>	<p><b>Proposed</b> Outdoor Developed Areas Guidelines ADAAG 245 &amp; 1011</p>	<p><b>Picnic Table Recommendation:</b> At least 20% of picnic tables, but no less than two, be of an accessible design, connected to an accessible route. Provide picnic tables that have a clear floor space of 30 inches minimum by 48 inches minimum, a table top between 28 inches minimum of 34 inches maximum and a minimum 27 inches knee clearance. The knee clearance should go 17 inches to 25 inches under the top. Relocate or purchase two accessible picnic tables and locate them on an accessible surface.</p>	<p><b>2</b></p>	<p><b>3</b></p>	<p>\$ 1,570.00</p>

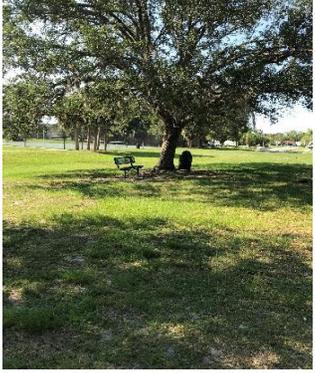
<p>No accessible route is provided to the bench for 18 feet.</p>	<p><u>Proposed</u> Outdoor Areas Standards ADAAG 1011</p>	<p><b>Bench Recommendation:</b> Provide a new accessible route with a running slope no steeper than 5% and a cross slope no steeper than 2% and a minimum clear width of 36 inches and connect to the companion seating of the bench.</p>	<p>2</p>	<p>4</p>	<p>\$ 1,500.00</p>

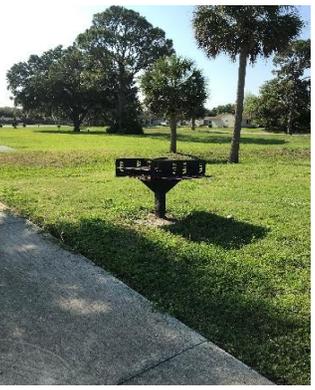
<p>BBQ does not provide adequate clear ground space.</p>	<p><u>Proposed</u> Outdoor Areas Standards ADAAG 1011</p>	<p><b>Bench Recommendation:</b> Provide a clear ground space of at least 30 inches by 48 inches positioned near the bench with one side adjoining the walkway. The clear ground space should have a slope no steeper than 2% in all directions. The clear ground space should not overlap the accessible route or another clear ground space.</p>	<p>2</p>	<p>4</p>	<p>\$ 750.00</p>			
<b>Men's Restroom</b>

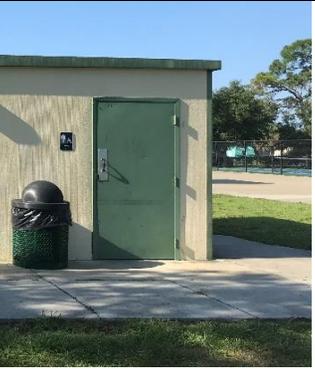
<p>The men's restroom has a door opening force too high at 15 lbs.</p>	<p>FAC 553.504(6)</p>	<p>Adjust the closer so the door opening force is no heavier than 8.5 lbs. to open and takes a minimum of 5 seconds to close or provide an automatic door opener at the door.</p>	<p>3</p>	<p>2</p>	<p>\$ 105.00</p>

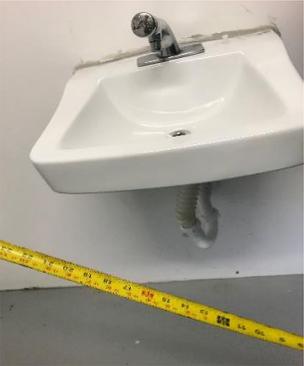
<p>The mens restroom sink does not provide pipe protection.</p>	<p>ADAAG 606.5</p>	<p>Provide a protective cover or protective pipe wrapping on the water shut offs and drain pipes.</p>	<p>3</p>	<p>2</p>	<p>\$ 80.00</p>		
<p><b>Women's Restroom</b></p>

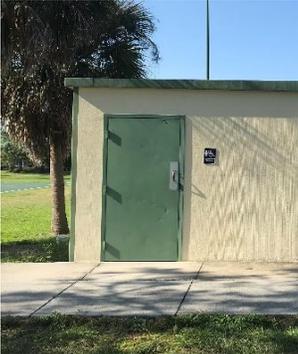
<p>The women's restroom door has an opening force too high at 14 lbs. and closes too quickly at 4 seconds.</p>	<p>FAC 553.504(6)</p>	<p>Adjust the closer so the door opening force is no heavier than 8.5 lbs. to open and takes a minimum of 5 seconds to close or provide an automatic door opener at the door.</p>	<p>3</p>	<p>2</p>	<p>\$ 105.00</p>

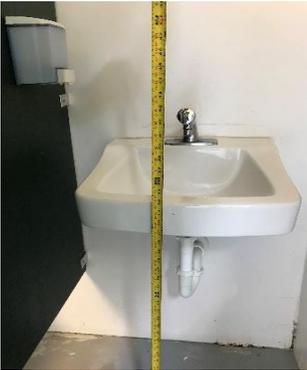
<p>The womens restroom sink does not provide pipe protection.</p>	<p>ADAAG 606.5</p>	<p>Provide a protective cover or protective pipe wrapping on the water shut offs and drain pipes.</p>	<p>3</p>	<p>2</p>	<p>\$ 80.00</p>

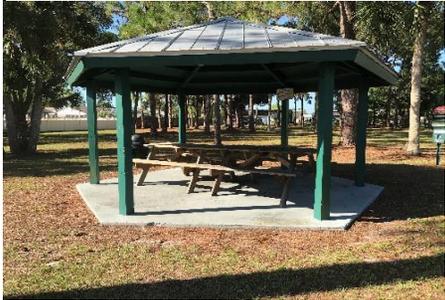
<p>The picnic shelter provides two picnic tables but none are accessible.</p>	<p><b>Proposed</b> Outdoor Developed Areas Guidelines ADAAG 245 &amp; 1011</p>	<p><b>Picnic Table Recommendation:</b> At least 20% of picnic tables, but no less than two, be of an accessible design, connected to an accessible route. Provide picnic tables that have a clear floor space of 30 inches minimum by 48 inches minimum, a table top between 28 inches minimum of 34 inches maximum and a minimum 27 inches knee clearance. The knee clearance should go 17 inches to 25 inches under the top. Relocate or purchase two accessible picnic tables and locate them on an accessible surface.</p>	<p><b>2</b></p>	<p><b>3</b></p>	<p>\$ 1,570.00</p>

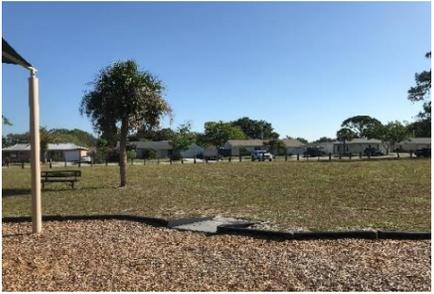
<p>No accessible route is provided to the playground.</p>	<p><b>Proposed</b> Outdoor Areas Standards ADAAG 1011</p>	<p>Provide a new accessible route with a running slope no steeper than 5% and a cross slope no steeper than 2% and a minimum clear width of 36 inches and connect to the companion seating of the bench.</p>	<p>2</p>	<p>4</p>	<p>\$ 3,500.00</p>

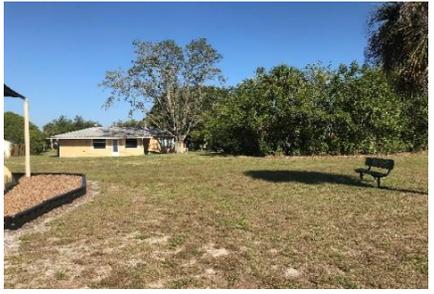
<p>No companion seating is provided to the bench.</p>	<p><b>Proposed</b> Outdoor Areas Standards ADAAG 1011</p>	<p><b>Bench Recommendation:</b> Provide a clear ground space of at least 30 inches by 48 inches positioned near the bench with one side adjoining the walkway. The clear ground space should have a slope no steeper than 2% in all directions. The clear ground space should not overlap the accessible route or another clear ground space.</p>	<p>2</p>	<p>4</p>	<p>\$ 750.00</p>

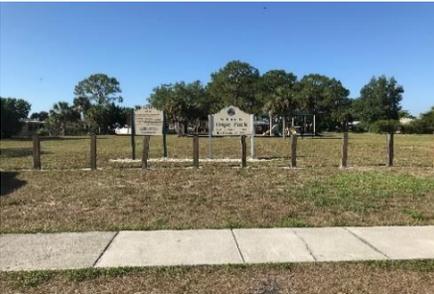
<p>No accessible parking is available.</p>	<p>FAC 553.512</p>	<p>Provide parking spaces on the shortest accessible route to be no steeper than 2% in all directions. The parking space should be a minimum of 12 foot wide and an access aisle a minimum of 5 foot wide. Provide a sign with the International Symbol of Accessibility and at the head and in the middle of the accessible parking space. The sign should be mounted 60 inches AFF and captioned with "Parking By Disabled Permit Only".</p>	<p>1</p>	<p>4</p>	<p>\$ 3,000.00</p>

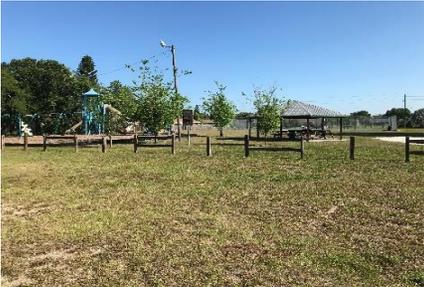
No accessible parking is available.	FAC 553.512	Provide parking spaces on the shortest accessible route to be no steeper than 2% in all directions. The parking space should be a minimum of 12 foot wide and an access aisle a minimum of 5 foot wide. Provide a sign with the International Symbol of Accessibility and at the head and in the middle of the accessible parking space. The sign should be mounted 60 inches	1	4	\$ 4,000.00

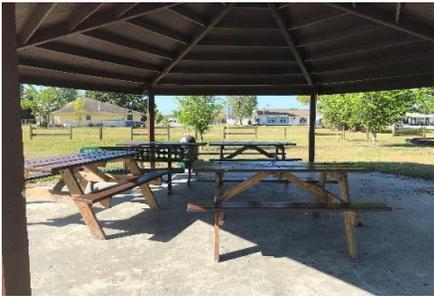
<p>The picnic shelter provides four picnic tables but none are accessible.</p>	<p><b>Proposed</b> Outdoor Developed Areas Guidelines ADAAG 245 &amp; 1011</p>	<p><b>Picnic Table Recommendation:</b> At least 20% of picnic tables, but no less than two, be of an accessible design, connected to an accessible route. Provide picnic tables that have a clear floor space of 30 inches minimum by 48 inches minimum, a table top between 28 inches minimum of 34 inches maximum and a minimum 27 inches knee clearance. The knee clearance should go 17 inches to 25 inches under the top. Relocate or purchase two accessible picnic tables and locate them on an accessible surface.</p>	<p>2</p>	<p>3</p>	<p>\$ 1,570.00</p>

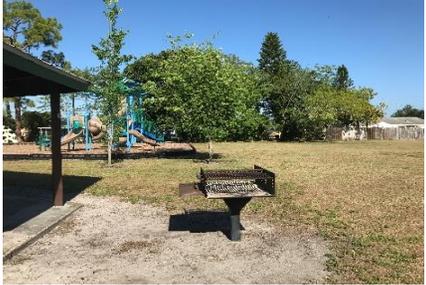
<p>No accessible route is provided to the pavilion, BBQ or playground.</p>	<p><b>Proposed</b> Outdoor Areas Standards ADAAG 1011</p>	<p>Provide a new accessible route with a running slope no steeper than 5% and a cross slope no steeper than 2% and a minimum clear width of 36 inches.</p>	<p>2</p>	<p>4</p>	<p>\$ 3,500.00</p>

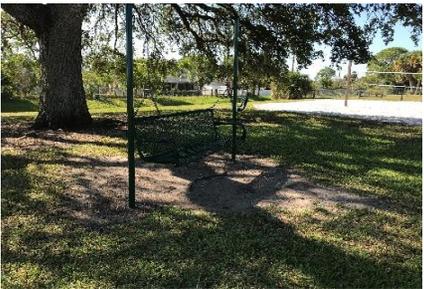
<p>No companion seating is provided to the swinging bench.</p>	<p><b>Proposed</b> Outdoor Areas Standards ADAAG 1011</p>	<p><b>Bench Recommendation:</b> Provide a clear ground space of at least 30 inches by 48 inches positioned near the bench with one side adjoining the walkway. The clear ground space should have a slope no steeper than 2% in all directions. The clear ground space should not overlap the accessible route or another clear ground space.</p>	<p>2</p>	<p>4</p>	<p>\$ 500.00</p>

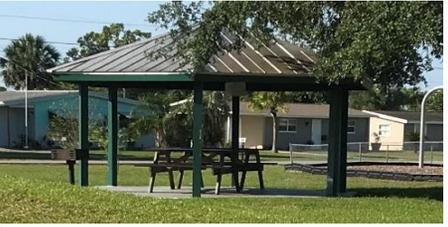
<p>The picnic shelter provides two picnic tables but none are accessible.</p>	<p><b>Proposed</b> Outdoor Developed Areas Guidelines ADAAG 245 &amp; 1011</p>	<p><b>Picnic Table Recommendation:</b> At least 20% of picnic tables, but no less than two, be of an accessible design, connected to an accessible route. Provide picnic tables that have a clear floor space of 30 inches minimum by 48 inches minimum, a table top between 28 inches minimum of 34 inches maximum and a minimum 27 inches knee clearance. The knee clearance should go 17 inches to 25 inches under the top. Relocate or purchase two accessible picnic tables and locate them on an accessible surface.</p>	<p><b>2</b></p>	<p><b>3</b></p>	<p>\$ 1,570.00</p>

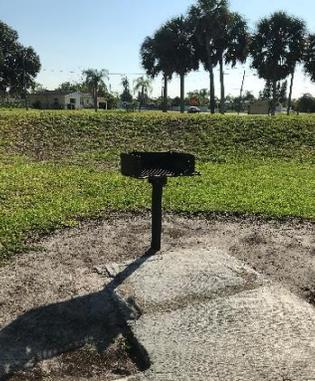
<p>Not adequate clear ground space around the bbq.</p>	<p><b>Proposed</b> Outdoor Areas Standards ADAAG 1011</p>	<p>Provide a clear ground space of at least 30 inches by 48 inches positioned near the bench with one side adjoining the walkway. The clear ground space should have a slope no steeper than 2% in all directions. The clear ground space should not overlap the accessible route or another clear ground space.</p>	<p>2</p>	<p>4</p>	<p>\$ 415.00</p>		
<p><b>Parking</b></p>

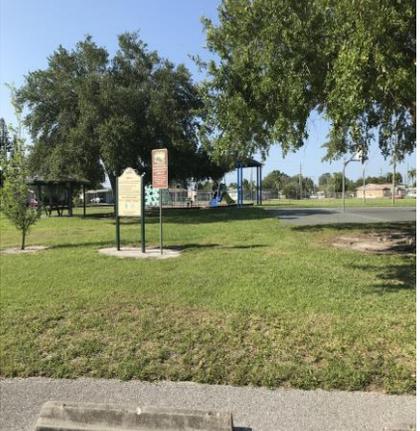
<p>No accessible parking is available.</p>	<p>FAC 553.512</p>	<p><b>Parking Recommendation:</b> Add at least one ADA parking stall. The parking space should be a minimum of 12 foot wide and an access aisle a minimum of 5 foot wide. Provide a sign with the International Symbol of Accessibility and at the head and in the middle of the accessible parking space. The sign should be mounted 60 inches AFF and captioned with "Parking By Disabled Permit Only".</p>	<p>2</p>		<p>\$ 3,500.00</p>

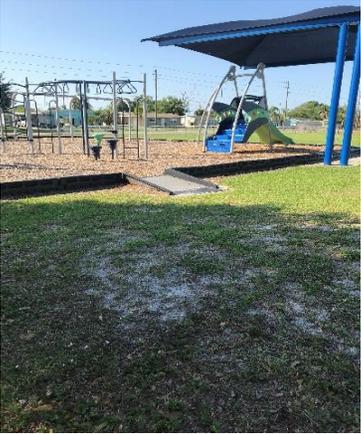
<p>No accessible route is provided to the playground.</p>	<p>ADAAG 403</p>	<p>Provide a new accessible route with a running slope no steeper than 5% and a cross slope no steeper than 2% and a minimum clear width of 36 inches.</p>	<p>2</p>	<p>4</p>	<p>\$ 1,500.00</p>

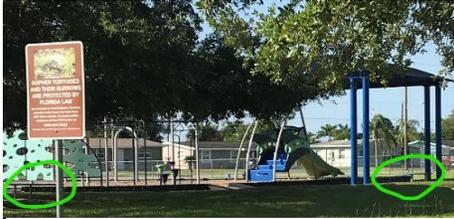
<p>No accessible route is provided to the benches.</p>			<p>1</p>	<p>4</p>	<p>\$ 860.00</p>

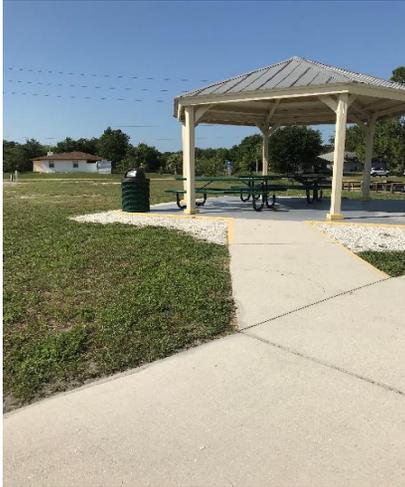
<p>The picnic shelter provides two picnic tables but none are accessible.</p>	<p><b>Proposed</b> Outdoor Developed Areas Guidelines ADAAG 245 &amp; 1011</p>	<p><b>Picnic Table Recommendation:</b> At least 20% of picnic tables, but no less than two, be of an accessible design, connected to an accessible route. Provide picnic tables that have a clear floor space of 30 inches minimum by 48 inches minimum, a table top between 28 inches minimum of 34 inches maximum and a minimum 27 inches knee clearance. The knee clearance should go 17 inches to 25 inches under the top. Relocate or purchase two accessible picnic tables and locate them on an accessible surface.</p>	<p><b>2</b></p>	<p><b>3</b></p>	<p>\$ 1,570.00</p>

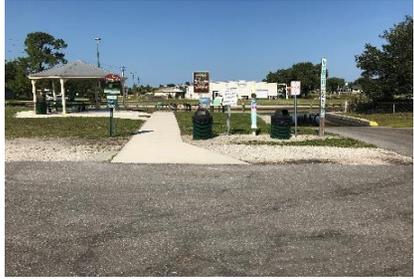
There is no accessible route to the fishing line disposal container.

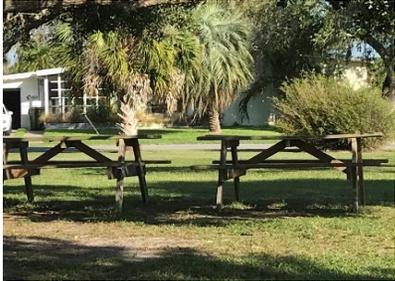
Two picnic tables but none are accessible.	<p><b>Proposed</b> Outdoor Developed Areas Guidelines ADAAG 245 &amp; 1011</p>	<p><b>Picnic Table Recommendation:</b> At least 20% of picnic tables, but no less than two, be of an accessible design, connected to an accessible route. Provide picnic tables that have a clear floor space of 30 inches minimum by 48 inches minimum, a table top between 28 inches minimum of 34 inches maximum and a minimum 27 inches knee clearance. The knee clearance should go 17 inches to 25 inches under the top. Relocate or purchase two accessible picnic tables and locate them on an accessible surface.</p>	<b>2</b>	<b>3</b>	\$ 1,570.00

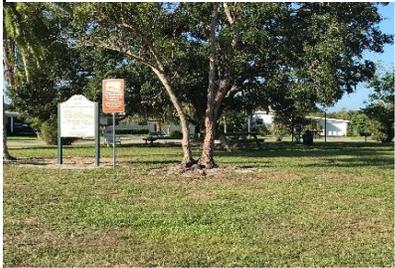
<p>No accessible parking is provided.</p>	<p>FAC 553.512</p>	<p>Provide an accessible parking space that is a minimum of 12 foot wide and an access aisle a minimum of 5 foot wide. Provide a sign with the International Symbol of Accessibility and at the head and in the middle of the accessible parking space. The sign should be mounted 60 inches AFF and captioned with "Parking By Disabled Permit Only". The parking</p>	<p>1</p>	<p>4</p>	<p>\$ 2,000.00</p>

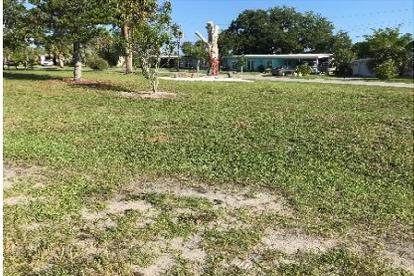
<p>There is not accessible route to the art.</p>	<p><b>Proposed</b> Outdoor Developed Areas Guidelines ADAAG 403 &amp; 1011</p>	<p><b>Picnic Table Recommendation:</b> Provide a new accessible route with a running slope no steeper than 5% and a cross slope no steeper than 2% and a minimum clear width of 36 inches and connect to the accessible picnic table and clear floor space side.</p>	<p>2</p>		<p>\$ 1,200.00</p>

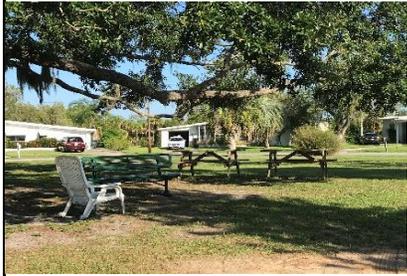
<p>No companion seating is provided to the bench and swinging bench.</p>	<p><b>Proposed</b> Outdoor Areas Standards ADAAG 1011</p>	<p><b>Bench Recommendation:</b> Provide a clear ground space of at least 30 inches by 48 inches positioned near the bench with one side adjoining the walkway. The clear ground space should have a slope no steeper than 2% in all directions. The clear ground space should not overlap the accessible route or another clear ground space.</p>	<p>2</p>	<p>4</p>	<p>\$ 525.00</p>

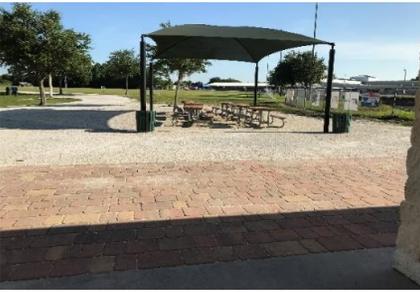
<p>The picnic shelter provides four picnic tables but none are accessible.</p>	<p><b>Proposed</b> Outdoor Developed Areas Guidelines ADAAG 245 &amp; 1011</p>	<p><b>Picnic Table Recommendation:</b> At least 20% of picnic tables, but no less than two, be of an accessible design, connected to an accessible route. Provide picnic tables that have a clear floor space of 30 inches minimum by 48 inches minimum, a table top between 28 inches minimum of 34 inches maximum and a minimum 27 inches knee clearance. The knee clearance should go 17 inches to 25 inches under the top. Relocate or purchase two accessible picnic tables and locate them on an accessible surface.</p>	<p><b>2</b></p>	<p><b>3</b></p>	<p>\$ 1,570.00</p>

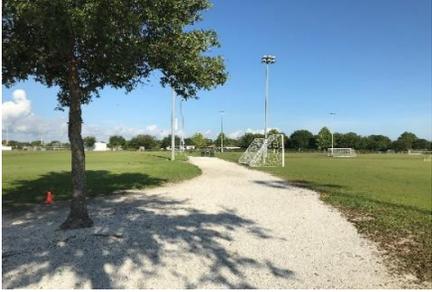
<p>No accessible route is provided to the fields.</p>	<p><b>Proposed</b> Outdoor Areas Standards ADAAG 1011</p>	<p><b>Recommendation:</b> Provide a new accessible route with a running slope no steeper than 5% and a cross slope no steeper than 2% and a minimum clear width of 36 inches and connect to the companion seating of the bench.</p>	<p>2</p>	<p>4</p>	<p>\$ 4,000.00</p>

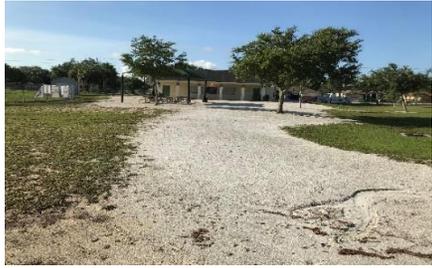
<p>No accessible route is provided to the pavilion.</p>	<p><b>Proposed</b> Outdoor Areas Standards ADAAG 1011</p>	<p><b>Recommendation:</b> Provide a new accessible route with a running slope no steeper than 5% and a cross slope no steeper than 2% and a minimum clear width of 36 inches and connect to the companion seating of the bench.</p>	<p>2</p>	<p>4</p>	<p>\$ 630.00</p>

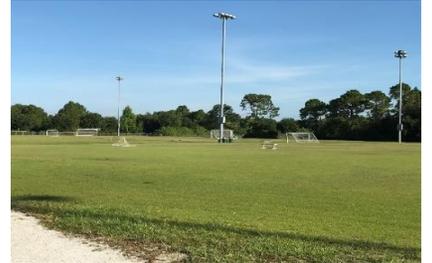
<p>No accessible route is provided to the team benches.</p>	<p>ADAAG 403</p>	<p>Provide a new accessible route with a running slope no steeper than 5% and a cross slope no steeper than 2% and a minimum clear width of 36 inches. <b>Option:</b> If providing a temporary accessible route, like a Mobi-Mat, place the material done to have a cross slope no steeper than 2%, a running slope no steeper than 5% and connected to an accessible route.</p>	<p>2</p>	<p>4</p>	<p>\$ 5,000.00</p>

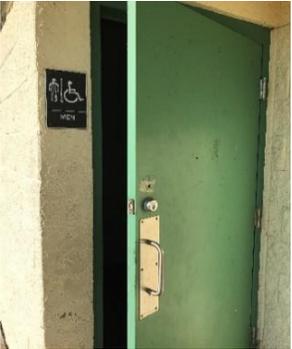
The men's restroom has a door opening force too high at 10 lbs.	FAC 553.504(6)	Adjust the closer so the door opening force is no heavier than 8.5 lbs. to open and takes a minimum of 5 seconds to close or provide an automatic door opener at the door.	<b>3</b>	2	\$ 105.00

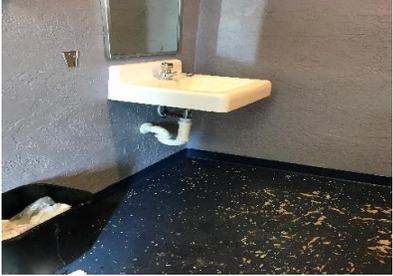
The men's restroom sink faucet shuts off too quickly at 7 seconds.	ADAAG 606.4	Provide a lever-operated, push-type or electronically controlled faucet. Self-closing faucets should remain open for at least 10 seconds. Push-type or lever-operated faucets should require not more than 5 lbs. to operate.	<b>3</b>	2	\$ 625.00		
Women's Restroom - Soccer Field

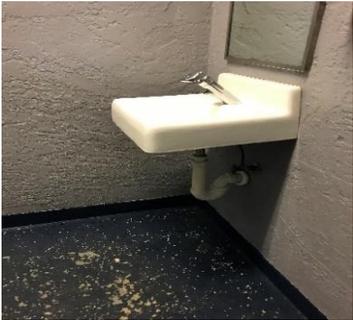
The women's restroom sink faucet shuts off too quickly at 7 seconds.	ADAAG 606.4	Provide a lever-operated, push-type or electronically controlled faucet. Self-closing faucets should remain open for at least 10 seconds. Push-type or lever-operated faucets should require not more than 5 lbs. to operate.	<b>3</b>	2	\$ 625.00

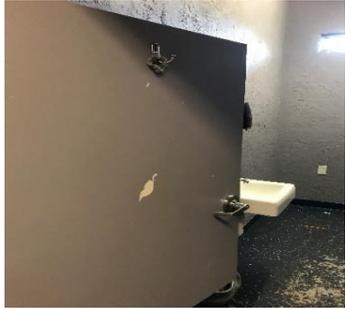
The women's restroom at the soccer field coat hook is mounted too high at 51 inches.

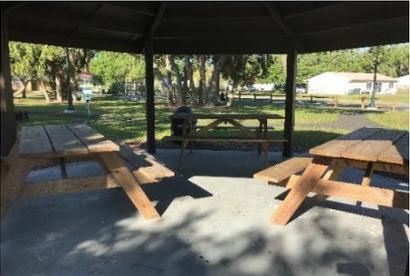
<p>The picnic shelter provides three picnic tables but none are accessible.</p>	<p><b>Proposed</b> Outdoor Developed Areas Guidelines ADAAG 245 &amp; 1011</p>	<p><b>Picnic Table Recommendation:</b> At least 20% of picnic tables, but no less than two, be of an accessible design, connected to an accessible route. Provide picnic tables that have a clear floor space of 30 inches minimum by 48 inches minimum, a table top between 28 inches minimum of 34 inches maximum and a minimum 27 inches knee clearance. The knee clearance should go 17 inches to 25 inches under the top. Relocate or purchase two accessible picnic tables and locate them on an accessible surface.</p>	<p><b>2</b></p>	<p><b>3</b></p>	<p>\$ 1,570.00</p>

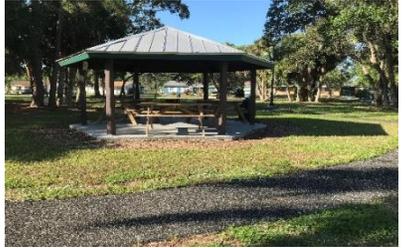
<p>No accessible route is provided to the pavilion.</p>	<p><b>Proposed</b> Outdoor Areas Standards ADAAG 1011</p>	<p>Provide a new accessible route with a running slope no steeper than 5% and a cross slope no steeper than 2% and a minimum clear width of 36 inches and connect to the companion seating of the bench.</p>	<p>2</p>	<p>4</p>	<p>\$ 630.00</p>

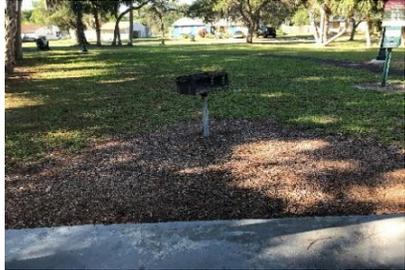
<p>The grill at the picnic shelter does not provide accessible access.</p>	<p><b>Proposed</b> Outdoor Developed Areas Guidelines ADAAG 1011.1</p>	<p><b>Grill Clear Ground Space Recommendation:</b> Provide a 48 inches by 48 inches clear ground space on all usable side of the grill and connected to an accessible route.</p>	<p>2</p>		<p>\$ 950.00</p>

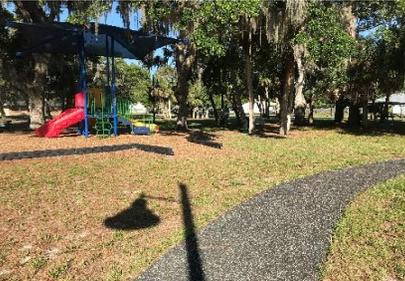
<p>No accessible route is provided to the playground.</p>	<p>ADAAG 403</p>	<p>Provide a new accessible route with a running slope no steeper than 5% and a cross slope no steeper than 2% and a minimum clear width of 36 inches.</p>	<p>2</p>		<p>\$ 1,100.00</p>

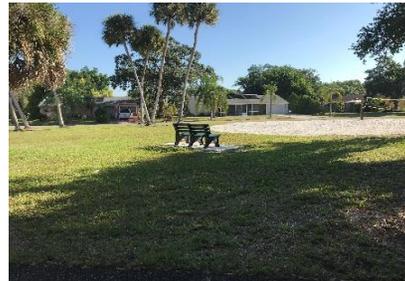
<p>No companion seating is provided to the bench.</p>	<p><b>Proposed</b> Outdoor Areas Standards ADAAG 1011</p>	<p><b>Bench Recommendation:</b> Provide a clear ground space of at least 30 inches by 48 inches positioned near the bench with one side adjoining the walkway. The clear ground space should have a slope no steeper than 2% in all directions. The clear ground space should not overlap the accessible route or another clear ground space.</p>	<p>2</p>	<p>4</p>	<p>\$ 1,000.00</p>

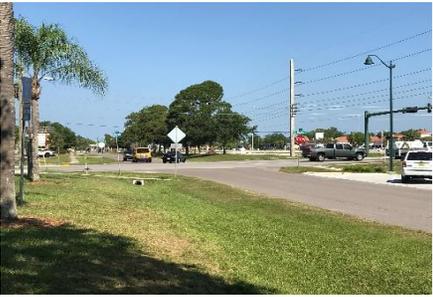
<p>There is no accessible route from parking to the park.</p>	<p>ADAAG 403</p>	<p>Provide a new accessible route with a running slope no steeper than 5% and a cross slope no steeper than 2% and a minimum clear width of 36 inches.</p>	<p><b>2</b></p>	<p>\$ 2,800.00</p>

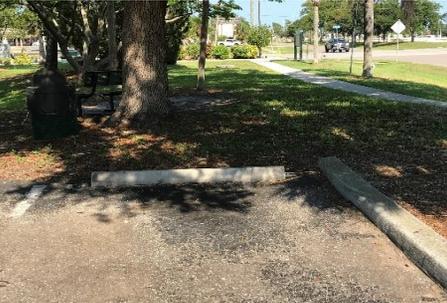
<p>A parking space is provided but not signed and it is not connected to an accessible route that would connect to the trail.</p>	<p>FAC 553.512</p>	<p>Provide an accessible parking space that is a minimum of 12 foot wide and an access aisle a minimum of 5 foot wide. Provide a sign with the International Symbol of Accessibility and at the head and in the middle of the accessible parking space. The sign should be mounted 60 inches AFF and captioned with "Parking By Disabled Permit Only". The parking and access aisle should be no steeper than 2% in all directions. Locate the accessible parking space on the shortest accessible route to the accessible entrance and next to an accessible route with a minimum 44 inches width.</p>	<p><b>1</b></p>	<p>\$ 1,500.00</p>

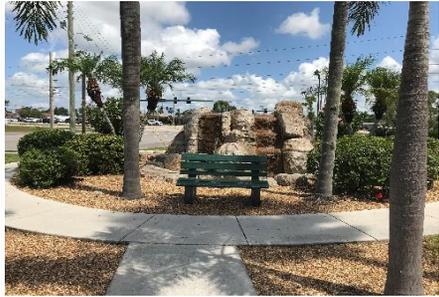
No companion seating is provided to the bench.

**Bench Recommendation:** Provide a clear ground space of at least 30 inches by 48 inches positioned near the bench with one side adjoining the walkway. The clear ground space should have a slope no steeper than 2% in all directions. The clear ground space should not overlap the accessible route or another clear ground space.
