**PHASE 2, STRUCTURAL ASSESSMENT**

**CITY OF NORTH PORT  
WORK AUTHORIZATION 8, PHASE 2  
PROJECT WM16HD**

**Prepared for: The City of North Port**

**September 30, 2016**

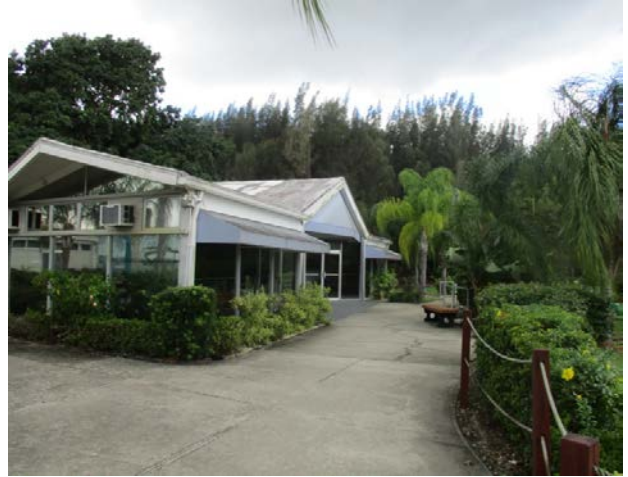
**Picture 2**  
Building 2 - NE Corner at Restaurant Area. Electric & Mechanical

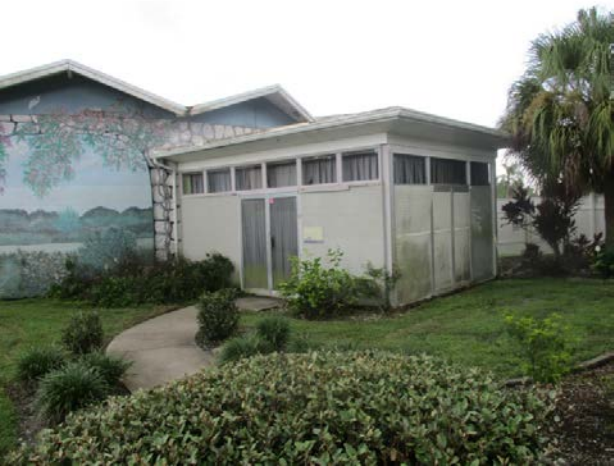
**Picture 3**  
Building 3 - Cyclorama Entry Building

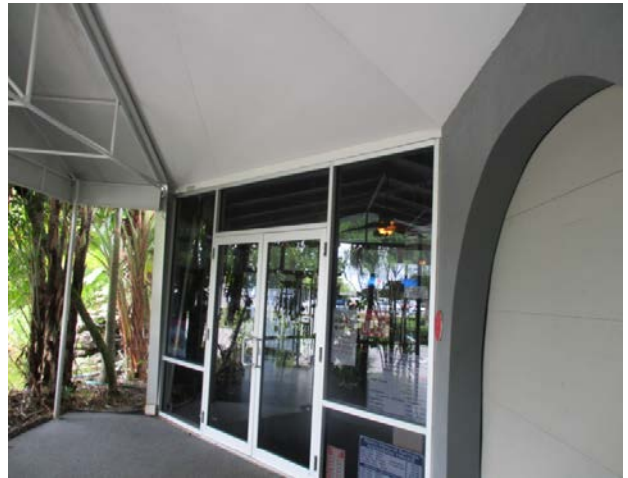
**Picture 4**  
Building 1 - Main Entry with Awning & Store Front

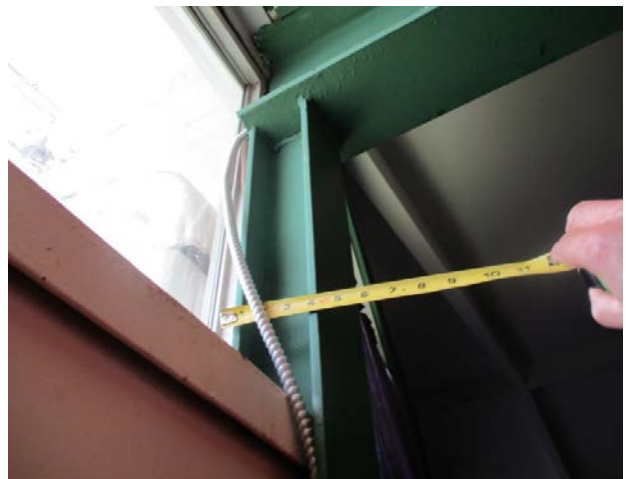
**Picture 6**  
Building 1 - 4" Column with Wall & Beam Connection

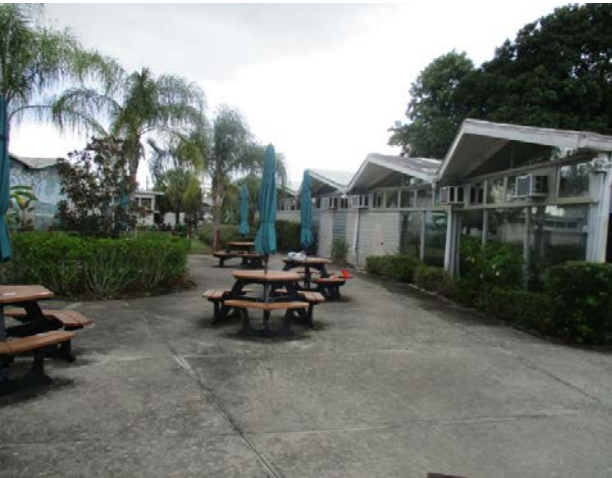
**Picture 9**

Building 2 - Dormer Sections from NE Looking SW

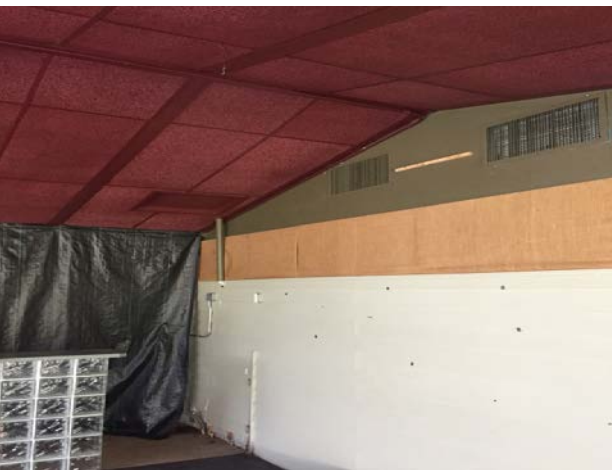
**Picture 11**

Building 2 - Dining Area

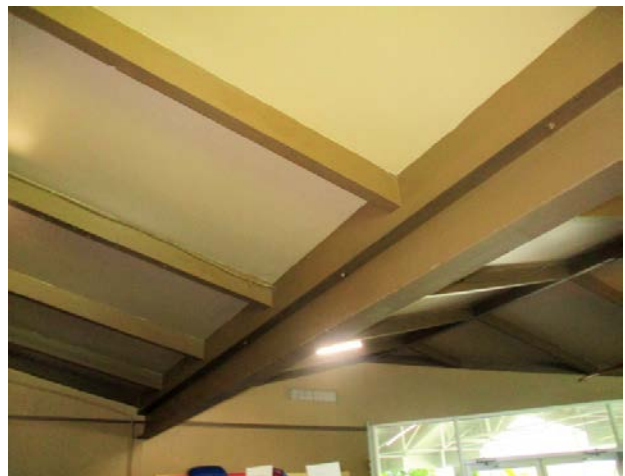
**Picture 12**

Building 1 - Typical Beam, Girder & Roof Deck Configuration

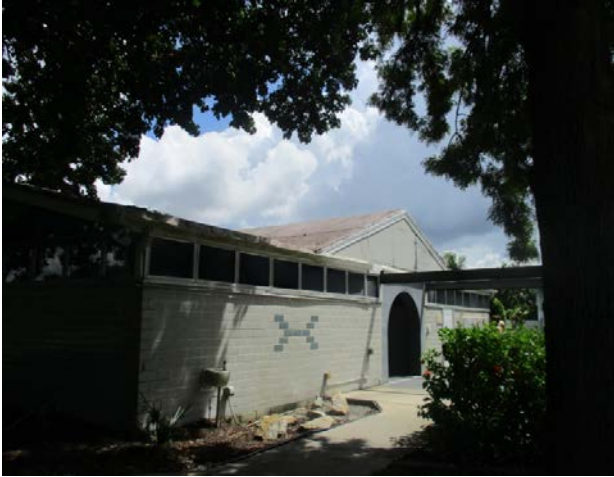
**Picture 13**  
Building 2 - View West to East of Building Front

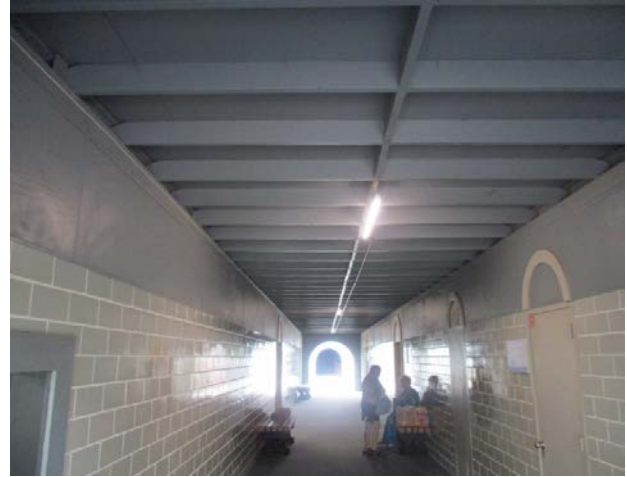
**Picture 14**  
Building 2 - Breezeway Looking South. Ceiling Joists.

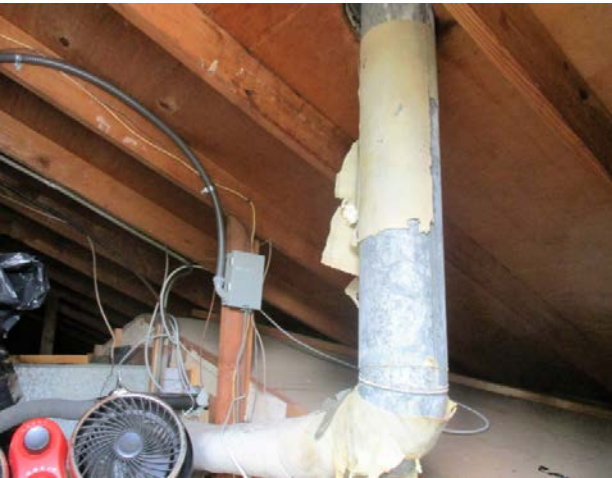
**Picture 15**  
Building 1 - Center Section & Support on Side Roof Deck

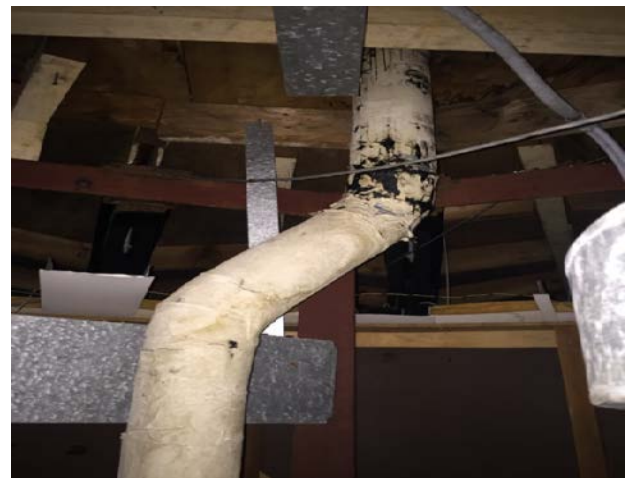
**Picture 16**  
Building 3 - Cyclorama Steel Collar & Support for Bar Joists
