# Damage Assessment Report

**Warm Mineral Springs Park Warehouse 1**

**Address: 12200 San Servando Ave**

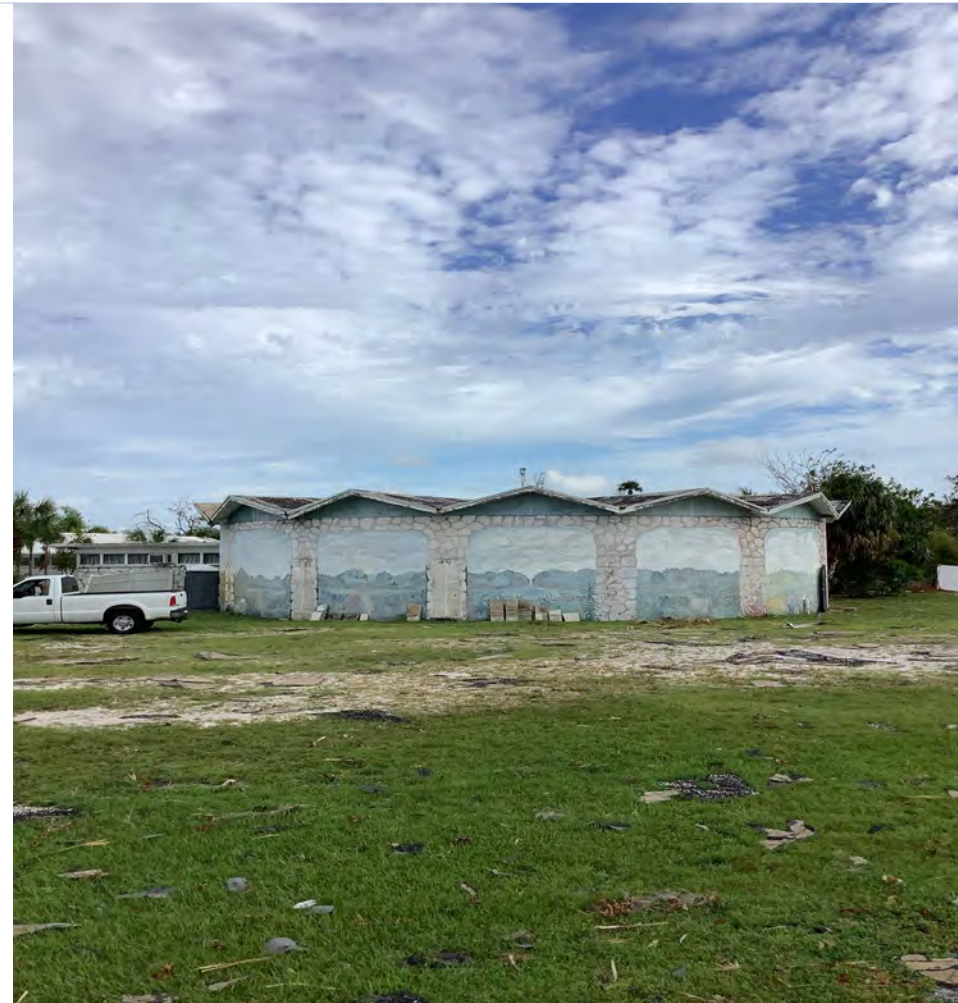
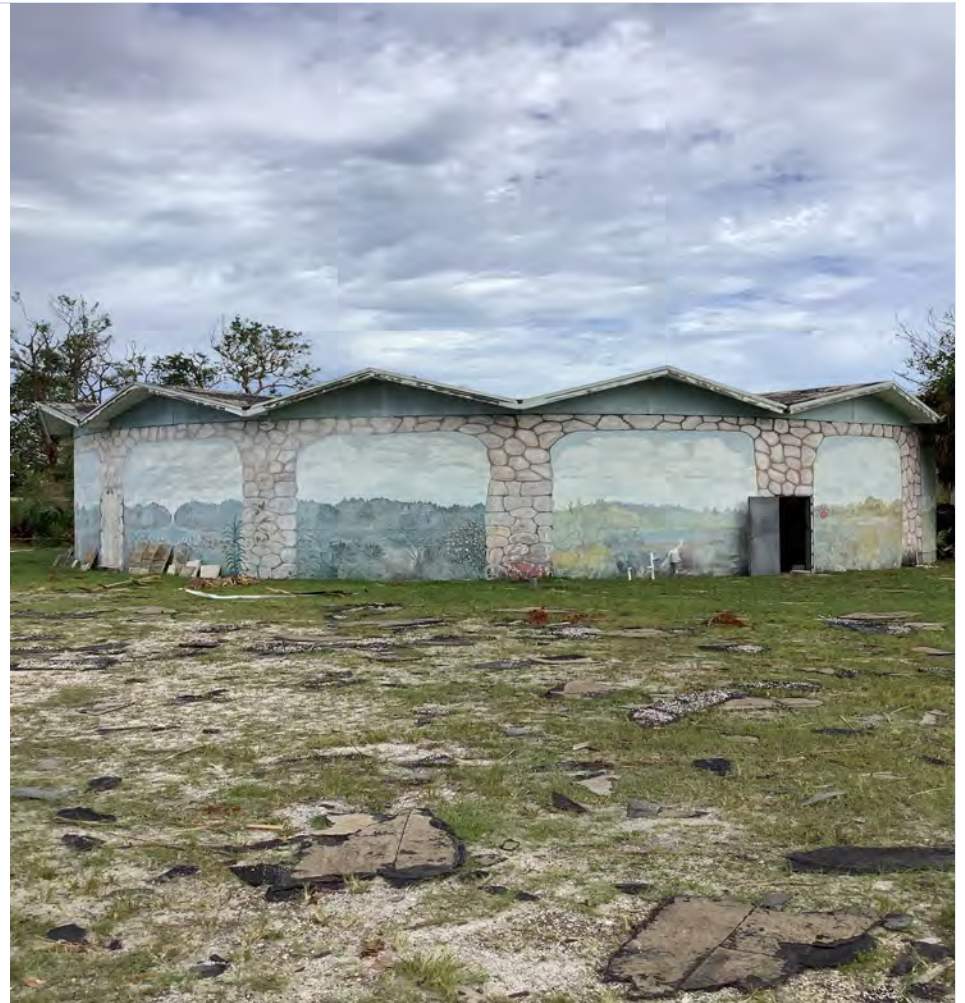
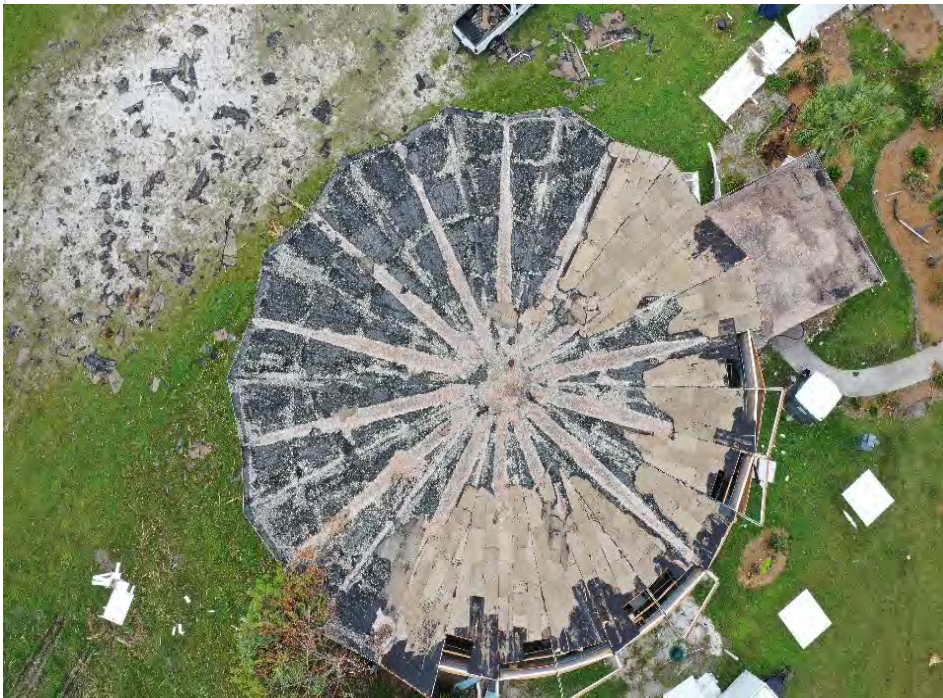
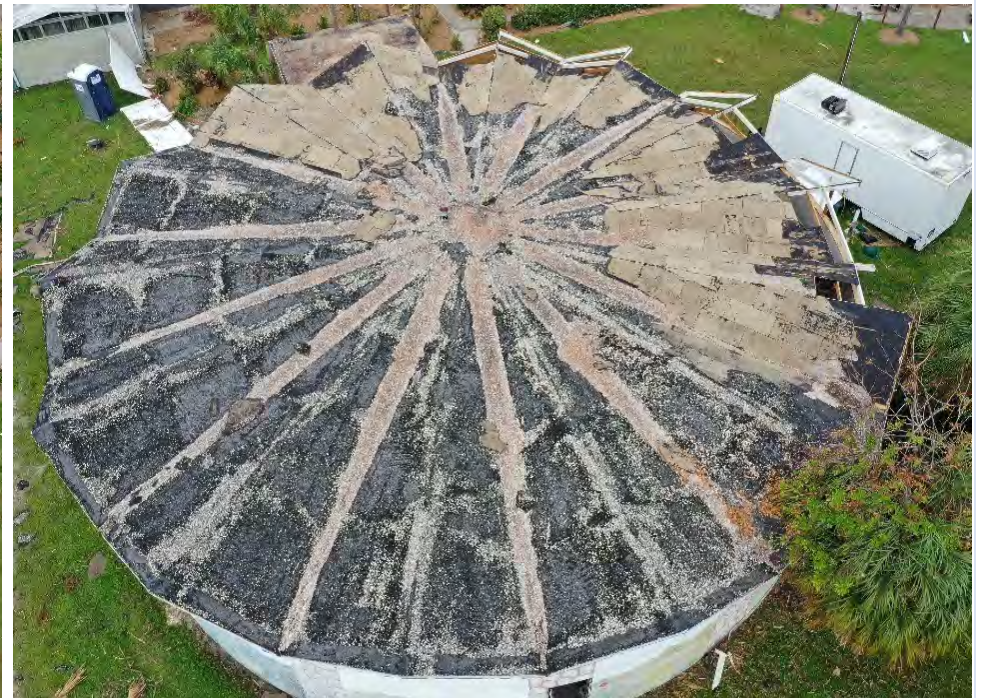
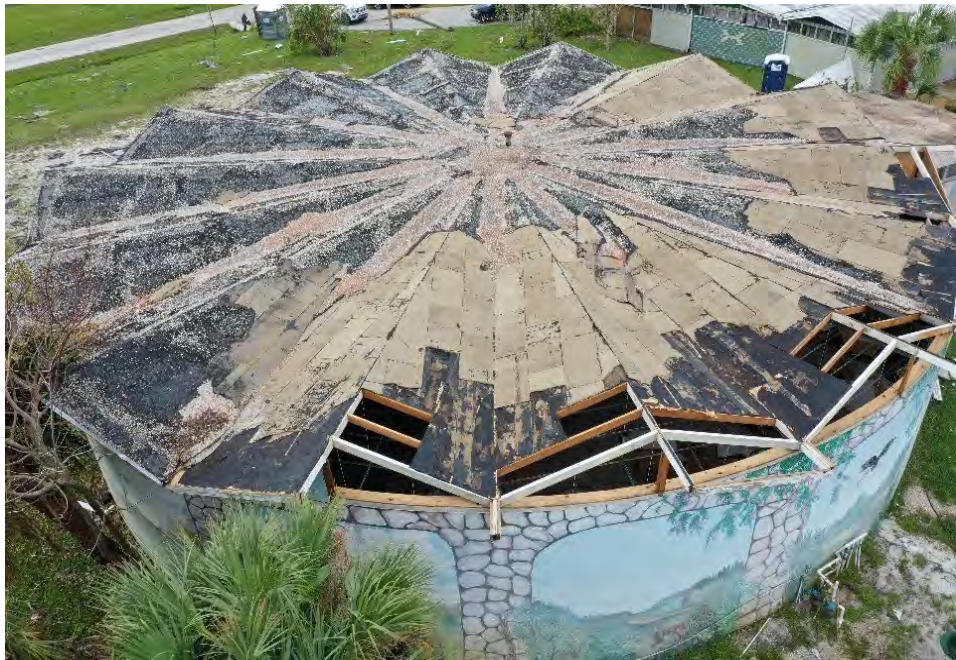
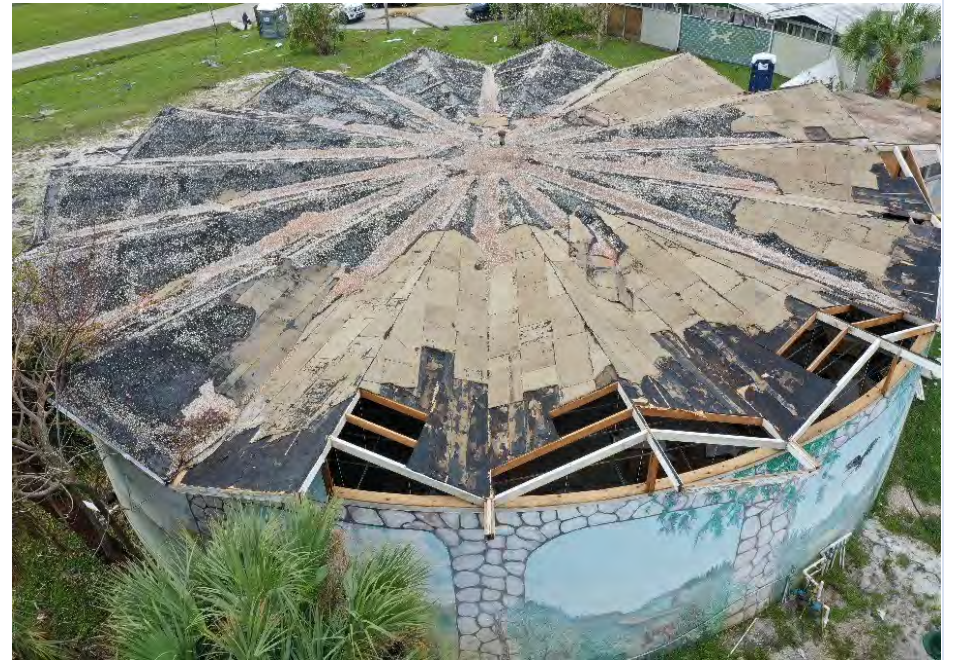
**Elevation: North**

Roofing

5,375 SF gravel ballast roofing

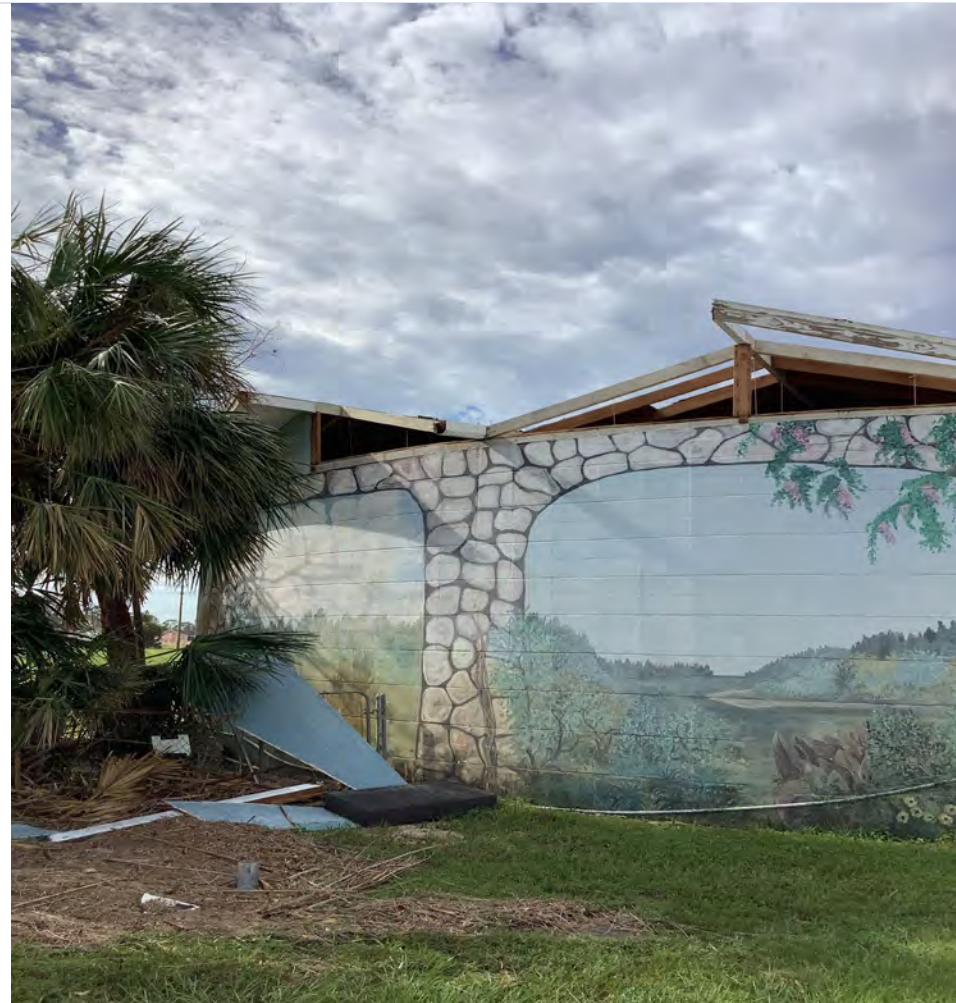
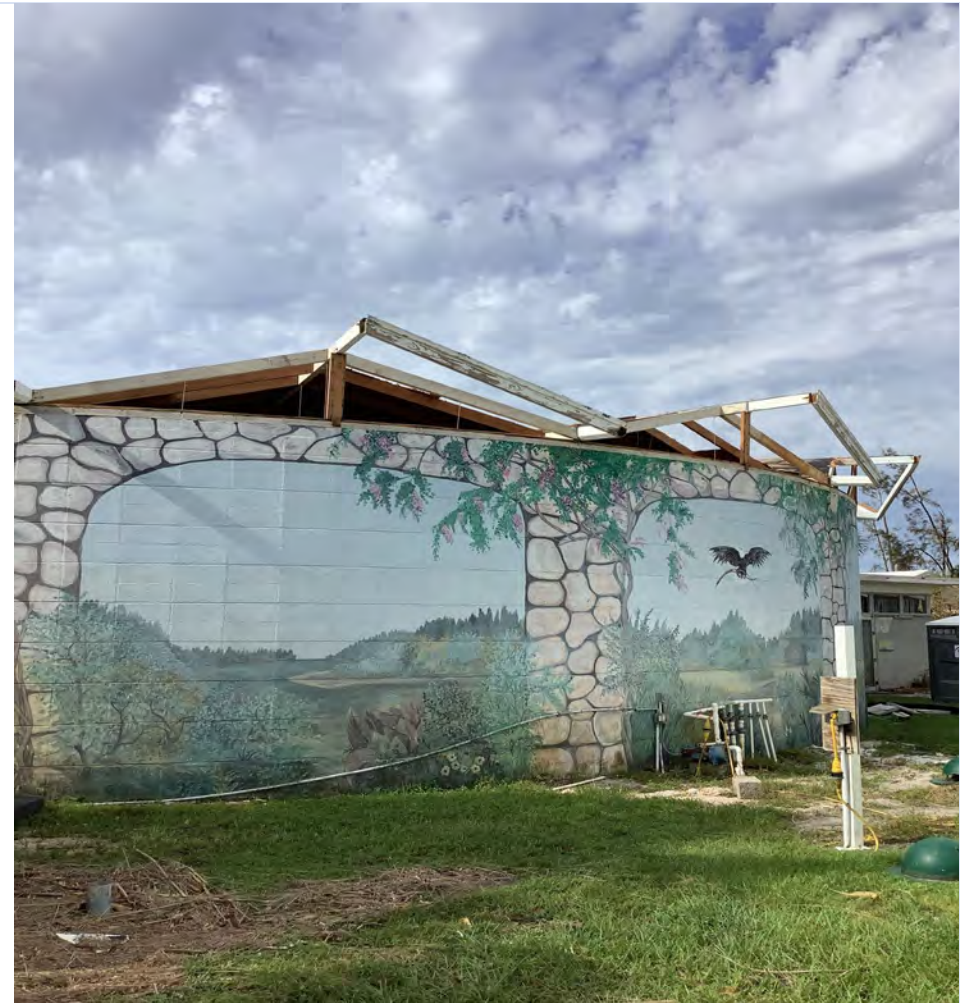
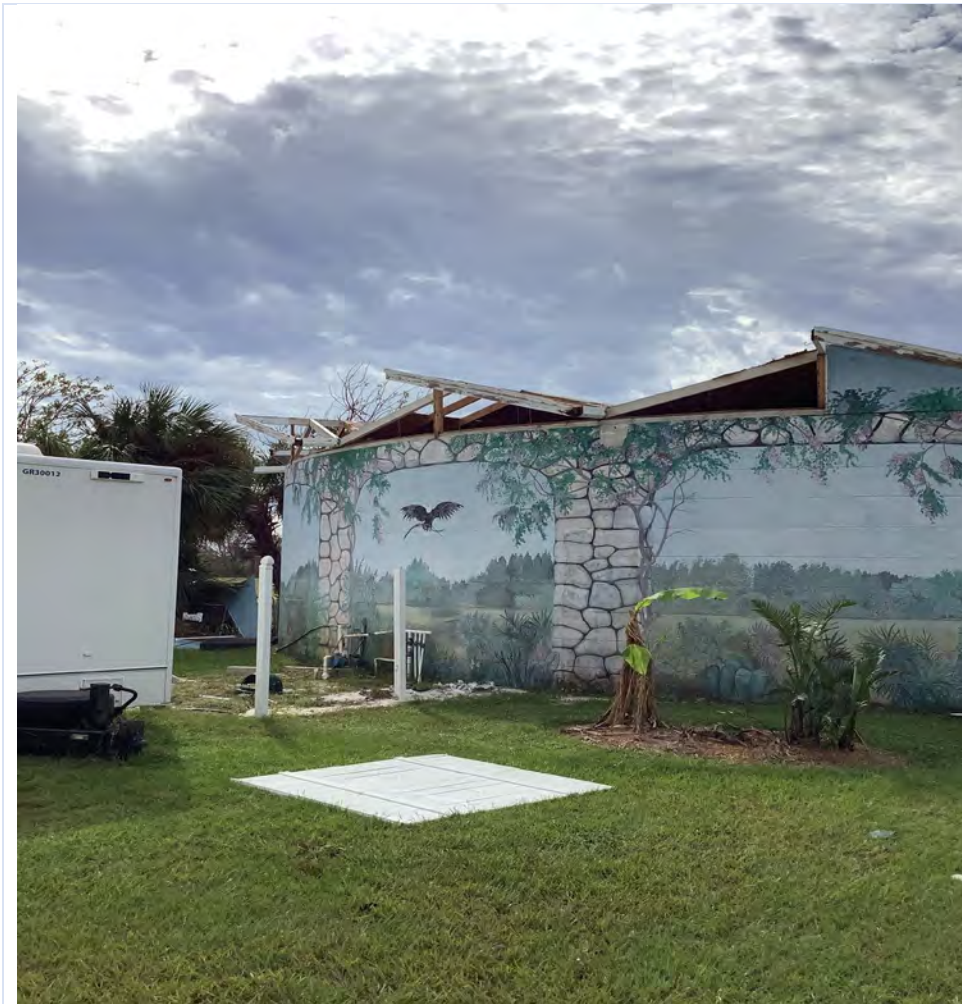
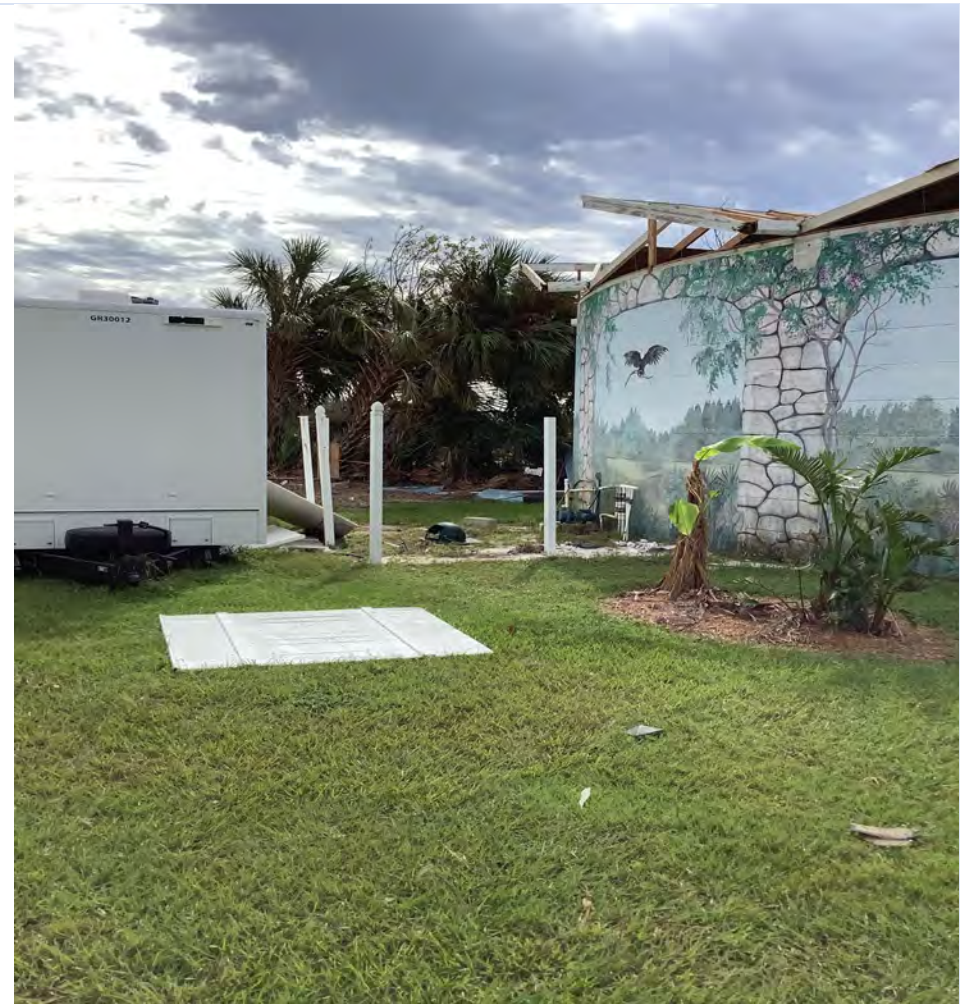
**Elevation: South**

Roofing, Framing

420 LF pressure treated lumber 2" x 6" (joist, hangers, and support bracing)

88 SF plywood siding 1/2"

6 EA vinyl post 8'H

5 EA vinyl fencing sections 6'H

208 SF plywood roof decking 3/4"

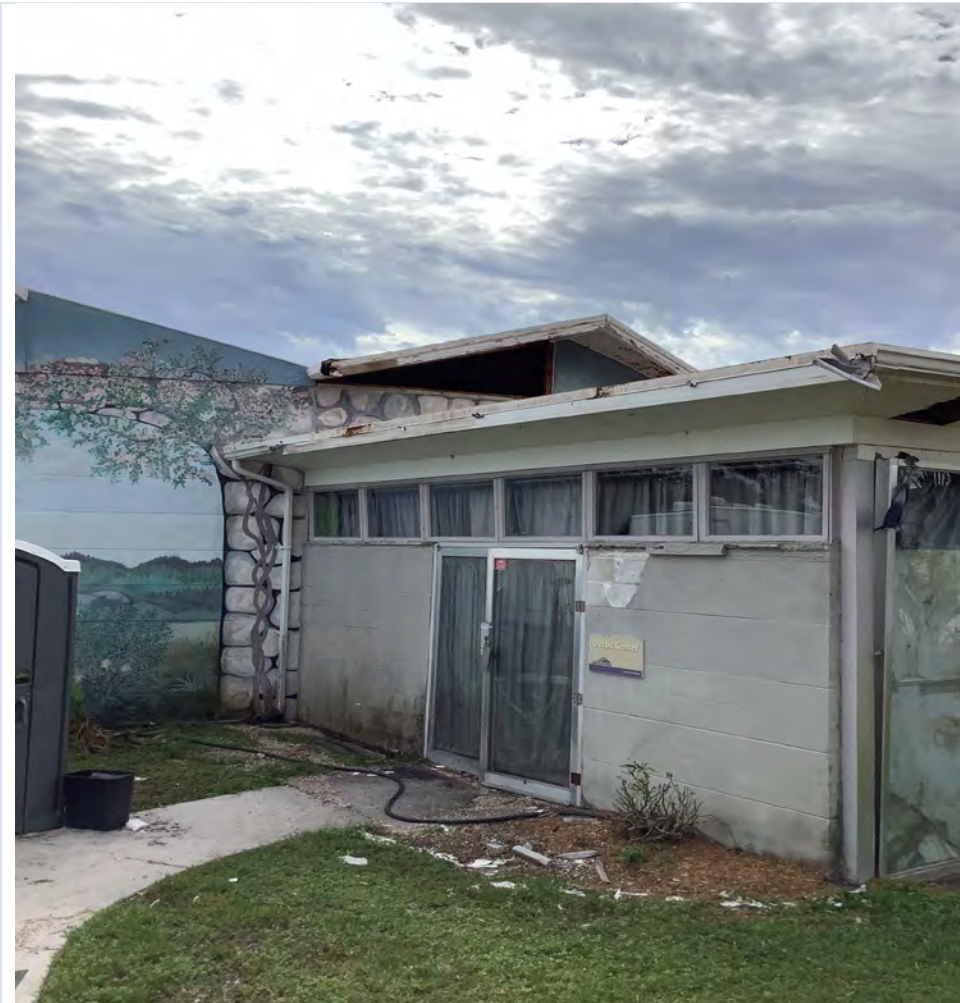
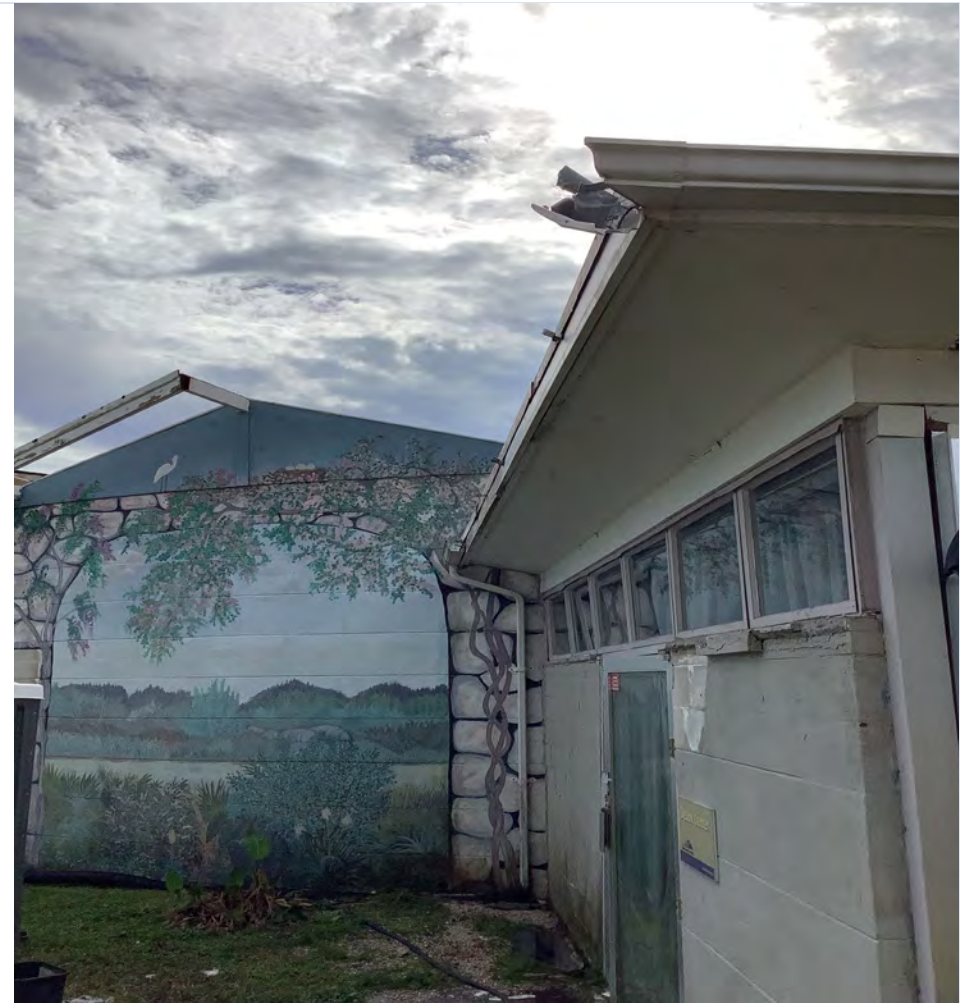
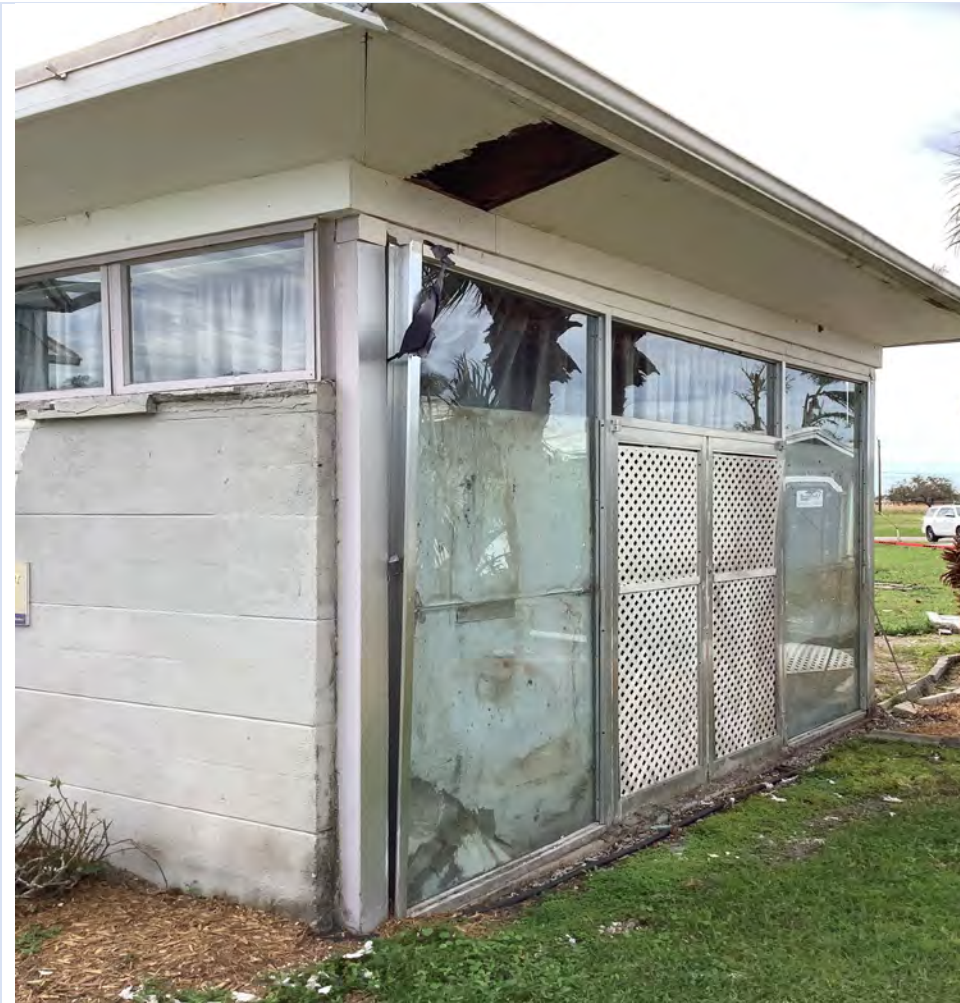
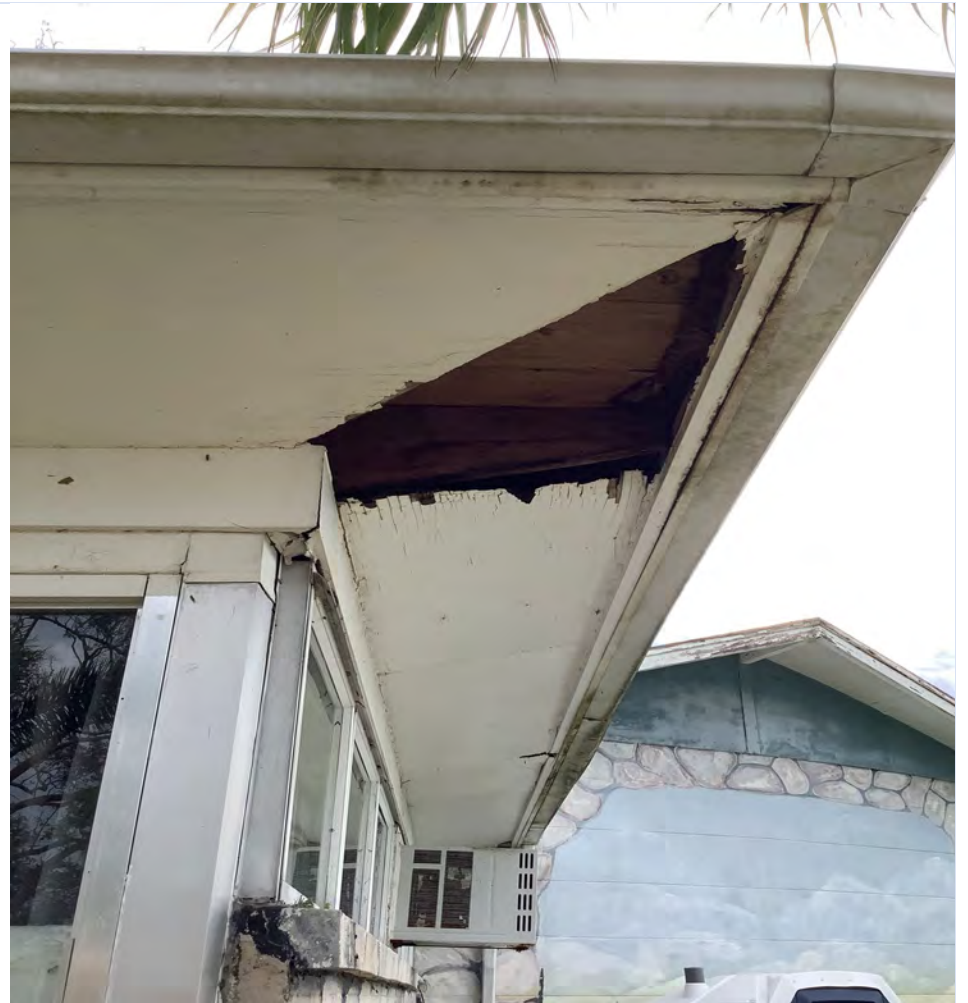
**Elevation: East**

Wall, Roofing, Gutter

20 LF K-style aluminum gutter

8 SF plywood soffit board 1/2"

16 SF plywood siding 1/2"

1 EA aluminum framed swing window 4' x 8'

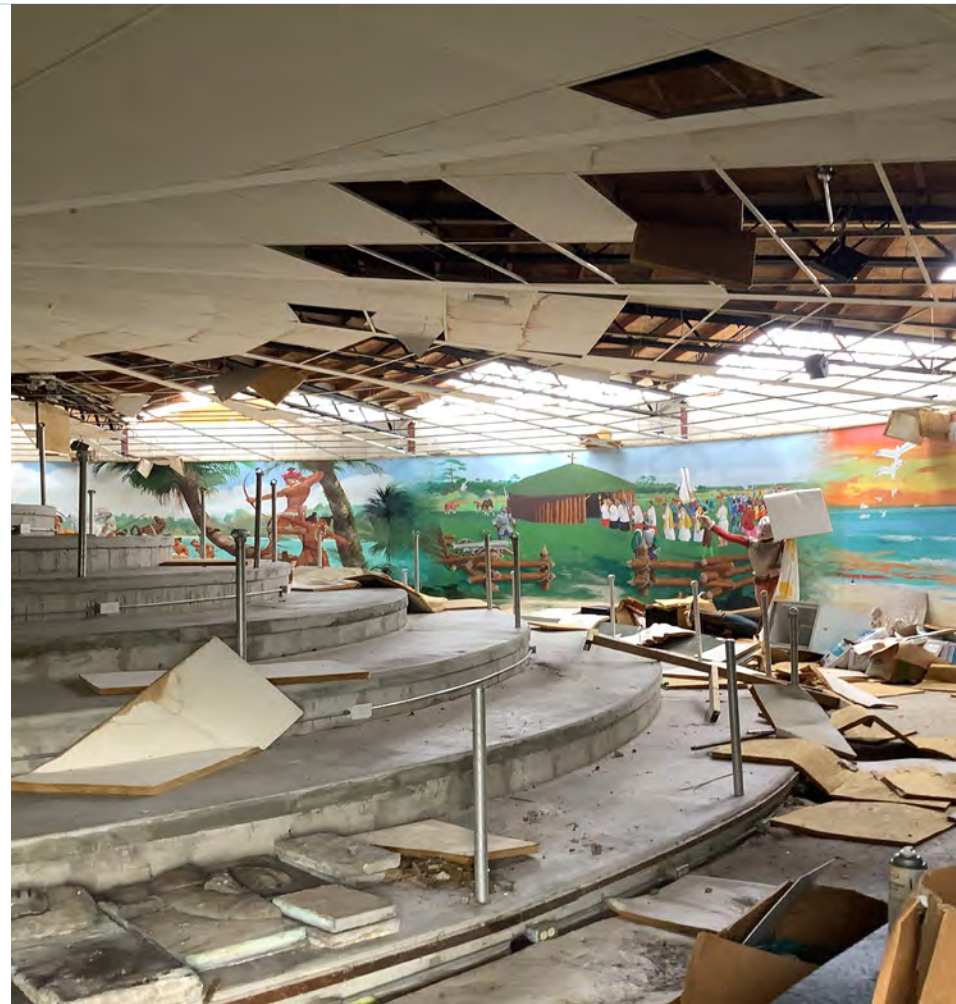
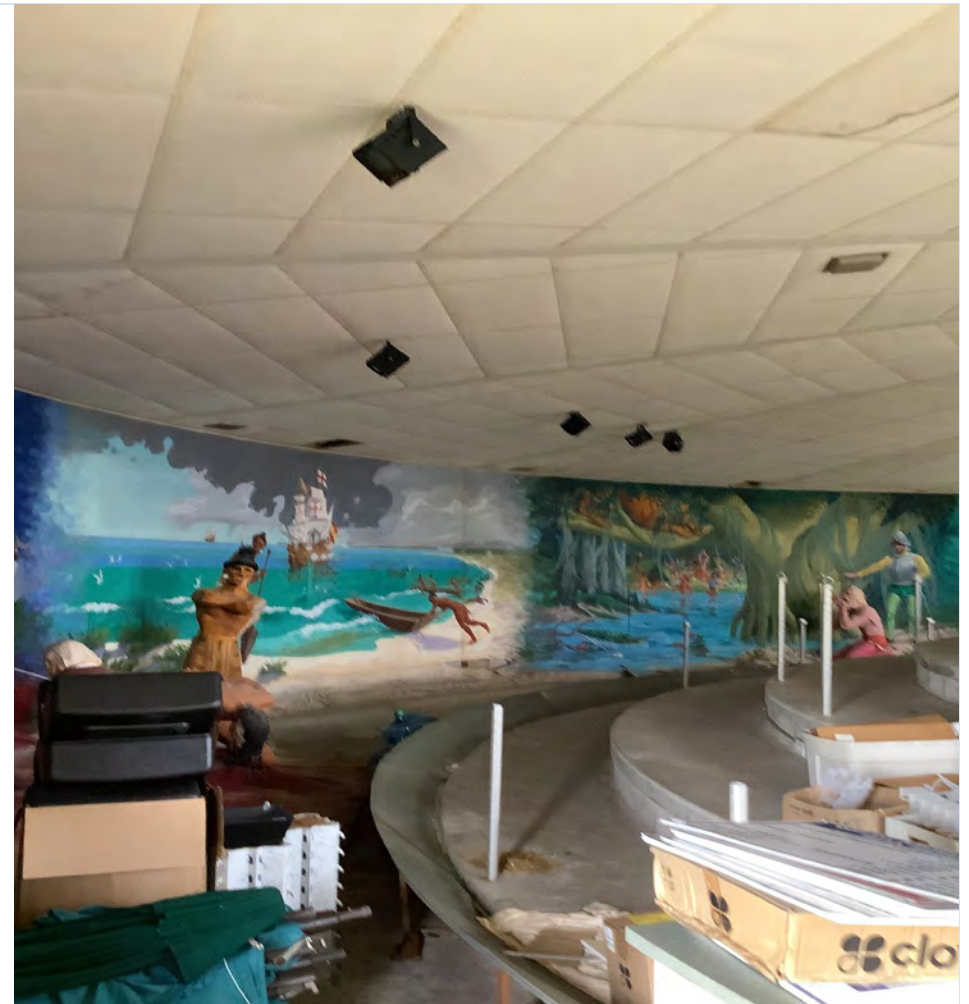
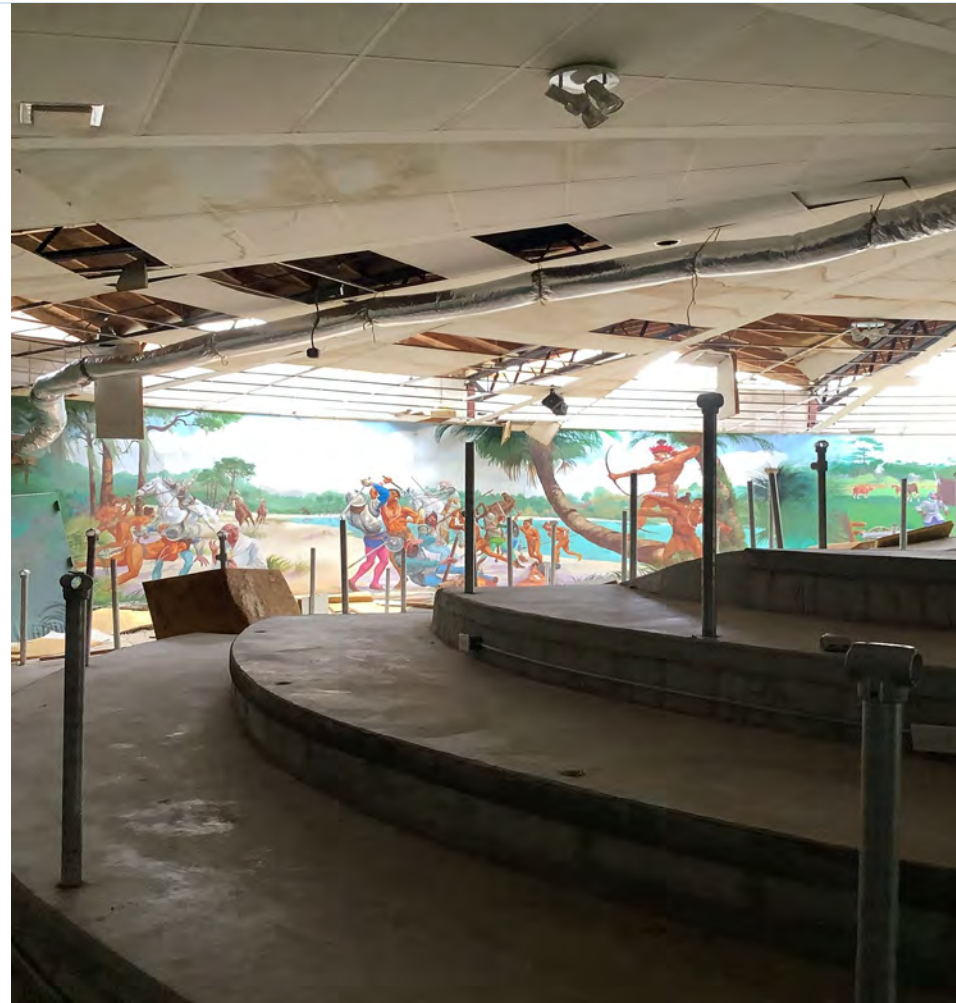
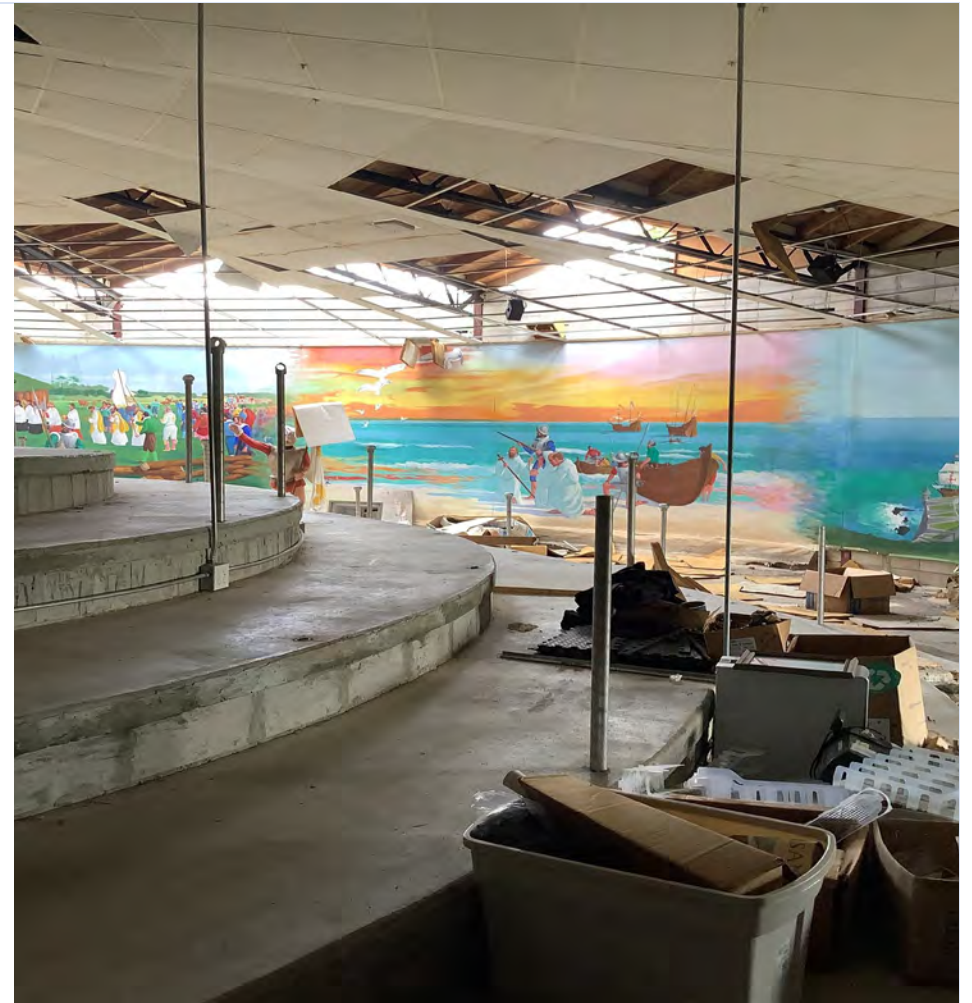
**Room #: Auditorium**

Ceiling, Wall, Electrical

5,049 SF ACT 2' x 4'

5160 LF metal grid track system

50 EA painted canvas panels with mesh grate backing 4' x 10'

12 EA effect lighting multicolor option spot lighting

6 EA flush mount enclosed lights 75 watt (2 bulb)

2 EA surface mount halogen spot light 3 light set

12 EA metal dividers strips 1/8" x 8"
