Date: January 9, 2026
To: City of North Port Department of Public Works
From: HighSpans Engineering, Inc.

Subject: Memorandum of Condition Assessment and Recommendations for Timber Pedestrian Bridges in the City of North Port

This memorandum provides a summary of the structural condition and recommendations of three timber pedestrian bridges owned and maintained by the City of North Port at locations indicated below. The bridges were inspected on December 10, 2025 by HighSpans Engineering and a more detailed report and condition assessment will be provided at a later date:

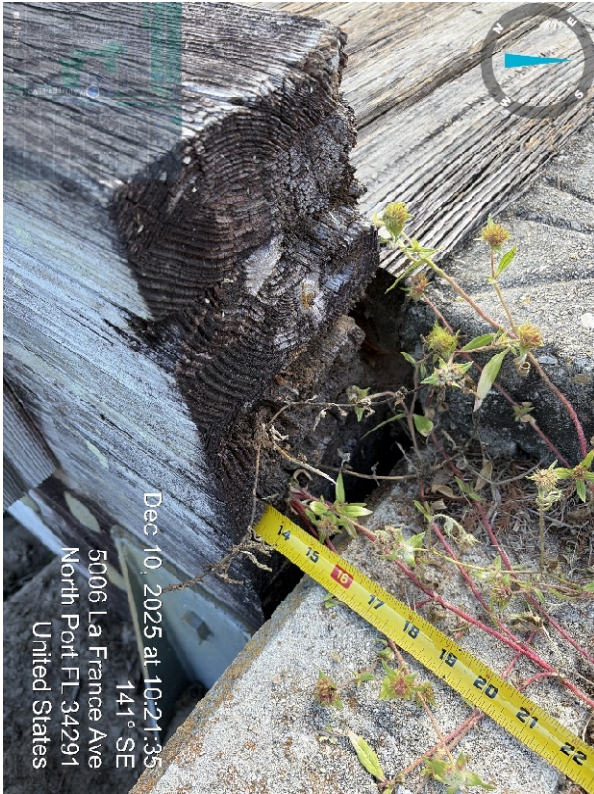
Structural deficiencies are present in the primary load carrying members of all three bridges. Rotting has been confirmed in the ends of all glulam arch beams with the maximum confirmed cavity being 14-inches deep along the length of the beam at Bridge 5. Due to the proximity to the concrete substructure,

Figure 4: Rot in arch beam end at Bridge 5 (typical for all bridges)

- Clean rot from arch beam ends and top surface and inject voids with wood epoxy.
- Provide metal flashings at ends of arch beams to protect from future water runoff.
- Seal openings/crevices created by delamination shown in Figures 8 and 9 with wood epoxy to prevent water intrusion and further deterioration.

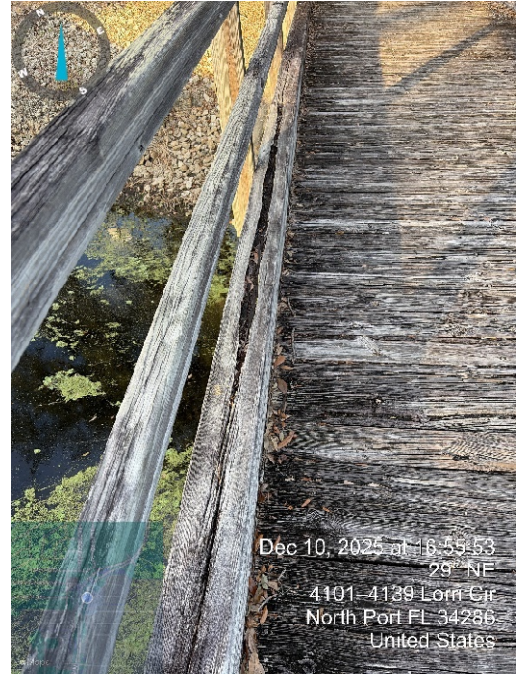
most of the beam end is inaccessible and the extent of this issue is not fully known. At Bridge 8, rotting has also been identified at the top surface of the beams at midspan with a depth of up to 2-inches missing from the beam. Finally, partial delamination of the beams was identified at Bridges 5 and 8. This severe deterioration of the arch beams has significantly reduced the load carrying capacity of the bridges. Additional defects are also present in the foundations with loose anchor nuts, concrete spalling, and non-uniform settlement.

Figure 6: Rot in top of arch beam at Bridge 8

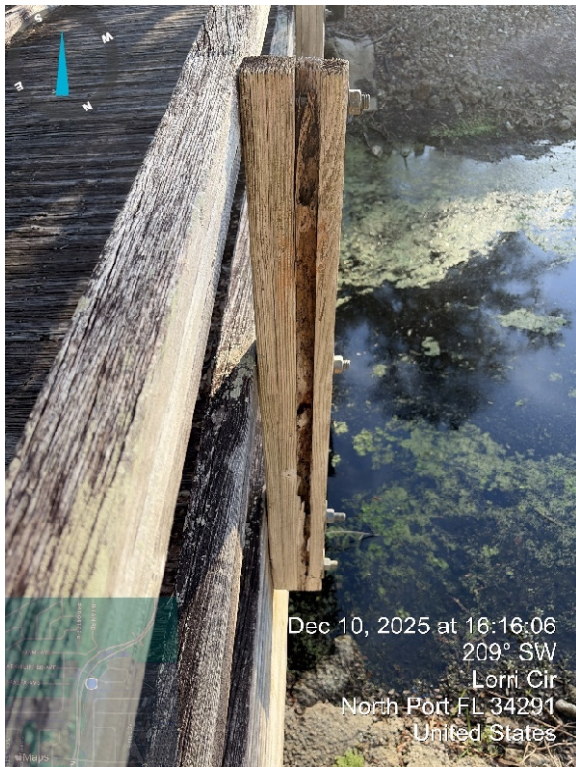
All three bridges are in generally poor condition and exhibit both serviceability and structural deficiencies. The primary concern with serviceability is the condition of the railings. Severe rot of several railing posts has resulted in a loose and weak railing. Additionally, the railing design does not meet the current requirements of the Florida Building Code, Building Section 1015.4 which stipulates that no openings shall be greater than 4-inch whereas the current railings have 14-inch openings. In addition, the heavily deteriorated decking surface exhibits many irregularities that are not . Several gouges, rotted portions, splintering, and lifted edges create tripping hazards throughout the walking surface. While not a component of the bridge itself, the connecting sidewalk also exhibits several tripping hazards greater than ½-inches high due to ground settlements.

Figure 5: Rot in railing post at Bridge 8 (typical for all bridges)

- Replace each rotten post with a group of four 2x4 Southern Yellow Pine (SYP) Grade No. 2 pressure treated for ground contact (UC4B). Reuse existing 3/4" bolts.

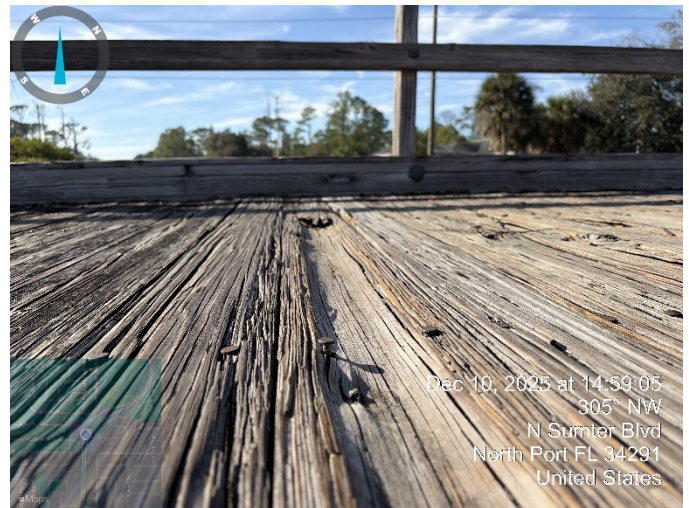
Figure 7: Worn decking creating tripping hazard at Bridge 6 (typical for all bridges)

- Overlay existing decking with 5/4" composite deck boards to restore walking surface.
- Provide solid rubber threshold mats at ends of bridge to provide ADA compliant slope up to decking overlay and utilize concrete screw anchors to secure threshold mat to concrete slab beneath.

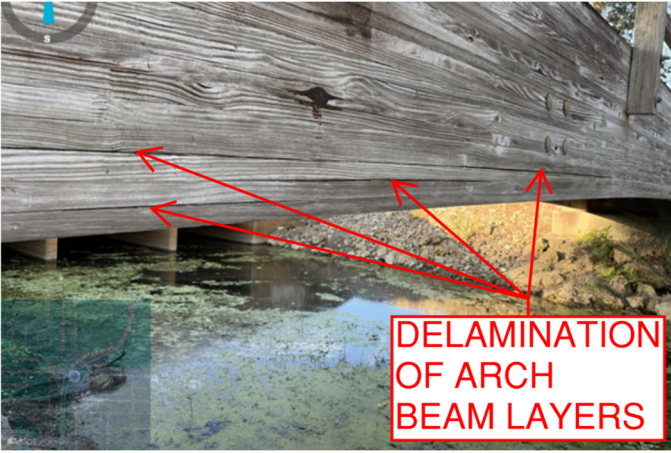
Figure 8: Delamination in Arch Beam at Bridge 8

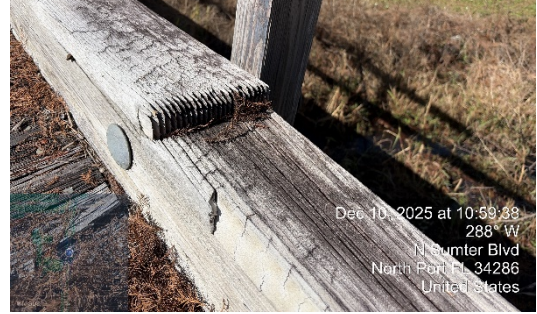
Figure 9: Delamination in Arch Beam at Bridge 5
