MCEP BRIDGE AND OBSERVATION DECK Limited Structural Condition Assessment

6968 Reisterstown Road
North Port, FL 34291

NPORT22004

March 10, 2023

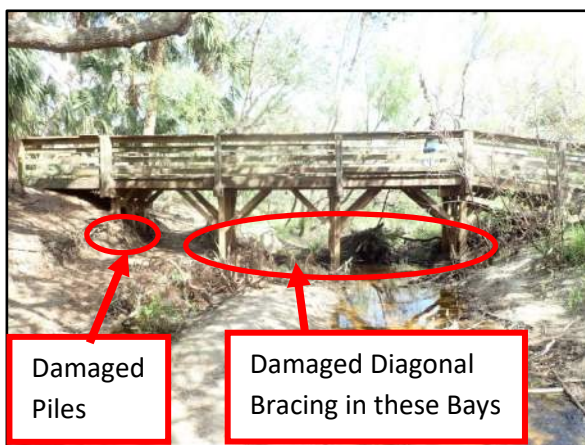
Picture 1 – Northwest Entrance Of Bridge

- A. At least two timber piles supporting the bridge deck at the northwest entrance were noted to have significant deterioration and loss of cross section. The location of these piles was marked in **Picture-1** below. It was noticed that this bridge has active equestrian traffic. The typical weight of a mature horse is above 1200lb; the state of these piles represents a safety concern with such loads. **(See Photograph 2)**.

- B. Wood diagonal braces between timber piles below deck has significant deterioration and corrosion in steel bolt connection **(See Photograph 3-4)**. The location of these damaged braces was also shown in **Picture-1** below.

- A. If the bridge is desired to remain in operation for equestrian traffic until repairs are made, it is recommended to install temporary shoring.
- B. New timber piles or steel helical piles can be added next to the damaged piles to support the bridge framing.

- a. Geotech testing will be required to obtain site specific soil information for the design of the new piles.
- C. Remove and replace damaged diagonal bracing between piles below deck with new pressure treated wood diagonals.

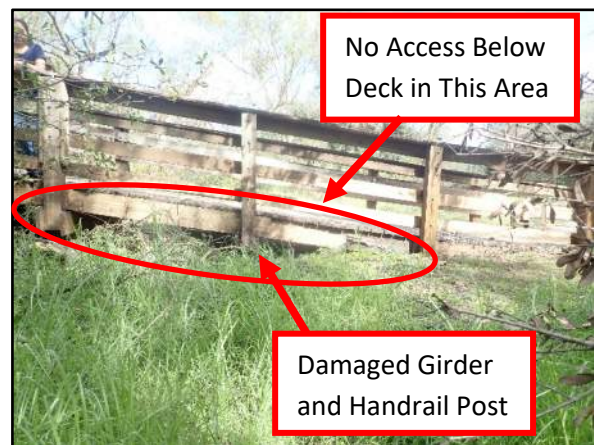
Picture 2 – Southeast Entrance Of Bridge

- C. The framing below deck in the initial 20ft length of the deck at southeast end could not be inspected due to lack of access. See **Picture-2** below showing the southeast end.

- D. Damages in the first line of girder on southeast end. The location of this girder was also shown in **Picture-2** below.
 - i. Separation between handrail post and girder **(See Photograph 5A)**.

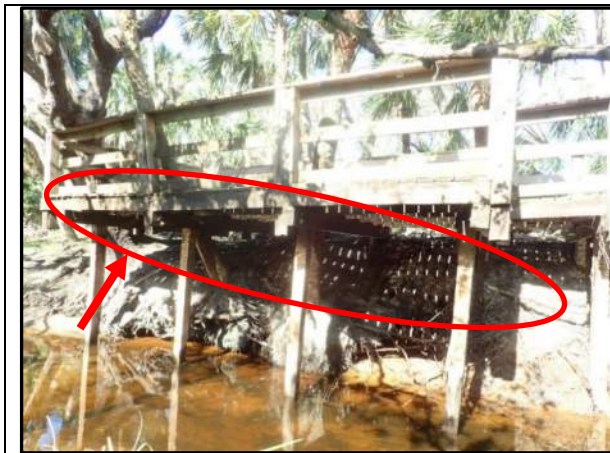
Picture 3 – South End of Observation Deck

- A. The four timber piles supporting the observation deck on south end and in direct contact with water have significant deterioration and loss of cross section (**See Photograph 12-13**). The location of these damaged piles was shown in **Picture-3** below.
- B. Many large trees are located at close proximity to the deck in the wider region of south end (**See Photograph 11-15**). The location of these damaged piles was shown in **Picture-4** below.
 - i. Two palm trees are located in the middle of the deck, with openings made in deck around the tree's trunk. One of the palm trees is leaning against the handrail.
 - ii. Large oak tree at corner with branches resting on handrail.
 - iii. The weight of these trees resting on the handrail can cause overstress in the handrail and deck framing. The railings area leaning due to the weight of the trees.

- A. Based on the damages observed in four piles in water and additional distress that can be caused by the trees resting on handrail, we recommend restricting access at least for a partial portion of the observation deck in south end as shown in **Figure 2** below.

- B. New timber piles or steel helical piles can be added next to the damaged piles to support the bridge framing.
 - a. Geotech testing will be required to obtain site specific soil information for the design of the new piles.
- C. Remove and replace damaged handrail vertical posts above deck with new pressure treated posts.
- D. Remove and replace damaged 2x6 deck panels with new pressure treated deck panels.
- E. All other piles, beams, and girders below deck should be inspected further when the deck panels are being removed. Targeted repairs may be required as needed to reinforce any damaged members.
- F. Replace corroded steel connections with new stainless-steel bolts.

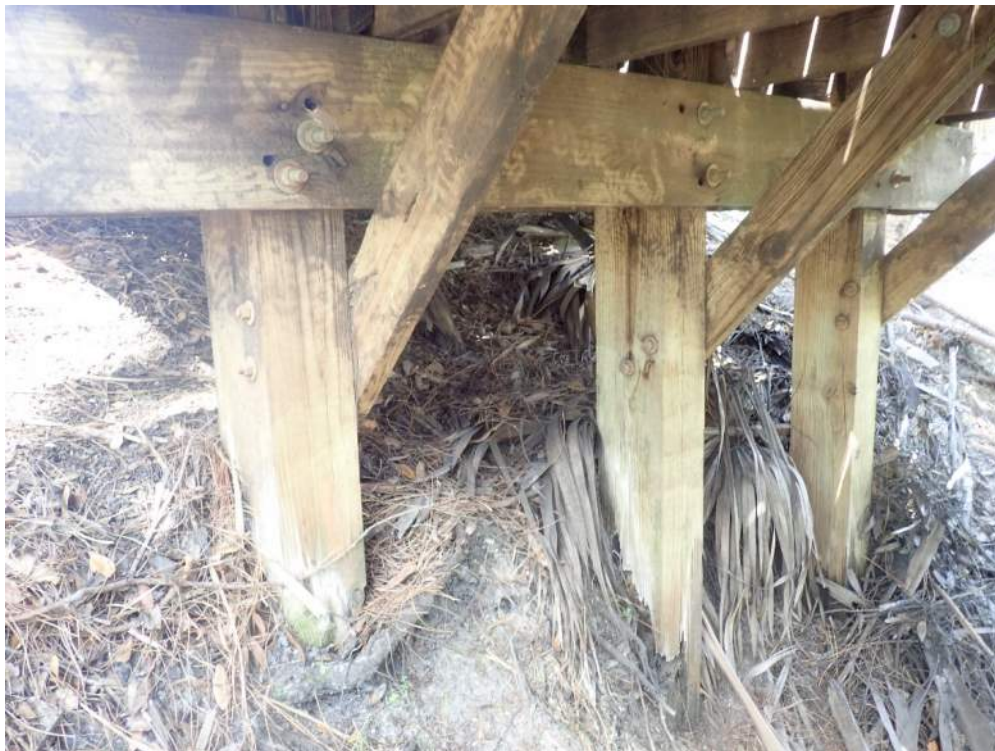
Photograph #2: Damaged Piles

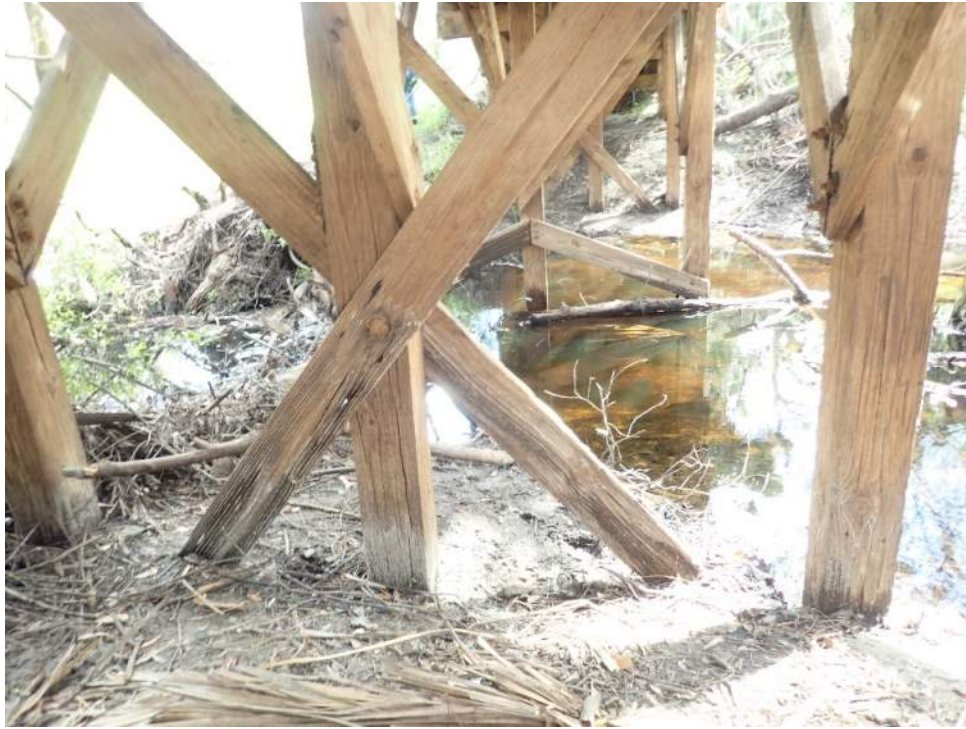
Photograph #3: Damaged Brace

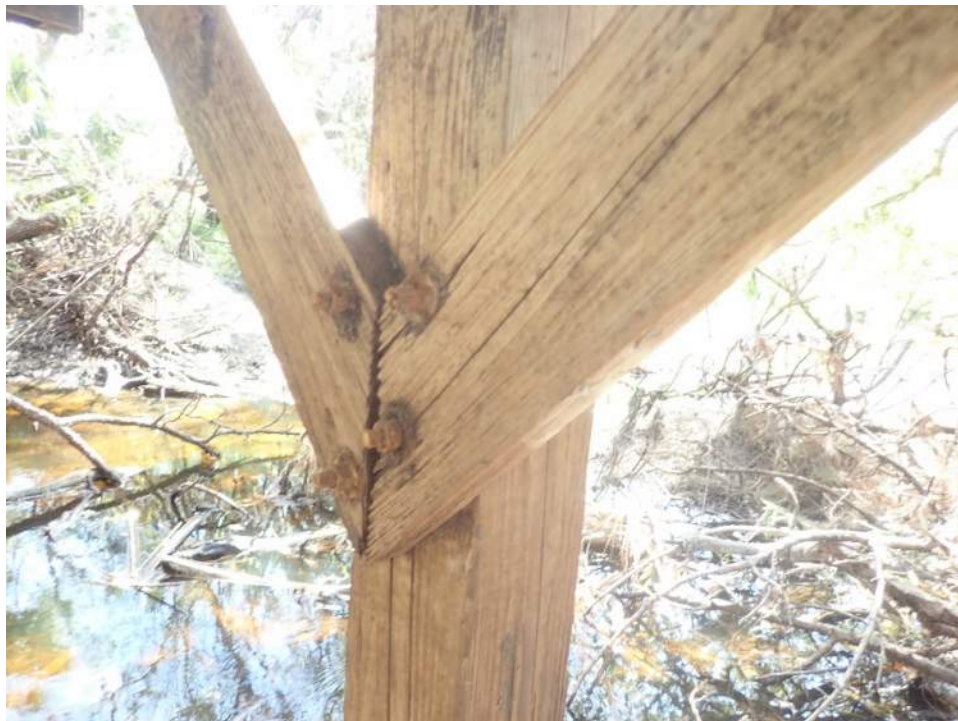
- F. Corroded bolts were noticed in several locations: **(See Photograph 3-6)**
 - i. Diagonal bracing to piles connections.
 - ii. Handrail posts to girders connections.

Photograph #4: Corroded Bolts

- D. Replace corroded steel connections with new stainless-steel bolts.
- E. Remove and replace damaged handrail vertical posts above deck with new pressure treated posts.

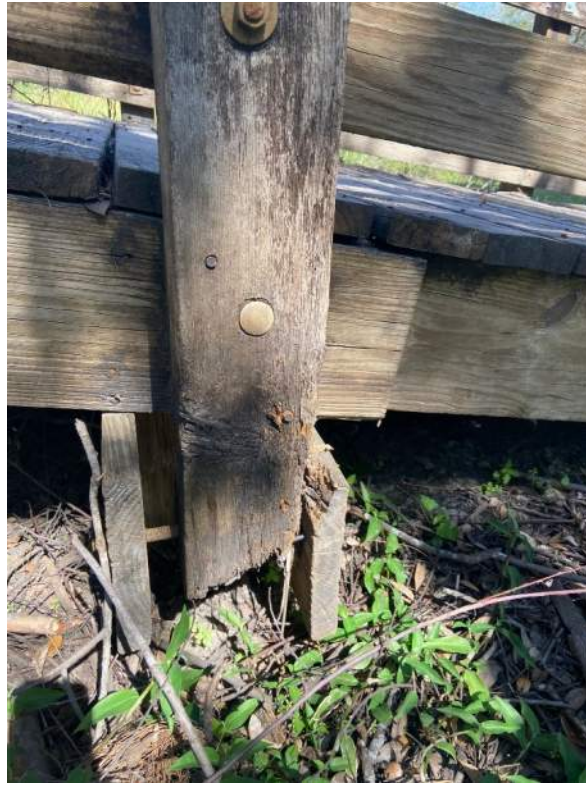
- ii. Deterioration at the end of girder at this location **(See Photograph 5A)**.
 - iii. Rotten Handrail post **(See Photograph 5B)**.
 - iv. Corrosion in girder to pile bolts and girder to handrail bolt connections **(See Photograph 5C)**.

Photograph #5A: Damaged Girder and Handrail Post

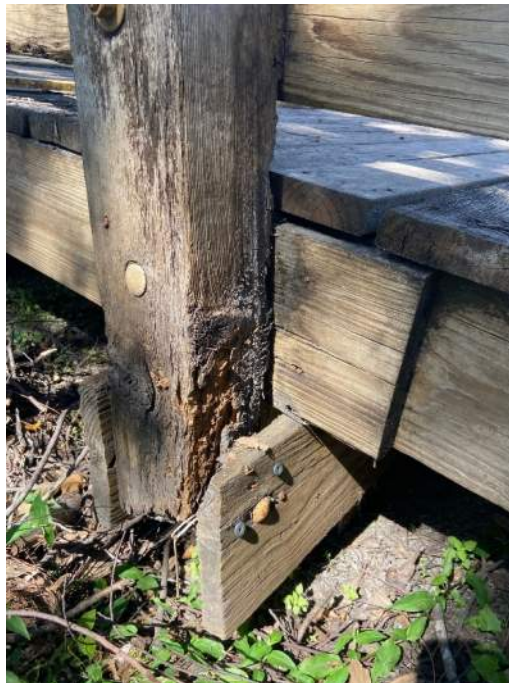
Photograph #5B: Damaged Girder and Handrail Post

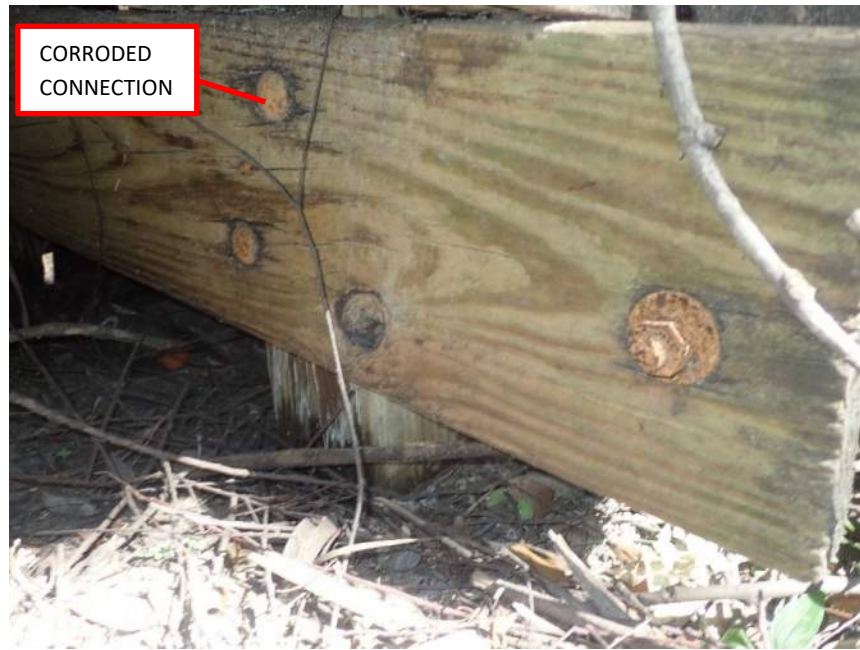
Photograph #5C: Corroded Girder to Beam Connection

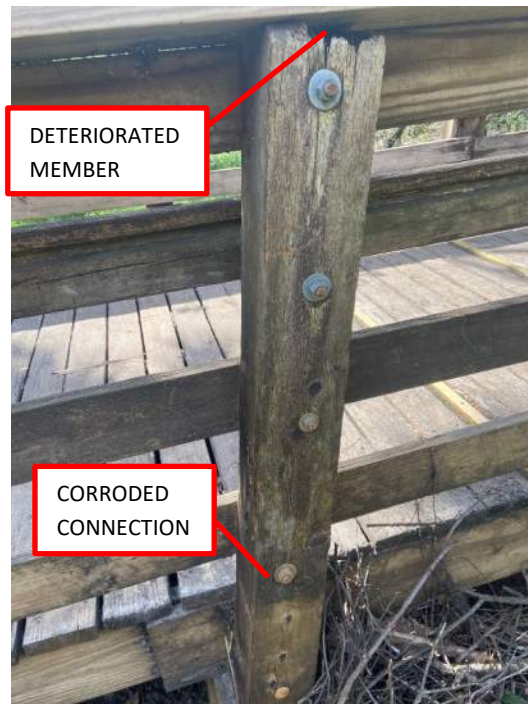
- H. Several 6"x6" vertical posts of the handrail were found to be rotten and deteriorated with water intrusion, insect and/or bird damage. Previous repair attempts were made to some of these handrail posts in the form of 2x6 members sistered to the damaged posts. The deterioration appears to be active & ongoing at several locations of the handrail post. **(See Photograph 6 & 8-9)**

Photograph #6: Damaged Handrail Post

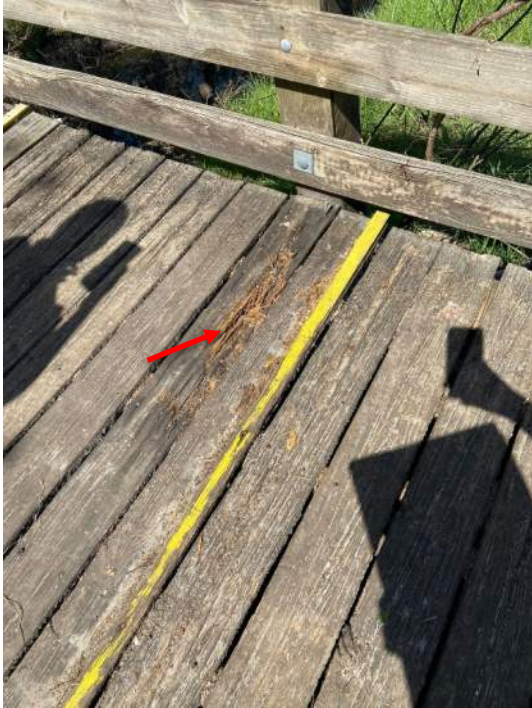
- G. 2x6 deck panels were noted to be soft and deteriorating at many places due to water intrusion, possible insect damage and vegetation growth. It appears that these deck panels are at the end of their useful life cycle. **(See Photograph 7)**

Photograph #7: Rotten Deck

- F. Remove and replace damaged 2x6 deck panels with new pressure treated deck panels.
- G. All other piles, beams, and girders below deck should be inspected further when the deck panels are being removed. Targeted repairs may be required as needed to reinforce any damaged members.

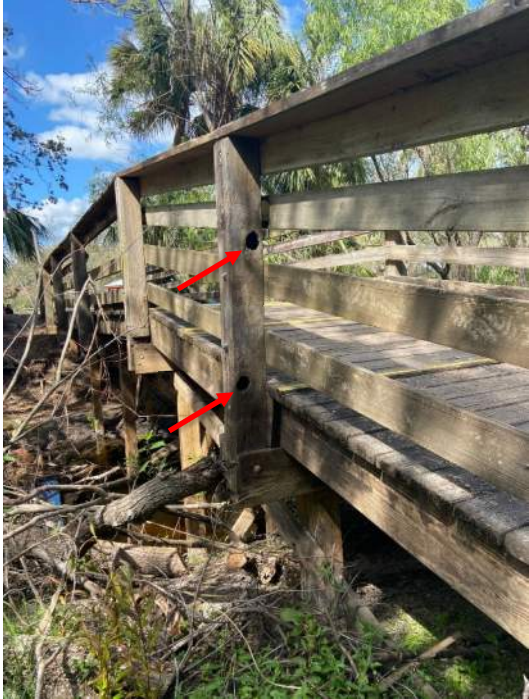
Photograph #8: Bird Damage at Post

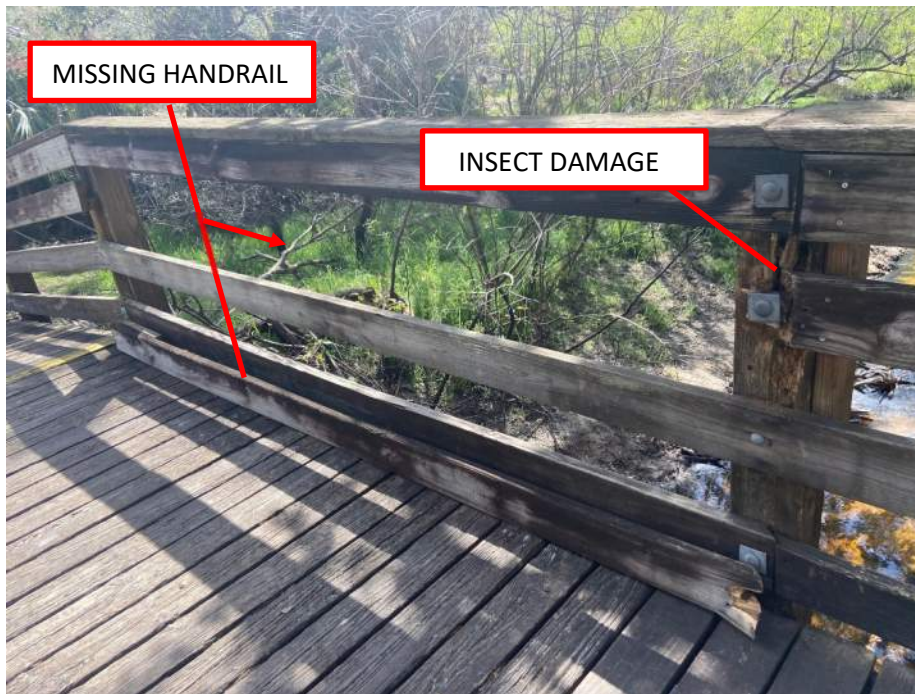
- I. One section of the handrail has missing horizontal midrail beam. It was also noted that the vertical handrail post supporting this midrail has significant damage with water intrusion and insect damage **(See Photograph 9)**. Unless the damaged vertical posts are replaced, it is likely that horizontal rails at other locations connected to damaged verticals may also fail in similar fashion.

Photograph #9: Beam Missing on Handrail

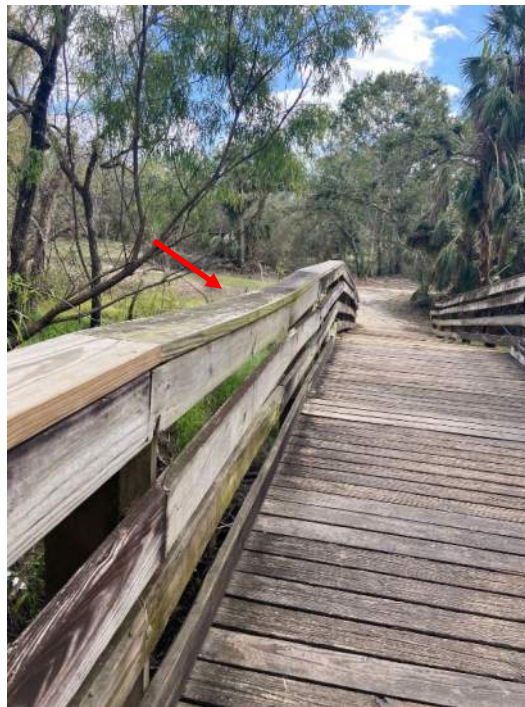
- J. It was noted that top rail at one section of handrail is deflecting. The vertical posts holding this beam were deteriorated. Previous repair attempts were made to the damaged vertical posts by sistering 2x6 members to damaged posts. **(See Photograph 10)**

Photograph #10: Deflection at Beam on Handrail

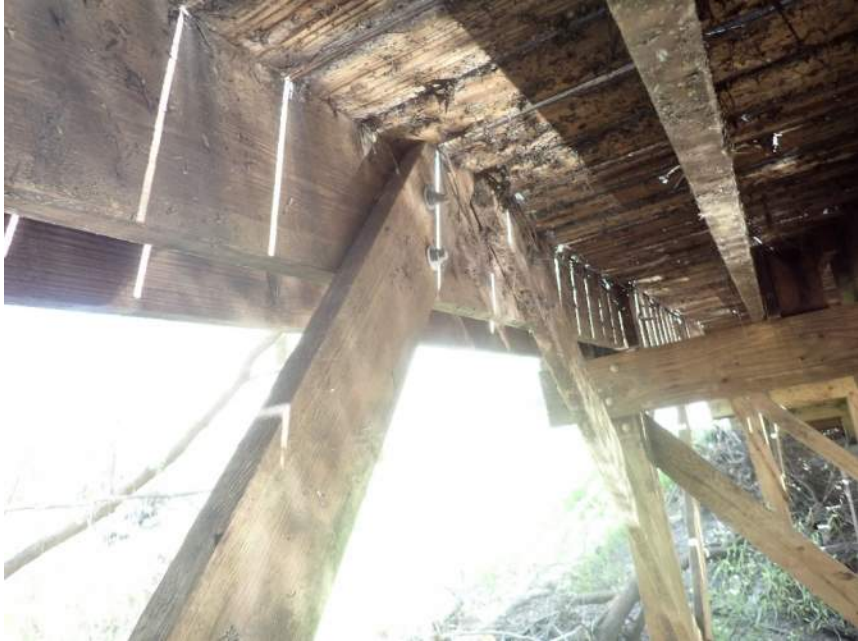
- K. Signs of raised water level were noticed. It was pointed out that during Hurricane Ian, the park was flooded and for more than a week inaccessible. **(See Photograph 11)**

Photograph #11: Debris Underside the Deck

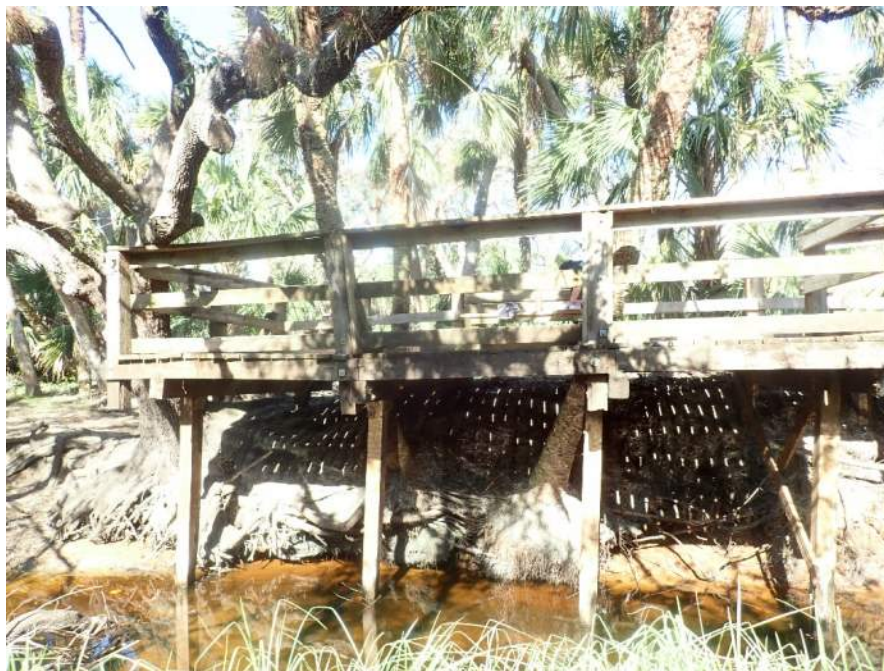
Photograph #12: Piles on Water

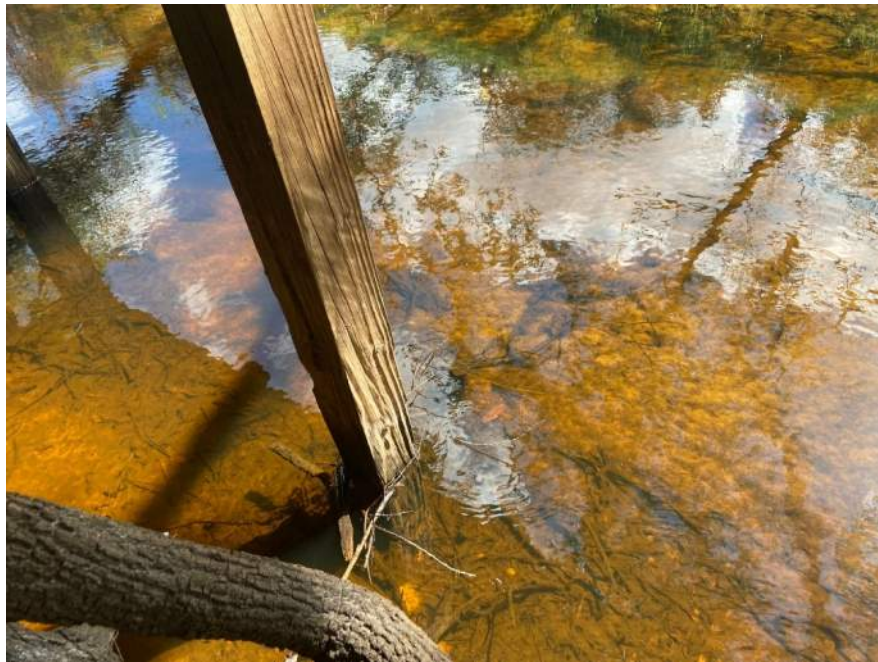
Photograph #13: Damaged Pile

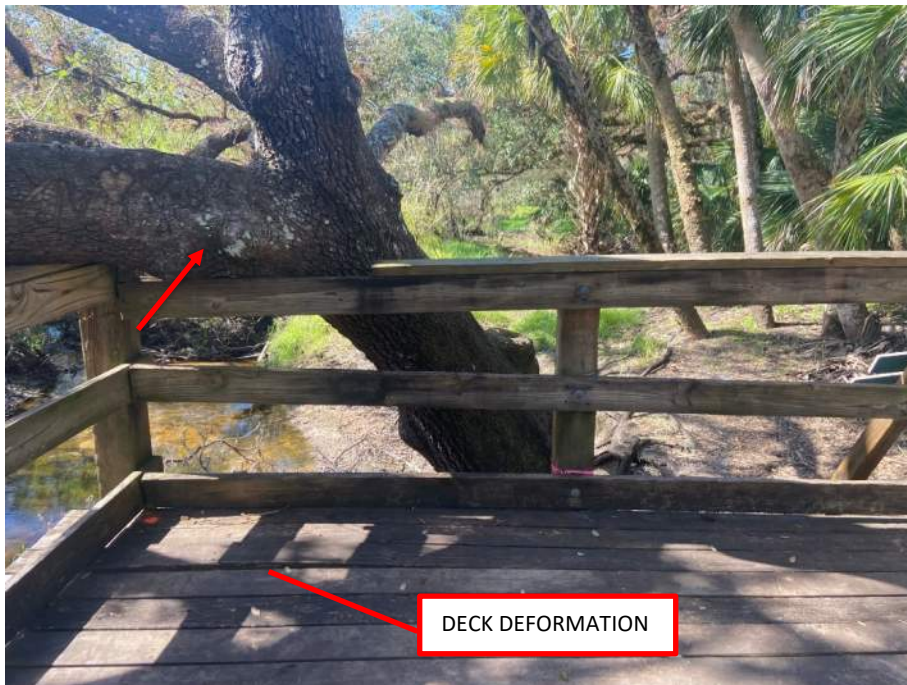
Photograph #14: Tree Branch Resting on Handrail

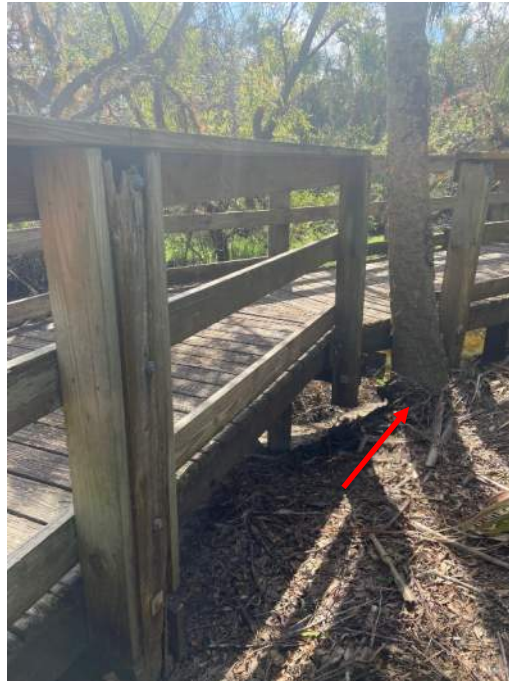
Photograph #15: Tree Very Close by to Deck

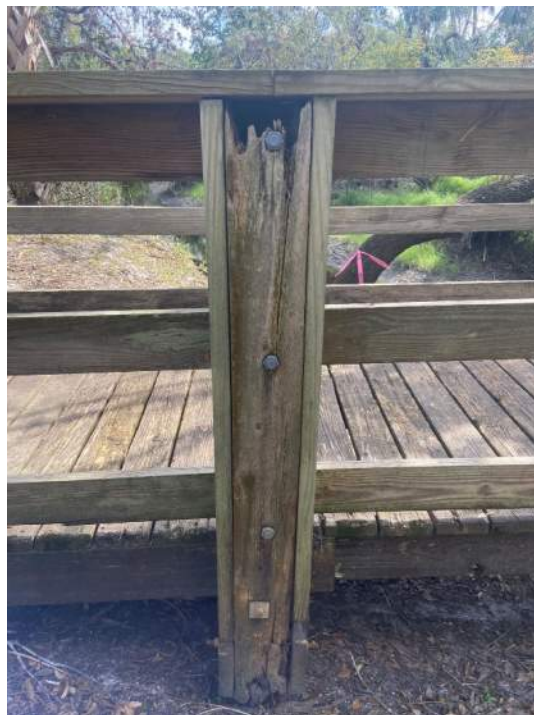
- C. Several 6"x6" handrail posts above deck have insect damage, water intrusion and/or missing bolts connections. Some of this post have previous repairs attaching 2"x6" to add additional support to the handrail. The insect infestation appears to be active & ongoing at several locations of the handrail post (**See Photograph 15-17**).
- D. The beams and girders below the deck that were inspected during our limited visual inspection appeared to be in acceptable condition at the time of our site visit.
- E. 2x6 deck panels were noted to be soft and deteriorating at many places due to water intrusion and possible vegetation growth. It appears that these deck panels are at the end of their useful life cycle (**See Photograph 18**)

Photograph #16: Damaged Post

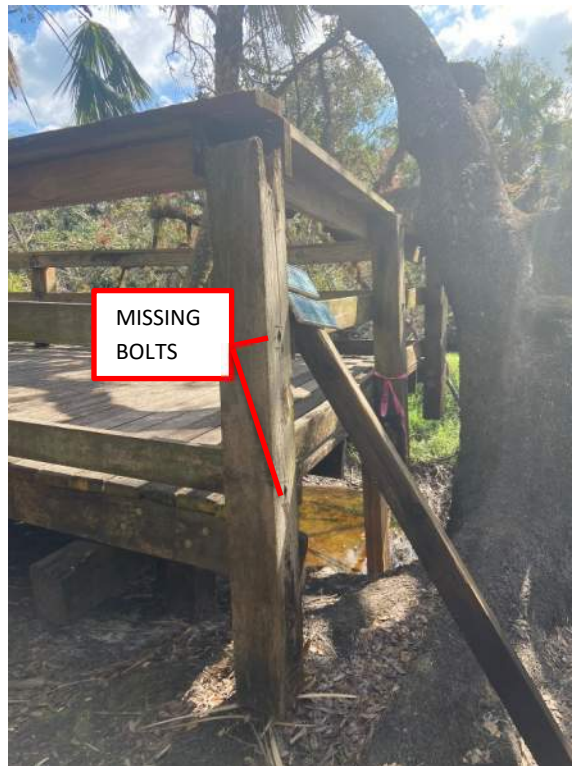
Photograph #17: Damaged Post

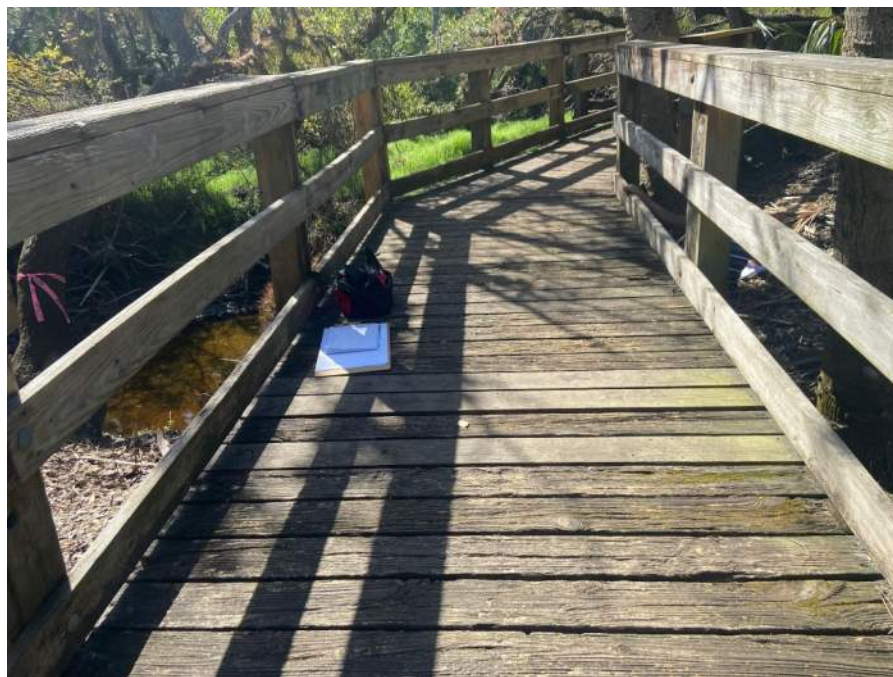
Photograph #18: Damaged Deck

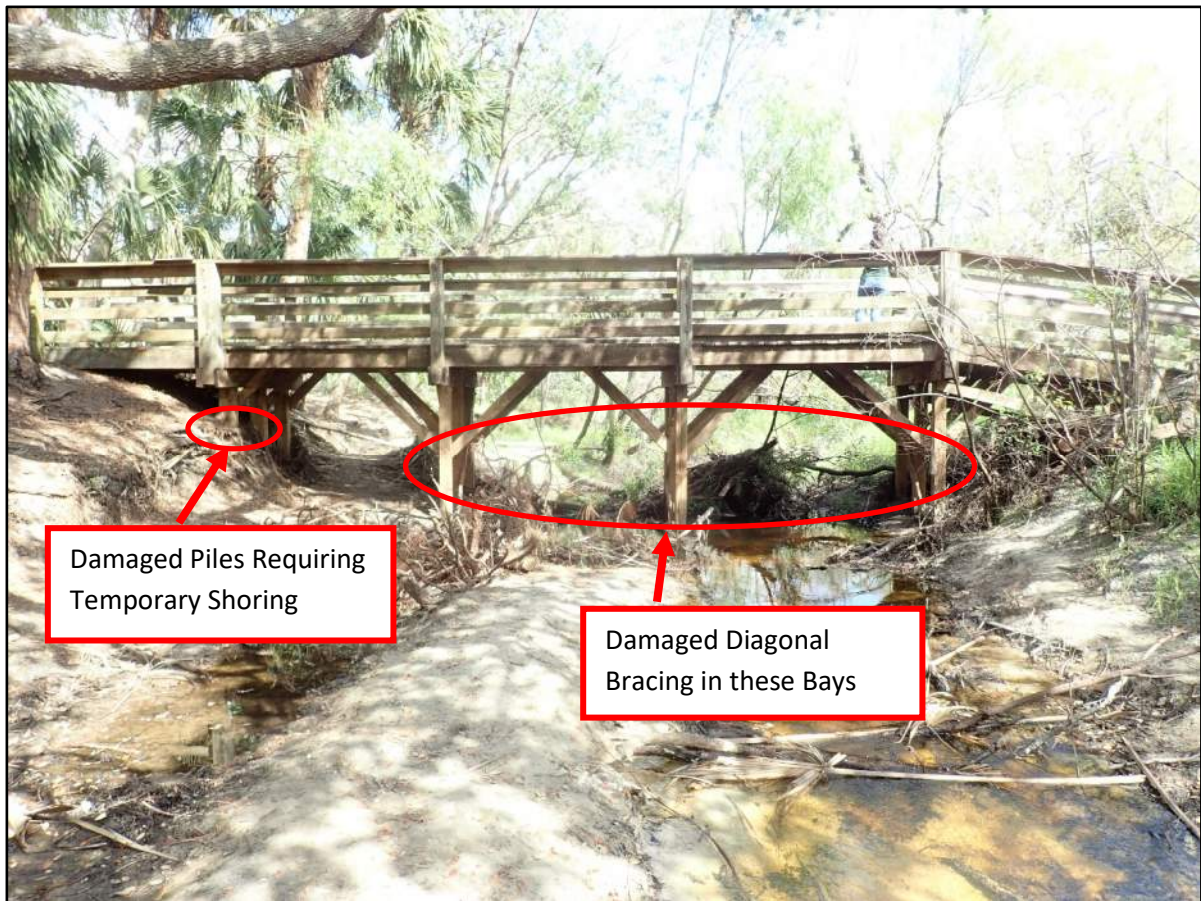
1. Two timber piles near the end of bridge have significant deterioration and loss of cross section.
2. Wood diagonal braces between timber piles below deck has significant deterioration and corrosion in steel bolt connections. The damage is more extensive at the bottom of the piles.

It does not appear the damaged piles can support full-service loads under equestrian traffic. Therefore, this should be considered a **Dangerous Condition** as defined by Section 202 of the 2020 Florida Existing Building Code. See the below **Photograph 1** for the relative location of the damaged beams.

Photograph 1 – Equestrian Bridge with Damages

1. Immediately restrict equestrian traffic on the bridge.
2. Place signage noting closure for equestrian traffic.
3. Install temporary shoring to support beams and stringers at the damaged piles location.
4. Pedestrian traffic may be allowed until temporary shoring and further repairs are completed.
5. Repairs to the timber piles by replacing or reinforcing with new helical or timber piles.
6. Repairs to the diagonal bracing and bolt connections.

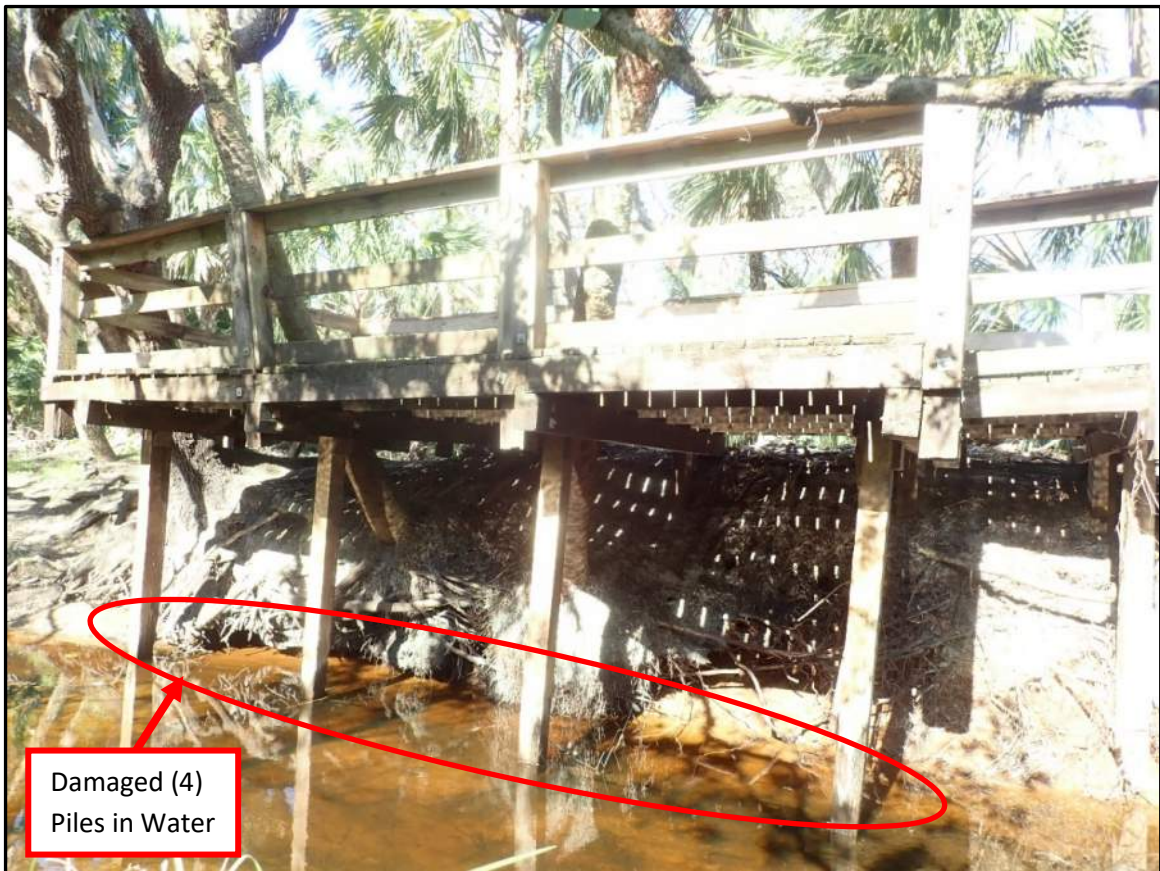
Significant damage was observed at the bottom of (4) timber piles in water supporting the bridge deck. Wood deterioration and loss of cross section was observed at the bottom of these piles located on the south end. See the below **Photograph 2** for the relative location of the damaged piles. It is our understanding that the bridge is being used for pedestrian traffic only. It does not appear the damaged piles can support full-service loads and should be considered a **Dangerous Condition** as defined by Section 202 of the 2020 Florida Existing Building Code.

Photograph 2 – Observation Deck with Damages

1. Immediately restrict access at least for a partial area of the deck that is supported on the damaged (4) piles. See the below **Figure 1** for the approximate region of deck that needs to be restricted for access.
2. Place signage noting closure of the partial area of deck.
3. Repairs to the damaged timber piles by replacing or reinforcing with new helical or timber piles.

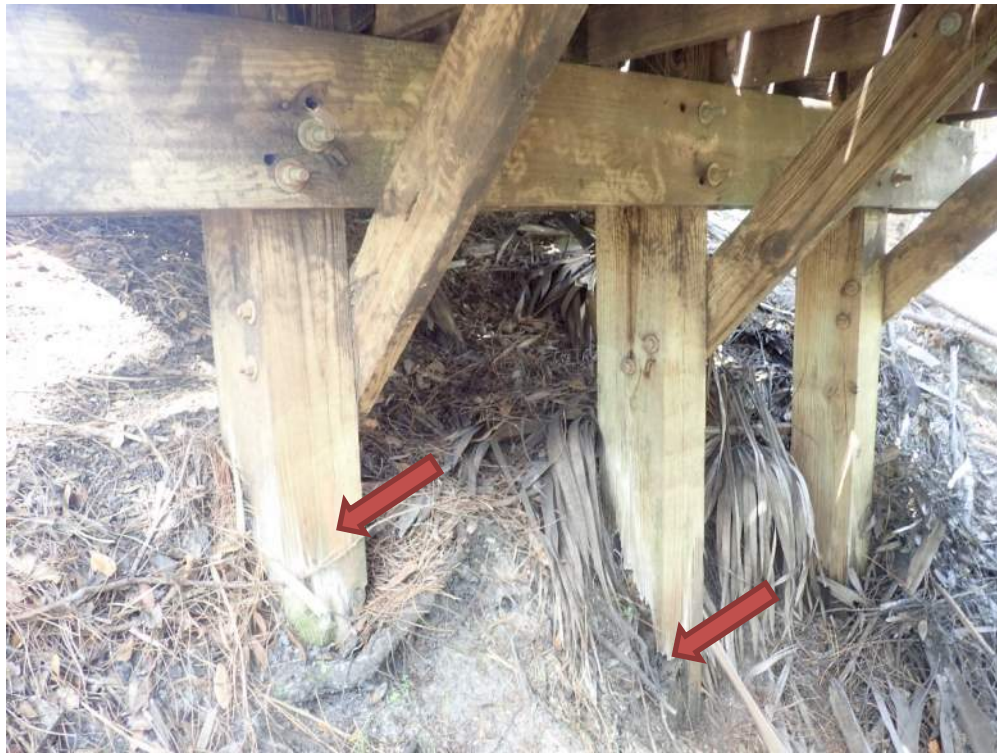
Photograph 1 – Damaged Piles In Equestrian Bridge

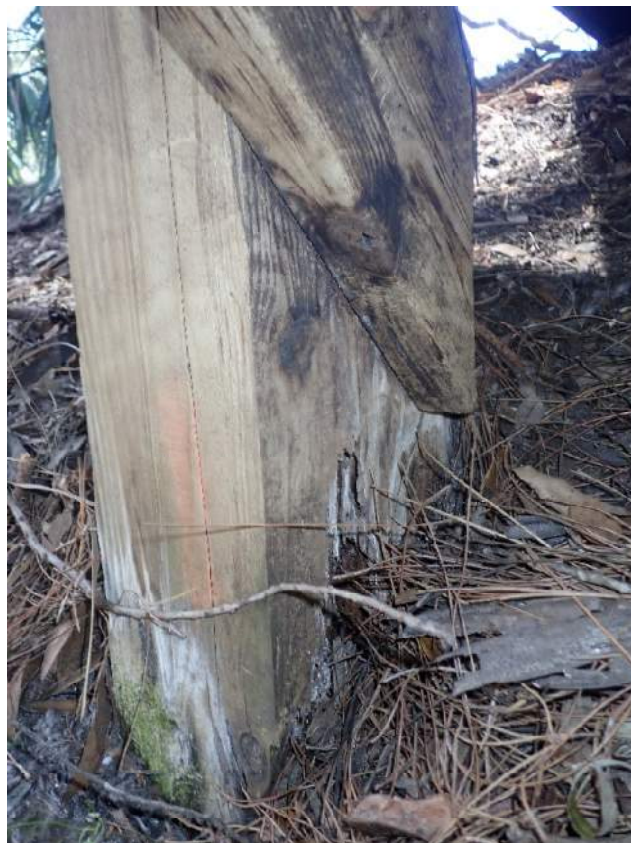
Photograph 2 – Closeup Of Damaged Piles In Equestrian Bridge

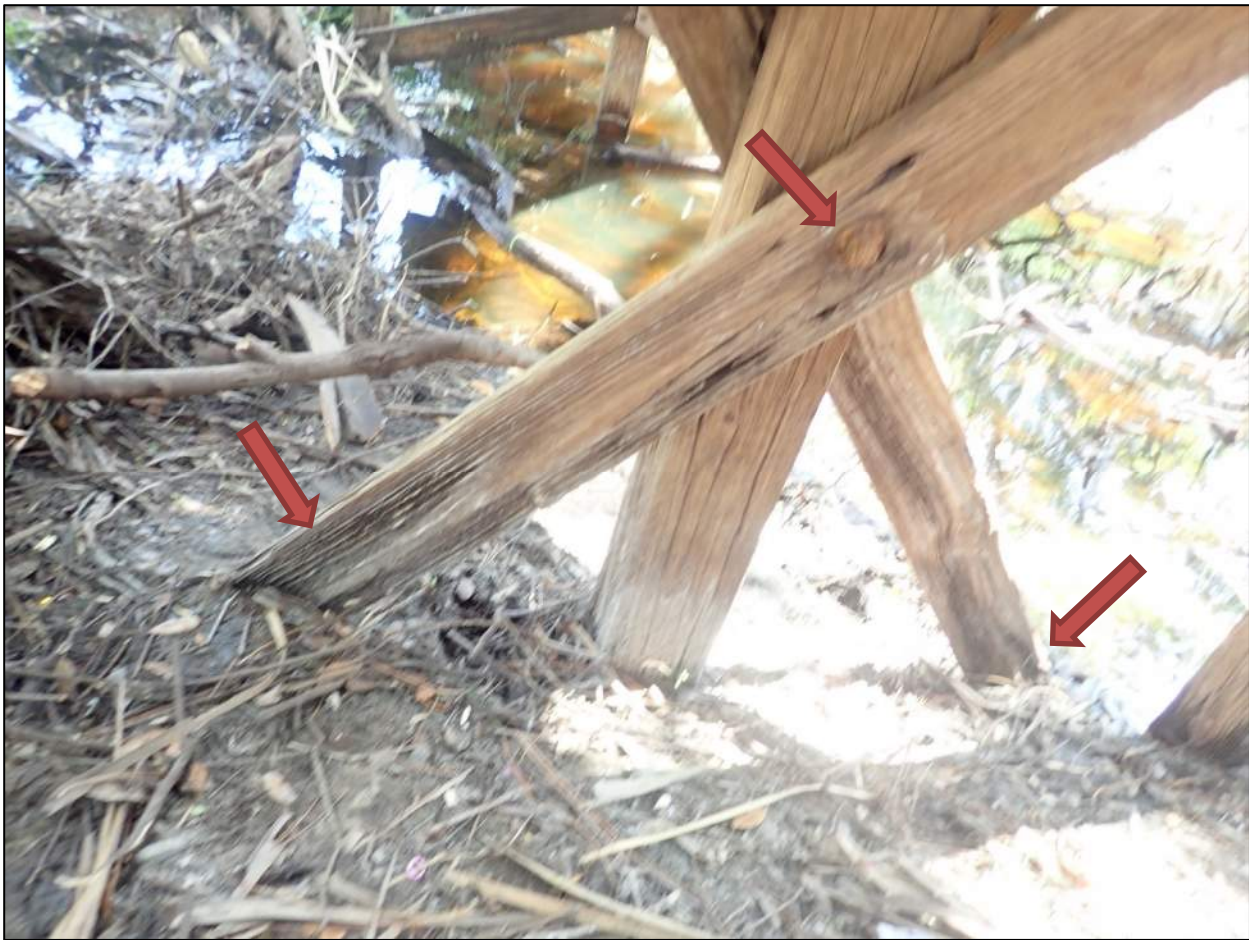
Photograph 3 – Example of Damaged Bracing In Equestrian Bridge

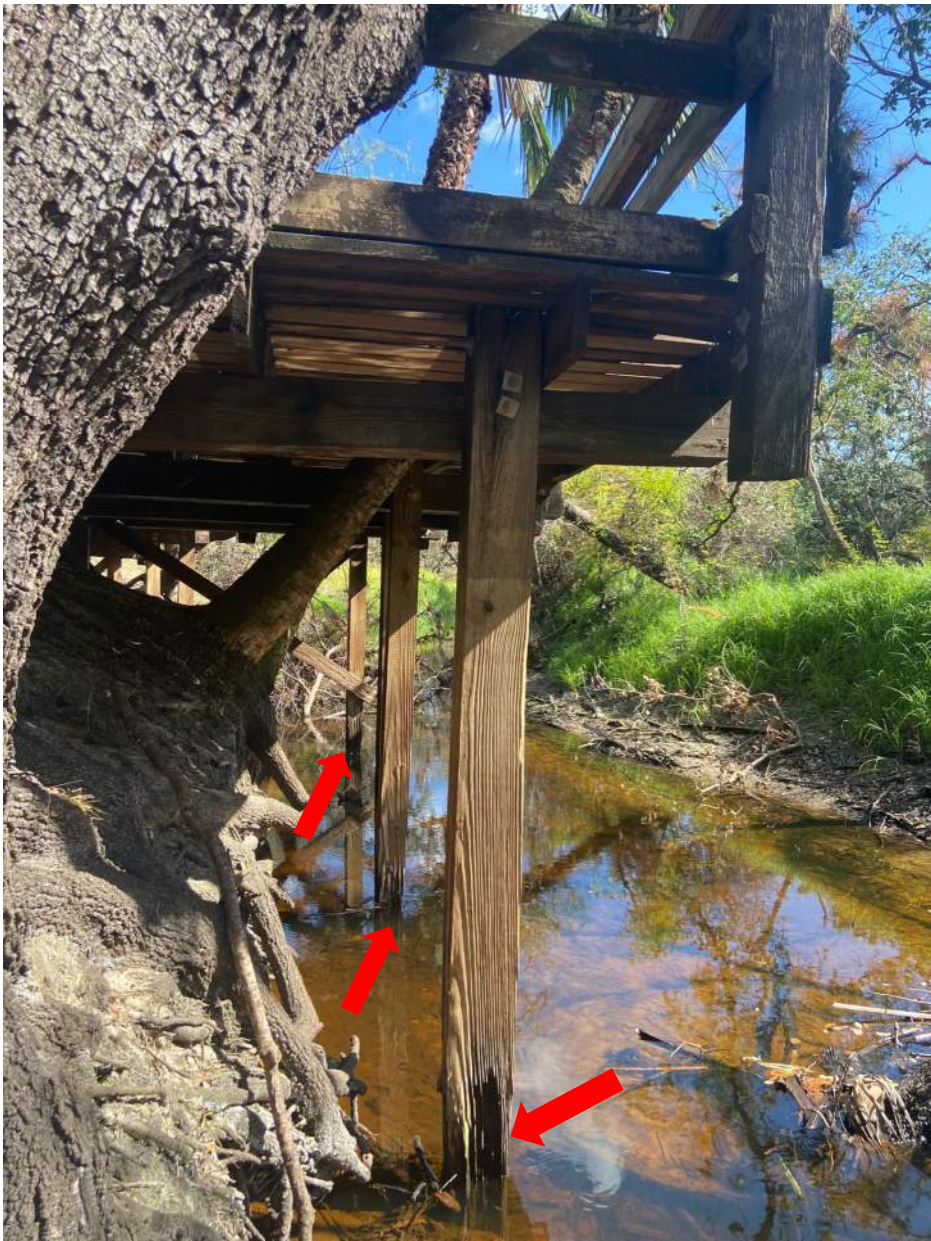
Photograph 4 – Damaged Piles In Observation Deck

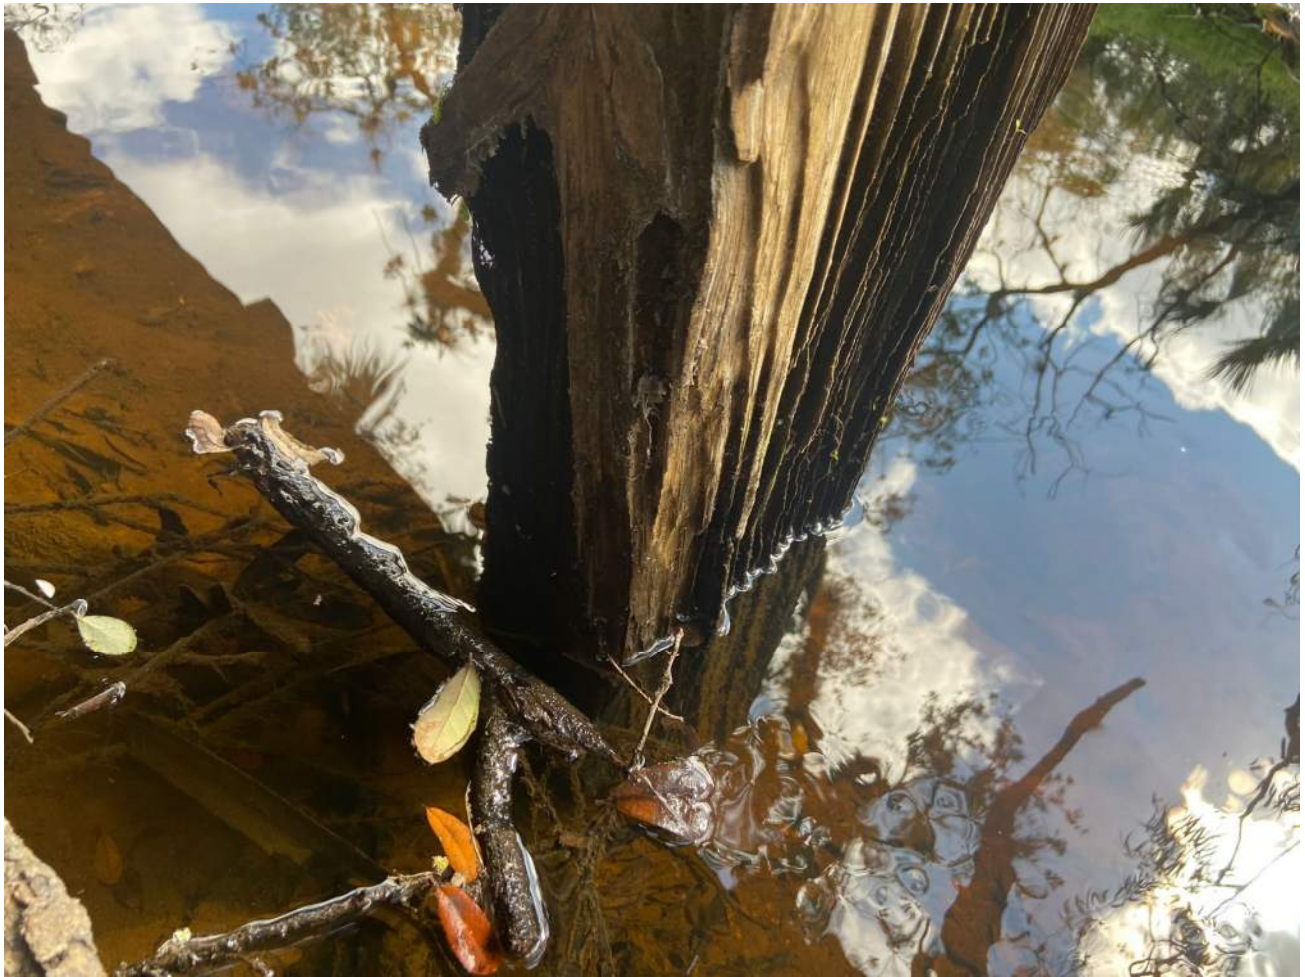
Photograph 5 – Closeup of Damaged Piles In Observation Deck
