MA Architects

This document has been prepared by GAI Consultants, Inc. on behalf of the City of North Port, Florida.

01. Parks Today

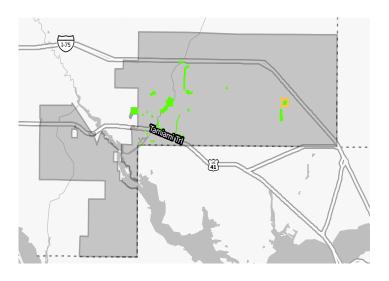
Figure 1 | Park Inventory

Atwater Community Park is located within a residential area, abutting an elementary school. It offers passive and active amenities, with an overall baseball theme. The park consists of well-maintained baseball fields with dugouts, batting cages and bullpens. On site, there is also a splash pad with textured rubber surfacing and a nearby pavilion offering shaded seating for parents to have clear views of their children. Adjacent to the splash pad is a wellshaded, baseball themed playground. Additional supporting structures within the site include a concession stand and restrooms. With a variety of amenities and an abundance of shaded parking, the park is an ideal location to host baseball events, allowing families to entertain children of all ages. The park is accessible to the nearby neighborhoods with two entries. The primary entrance is a passive space with pavilions along the sidewalk, with nearby parking creating a space ideal for small family picnics. The secondary entrance includes a sidewalk leading to the park; however, it does lack a crosswalk.

The amenities throughout the site are in good condition and are very well-maintained. The circulation and the spatial organization of the site make it easy to navigate through. There is an opportunity to add more seating within the playground area and improve existing seating with a bench pad and added walkway. There are potential CPTED issues near the playground; including firebush on the north side which may create blind spots. There is an opportunity to add low hedges along the playground to add a protective buffer between the parking lot and play area. Although the chalk wall may not be a major concern, it also creates blind corners due to its height. The Splash pad surfacing is a textured rubber, which children have been slipping on, and nearby water fountain may need to be replaced, due to clogs and rust.

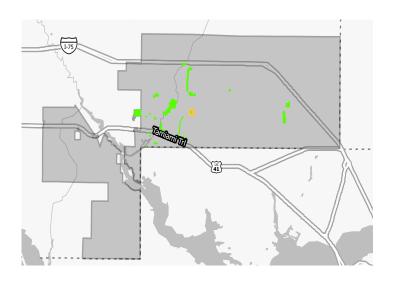
Figure 2 | Park Inventory

Surrounded by residential areas, abutting the Blue Ridge Waterway, this neighborhood park is in a convenient location for nearby residents. The park provides access into the waterway with a well-maintained kayak launch, as well as a playground, a pavilion with seating and open green space. There is abundant parking, although it lacks shade. The park has no crosswalks connecting adjacent homes to the park.

There is good circulation throughout the park, but the benches and kayak launch are not very accessible, with steep slopes and no path. The benches are starting to wear, and although they are in fair condition now, they will need to be replaced soon. A good portion of the site is a natural area with the potential to add a boardwalk or trail.

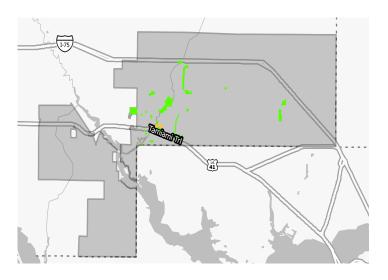
Figure 7 | Park Inventory

Located behind the Fire station, abutting the Cocoplum Waterway and the North Port Scout House, Dallas White Park consists of a baseball field, sand volleyball court, a playground, and a tennis court. The softball field is in good condition with shaded bleachers. However, the dugouts are missing fencing and shade structures. The dugouts' walls prevent visibility into both the dugouts and the fields creating a CPTED blind spot. The volleyball court is in need of repairs, specifically the posts and the net, which are currently being held up by adjacent light poles. The tennis courts are in good condition with a few minor cracks. The playground included ADA structures and overall is in good condition: however, the playground lacks ADA compliant access points. The park also has access into the waterway with a kayak/canoe launch and boat ramp that are currently non-functional. Although there is a clear vehicular access point into the park, there is no clear pedestrian circulation within the park, connecting the variety of amenities it offers. There are some signs of undesirable uses within the park which may be avoided by increasing regular park users and enhancing the park with CPTED strategies.

Future plans for the site include the replacement of the softball field with a multipurpose field as well as general ADA enhancements throughout the site.

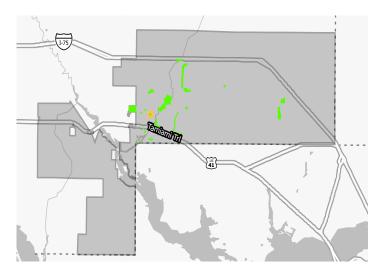
Overall, the park is well-maintained, and its amenities remain in good condition. However, some of the educational signage has experienced sun-related wear and would benefit from replacement. While the walking loop facilitates smooth circulation throughout the park, the southwest portion could benefit from additional shade trees. The entrance sidewalk integrates well with the gardens, but improved crosswalk signage across Pan American Boulevard and additional markings at the driveway entrance would enhance pedestrian safety. Additionally, the park's entrance signage differs from standard City of North Port Parks signs. Installing an additional standard park sign and with its current monument sign would help reinforce its identity as a city operated park.

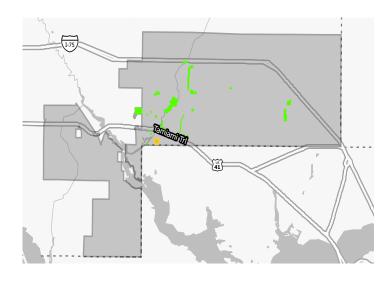
Figure 10 | Park Inventory

Enclosed by residential areas, Highland Ridge Park offers the residents a multitude of amenities. The site consists of well-maintained racquetball court, tennis court, and basketball courts, all of which have slight cracking on the surfacing. The basketball backboards may need to be replaced soon due to rust and wear. The shuffle ball court is in fair condition, but it is in the need of updates, including resurfacing and restriping. The playground on site is mainly in good condition, but is displaying some signs of rusting. The pickleball courts on site are in good condition and get lots of use on site. To account for its usage, there may be a need to integrate more parking. Court dividers may also need to be installed in the pickleball court to replace the existing PVC structures. The site also includes a considerable amount of open green space surrounded by seating under the perimeter canopy trees. The site includes 3 shade structures with picnic tables underneath, offering shaded seating with clear views into the playground, basketball court, and pickleball courts. There is also a restroom on site as well as a storage structure, both of which are in good condition.

The site has good circulation and is generally ADA accessible. Some of the site furnishings are worn out and in need of replacements, especially the benches and grills. There are opportunities to integrate a trail encompassing the entirety of the site as well as more canopy trees along internal sidewalks and near the playground. To encourage safe pedestrian access, there is an opportunity to include crosswalks at the main pedestrian entry points.

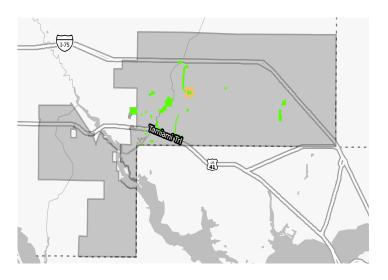
Figure 14 | Park Inventory

Larry Thoennissen Athletic Fields is located adjacent to George Mullen Activity Center, near the City Hall. The facilities this park offers, includes fields for football and soccer, with bleachers that are in good condition. The main field is located more central to the George Mullen Activity Center and is in good condition. The shaded bleachers for the fields need replacements. Of the three, two structures are broken and the third has broken shade fabric. There are also storage structures and restrooms on site.

The second field, the practice field, is in the northern part of the site and has no signage or defined formal parking. The practice field is also in good condition and is currently going through renovations for the goal posts. There is opportunity to formalize the parking space for the practice field, as well as seating and shade near the field. There is currently no pedestrian connection between the two fields, the site can benefit from a path or trail connecting the two fields unifying the space.

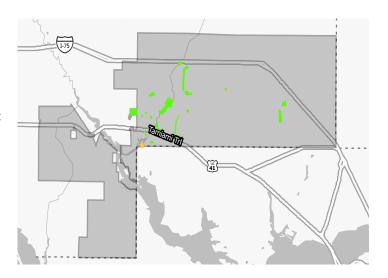
Located in a residential area, abutting the Myakkahatchee Creek, Marina Park consists of a boardwalk with integrated kayak launches, a boat ramp, restrooms, a pavilion with picnic tables, and on-site parking. The site includes the coast guard facility, which includes a dock and a building. Overall, the site is in good condition and the boardwalks seem to be new additions. With the lack of shade within the park, there is an opportunity to integrate additional tree canopy into the site.

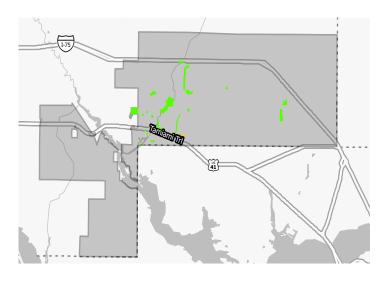
McKibben Park caters to all ages with a variety of amenities, including a racquetball court, basketball court, tennis courts, shuffleboard courts, playground, open green space, and kayak/canoe launches. The sport courts surfacing is in good condition, although the basketball nets and backboards will need replacements soon. The playground, with integrated shade, includes ADA compliant access points. A nearby pavilion with picnic tables allows parents a clear view of their children in both the sport courts and the playground. The site includes ADA kayak/canoe launches with supporting facilities like a kayak stand and designated parking area for visitors specifically seeking water access. The primary parking lot for the park is in good condition but will need to be restriped soon.

Throughout the site, swinging benches and picnic tables offers users multiple places to rest, with views of the waterway. However, the park would benefit with integrating more shade into the park for the comfort of its users, especially along sidewalks and the waterfront. There is a horseshoe pit, but no posts.

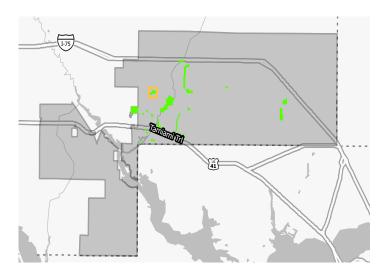
Narramore Sports Complex is a well-maintained recreational facility featuring multiple multi-use fields and a dedicated softball complex. The fields are kept in excellent condition through a regular resodding schedule, with the most recently resodded field currently in outstanding shape. A newly installed shade canopy near the concession stand provides relief for visitors, enhancing comfort during events. Restroom facilities are conveniently located near each sport area, ensuring accessibility for patrons. The softball fields are also in excellent condition, further contributing to the complex's appeal.

Opportunities for enhancement include installing shaded bleachers near the multi-use fields to improve spectator comfort. Increasing tree coverage throughout the facility would provide additional shade, creating a more pleasant environment for athletes and visitors alike. Additionally, the newly installed shade canopy would benefit from added hardscape elements to improve usability and aesthetics. There is also a lack of accessibility to all fields, adding in a connecting sidewalk to seating would allow the ability for everyone to enjoy the facilities. The parking lot would benefit from restriping in the near future to enhance organization and traffic flow. Finally, pedestrian crossing improvements, such as road markings and signage, are needed to ensure safer access for families crossing South Narramore Street to reach the complex.

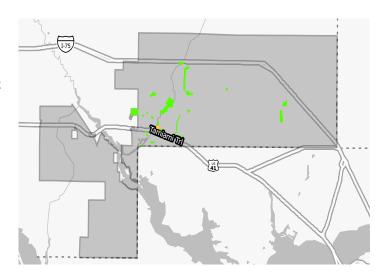
Located in front of the Fire Station and adjacent to the Myakkahatchee Disc Golf Course, the North Port Skate Park is a popular spot for local skaters and bikers alike. The site consists of a small-scale bike park with ramps, which are slightly worn out and may need to be replaced in the future. The main attraction, a large-scale skate park, is in good condition, but can be improved with new coping on some of the edges. In addition, more ramps could be added with and without rails. The park gets lots of use from the community and the neighboring cities, due to the variety and scale of skate structures it offers. There is a shaded seating overlooking the skate park, but most of the park lacks trees and shade. There is also a concession stand on site, which is in the need of renovation, as the attached water fountain is functionally obsolete. The park would benefit from shade and signage for where to park, since there is no onsite parking.

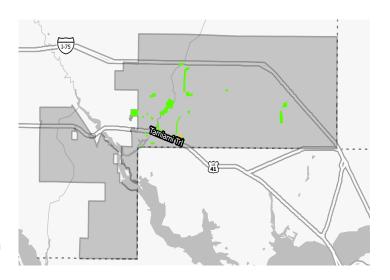
Figure 25 | Park Inventory

Fully enclosed with residential homes, Pine Park is a neighborhood consisting of a sand volleyball court, a small playground, shaded seating, pavilions and an open green space. The site is a great gathering point for nearby families. There is parking along the one of the two pedestrian accesses into the park. The site has good pedestrian circulation throughout with a shaded trail connecting all the amenities. The playground is well shaded and in fair condition however, the equipment seems dated when compared to the other playgrounds within the parks system. In addition, the shade structure for the playground will need to be replaced. The pavilions are in good condition, although some soil erosion is present around the concrete slab.

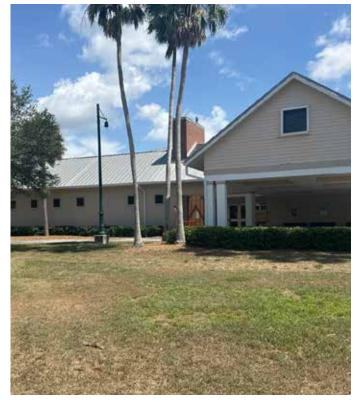
Figure 29 | South Elevation

The exterior envelope is in good condition, with no visible signs of damage or moisture intrusion. The standing seam roof, along with gutters and downspouts, is intact and functioning as intended, with no evidence of deterioration or water-related issues. The surrounding landscape is well-maintained and graded to direct water away from the building.

The interior is also in good condition. It has been recently painted, is clean, and free of stains. Natural light is present throughout and generally adequate. Restroom fixtures, including toilets, lavatories, and accessories, exhibit no wear and are fully functional and in acceptable condition. Wall and floor finishes throughout are in good condition showing no signs of water damage, excessive wear or deterioration. The restroom casework is dated, but remains functional and in good condition.

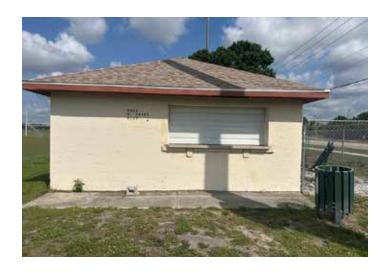
Concessions & Storage Building

Overall, the building appears to be under-maintained, with obvious deficiencies observed in either the exterior or interior systems. There is noticeable stepped cracking along the north wall and interior repairs needed.

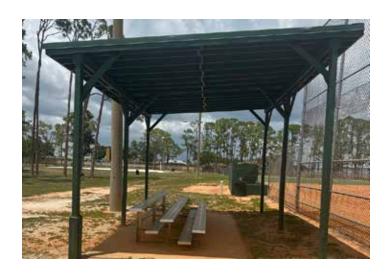
Shade Structures

The structure is considered to be in good condition, with no major issues affecting performance or safety with the exception of the concrete pad not being reliable for accessibility.

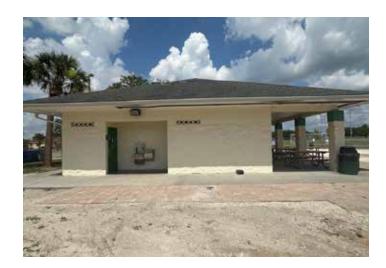
Soccer Concessions and Restrooms

Overall, the building appears to be maintained, with no significant deficiencies observed in either the exterior or interior systems. A decent amount of wear and tear.

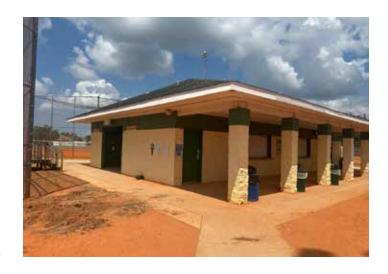
Softball Concessions and Restrooms

Overall, the building appears to be maintained, with no significant deficiencies observed in either the exterior or interior systems. A decent amount of wear and tear.
