MEMORANDUM

Department of Public Works

SUBJECT: Community Services Facility - 4940 Pan American Boulevard

North Port Senior Center Site Observations from 8-13-2025 Field Visit

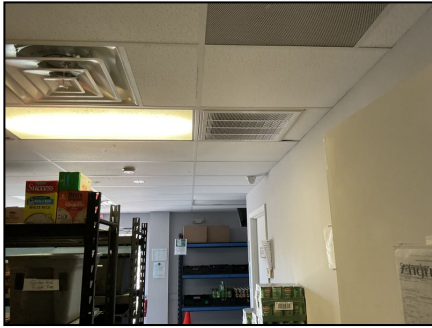
- The ductwork system is beyond its recommended useful life.

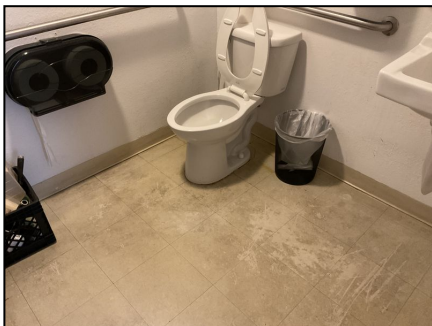
Interior Finishes

The painted wall finishes were in good condition. The vinyl tile floor finishes were in fair condition. The suspended acoustical tile ceiling finishes were in good condition.

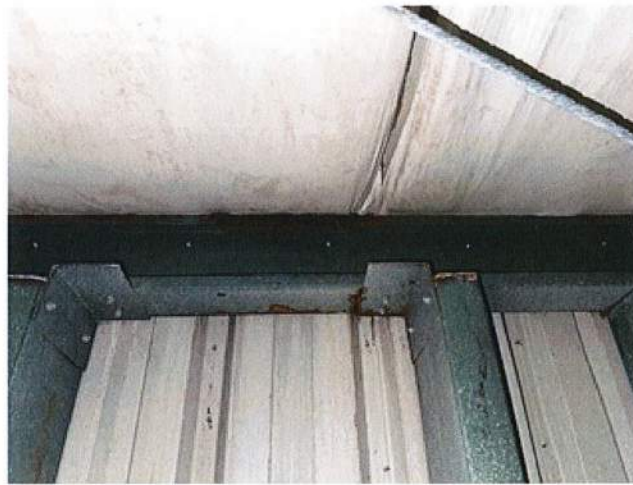
Perimeter Purlin Corrosion (PEMB)

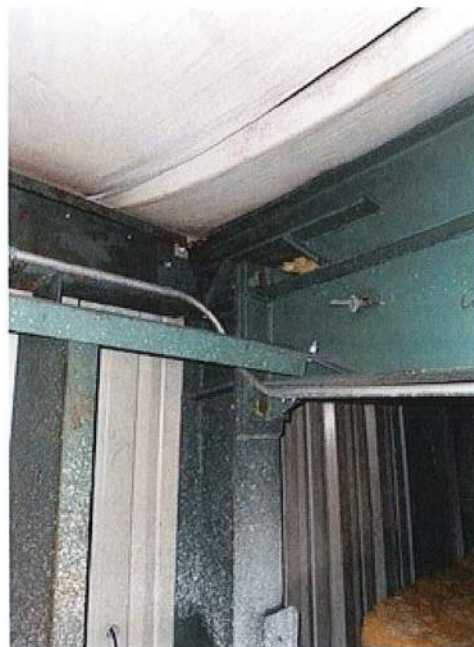
Purlin to Building Frame Connection Corrosion (PEMB)

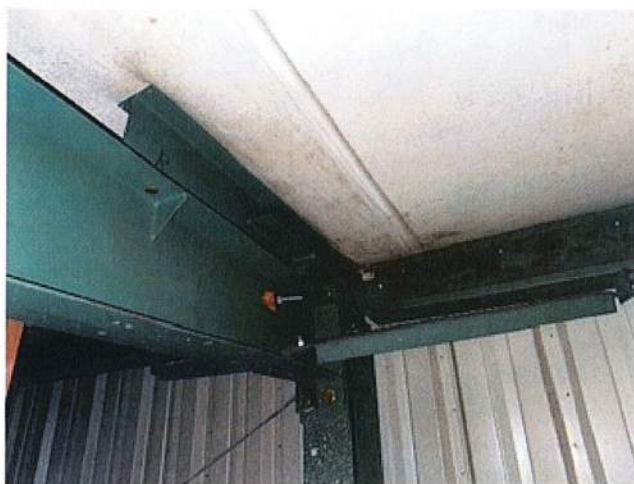
Purling to Building Frame Corrosion Connection (PEMB)

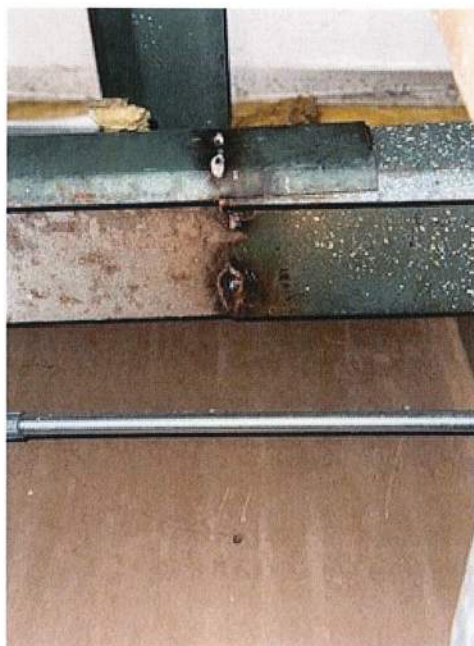
Pulin's Welded Connection Corrosion (PEMB)

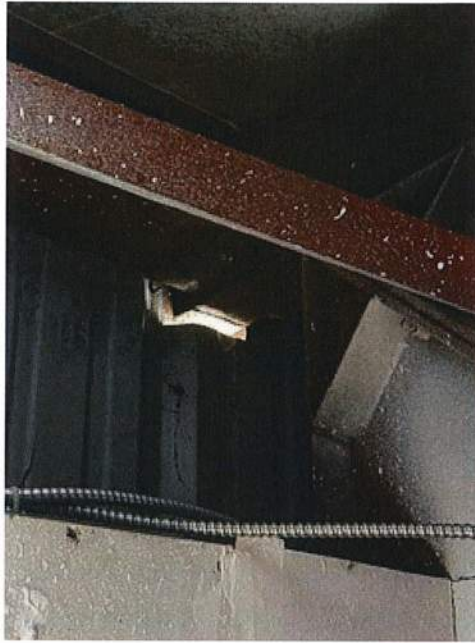
Exterior Wall Panel Opening / Exposing Interior of Bldg. to the Elements (PEMB)

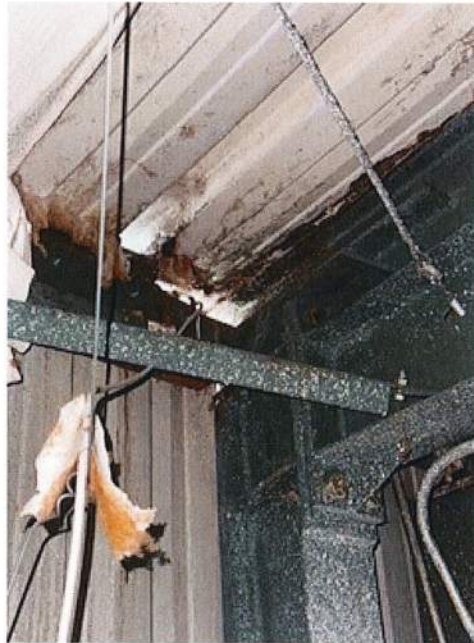
Exterior Wall Panel Opening / Exposing Interior to Elements / Corrosion at Purlin and Bldg. Frame (PEMB)

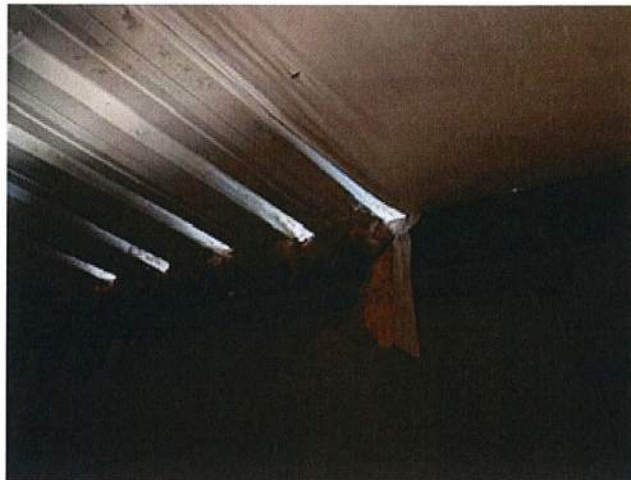
Exterior Roof Panel Openings / Interior Exposed to Elements / Purling Corrosion

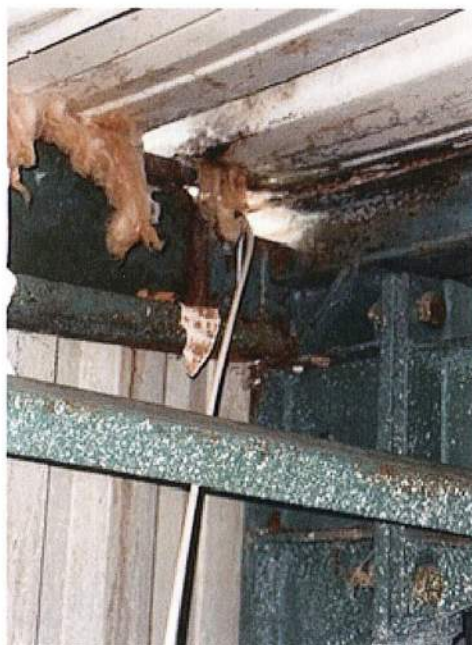
Exterior Roof Panel Openings / Interior Exposed to Elements / Corrosion at Purlin and Bldg. Frame (PEMB)

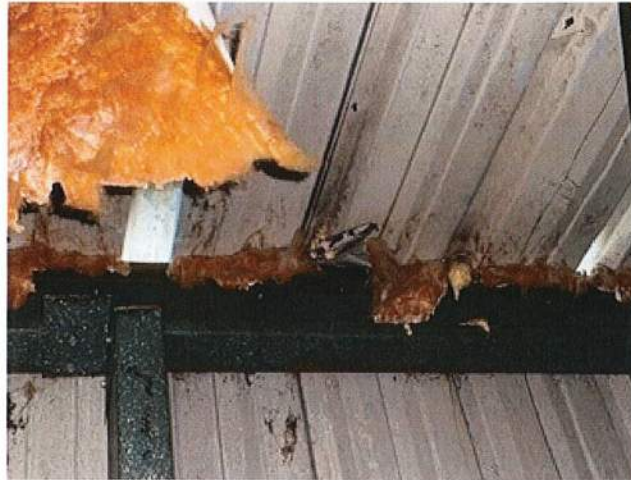
Perimeter Purlin Corrosion / Openings in Roof Deck / Interior Exposed to Elements (PEMB)

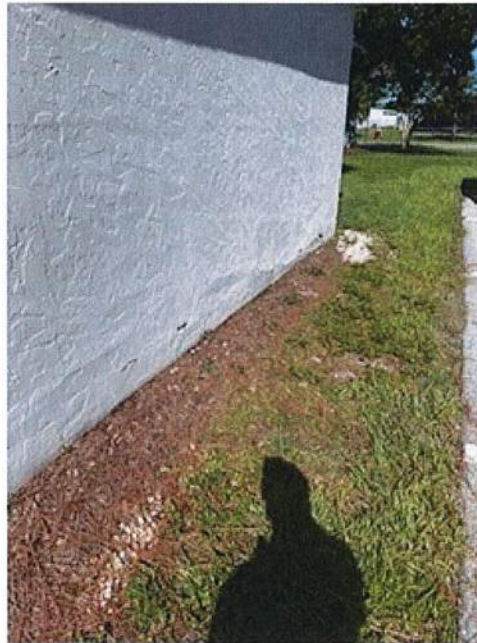
Bulging in Stucco Finish (Masonry Structure)

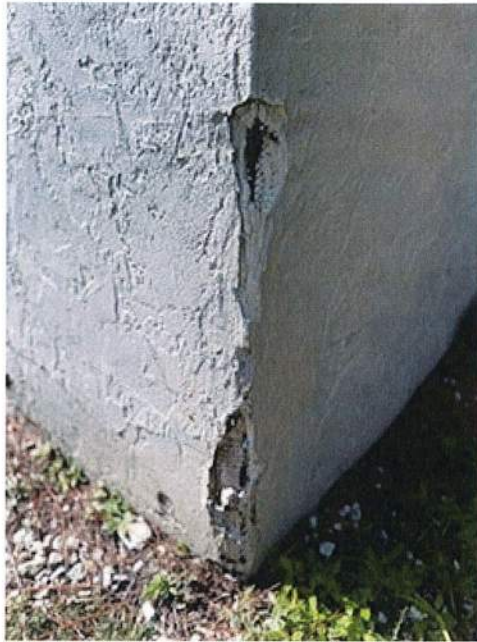
Stucco Finish Chipped Away at Corners (Masonry Structure)

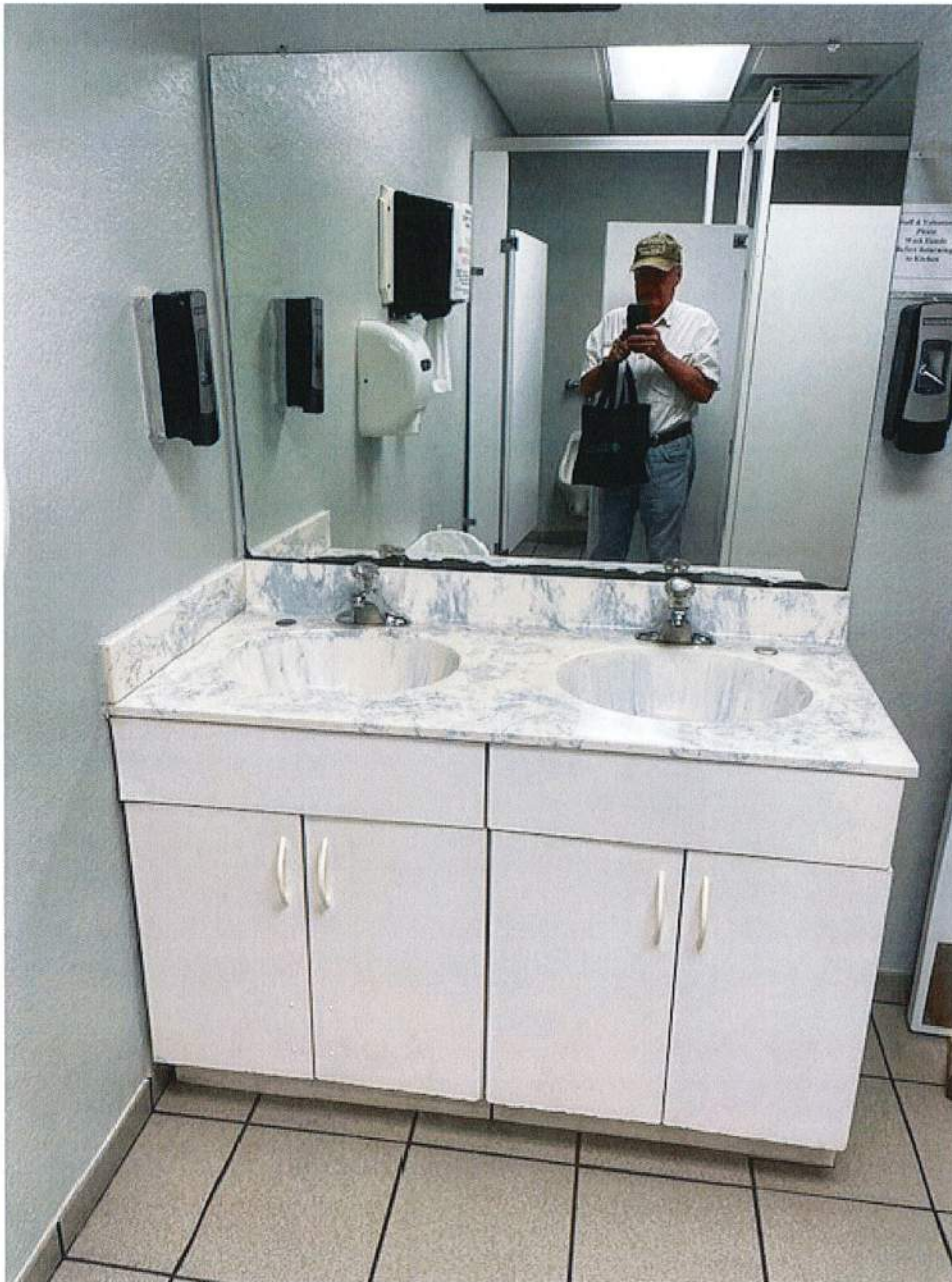
Men's Toilet Room -- non compliant lav's.
non compliant

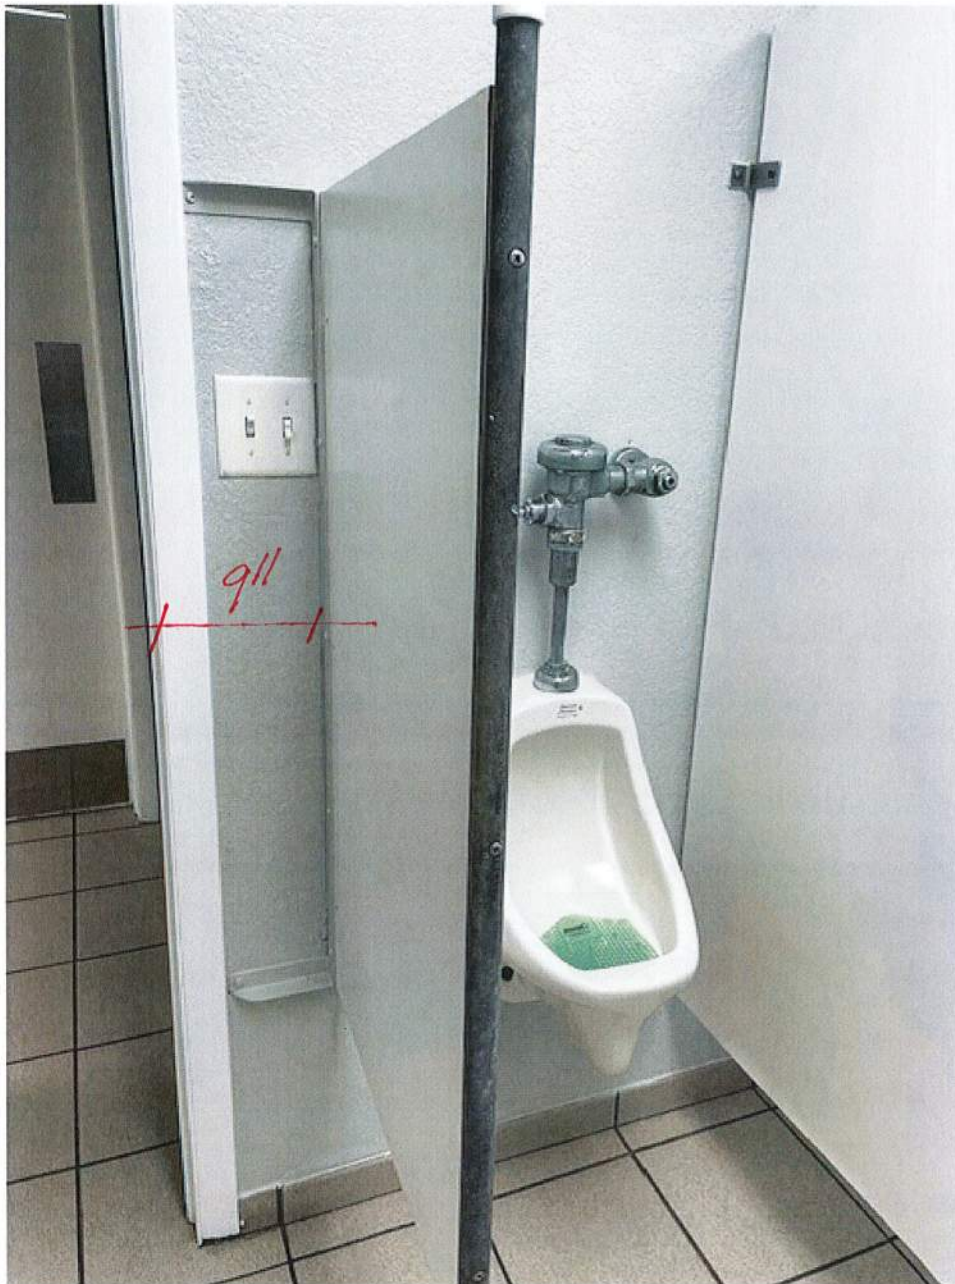
Men's Toilet Rm. ADA - Pull side = 18 inches

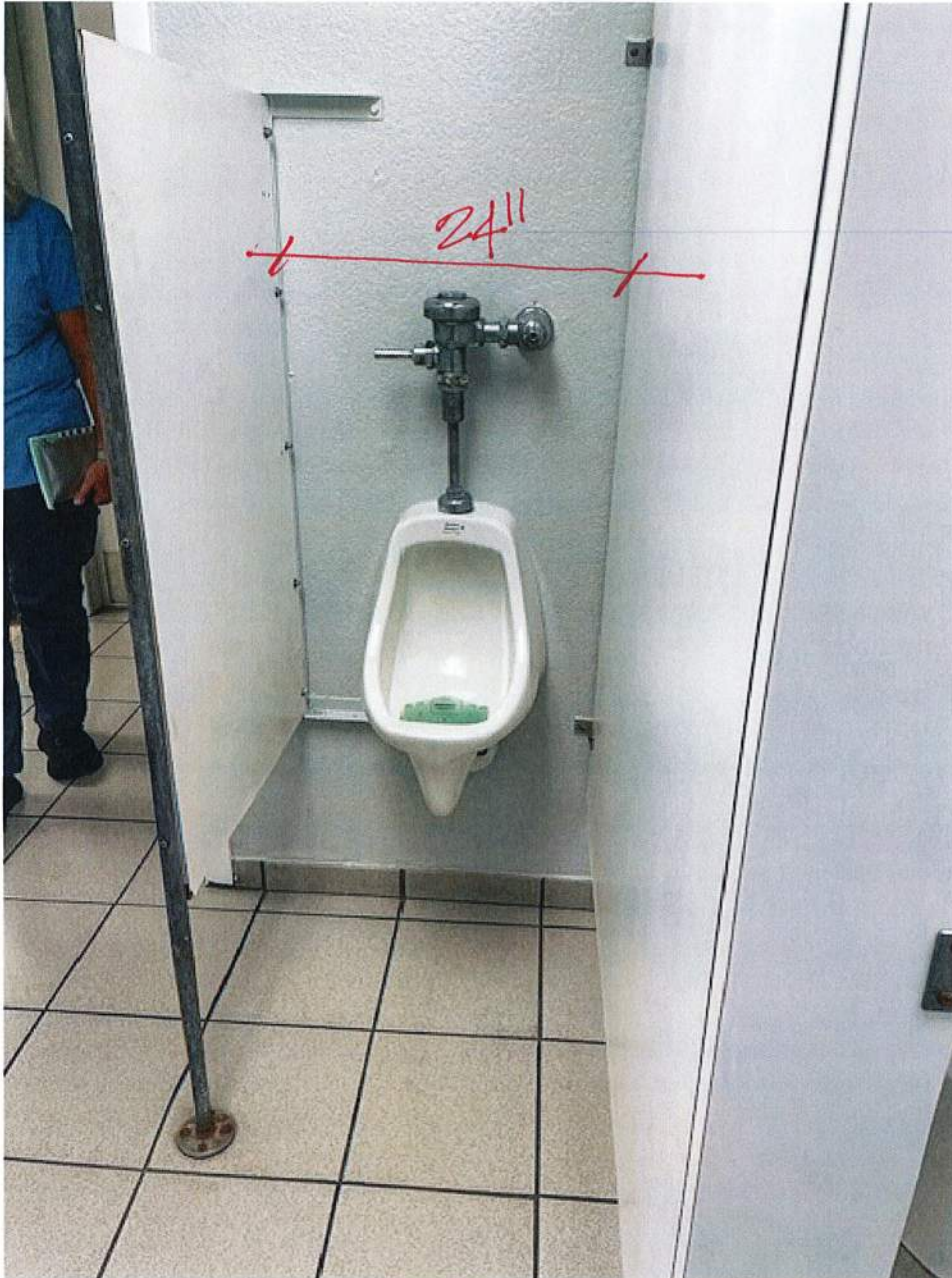
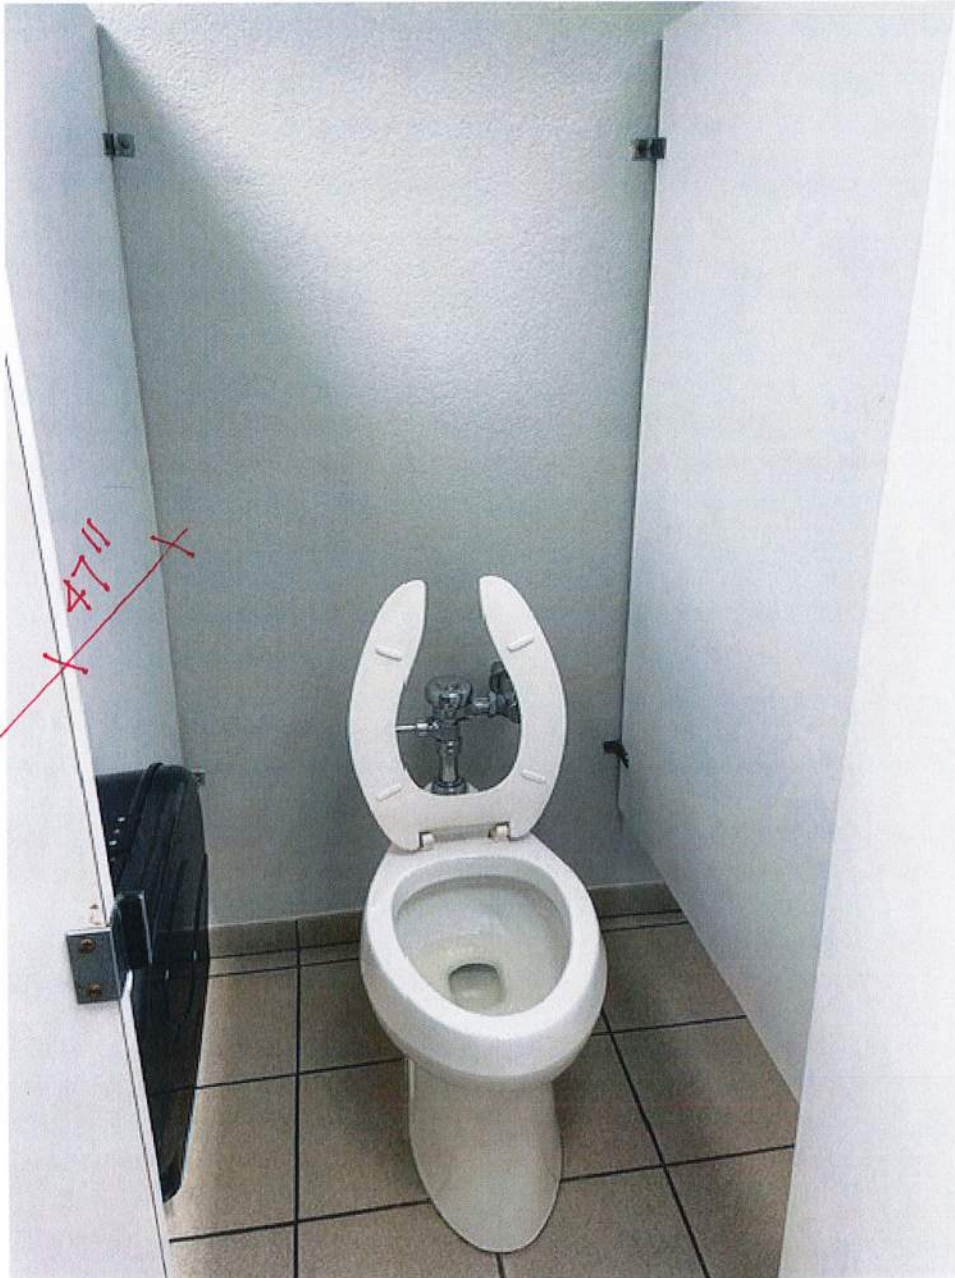
Men's Toilet Room

- water closet non Code
Compliant = 60 inches deep.

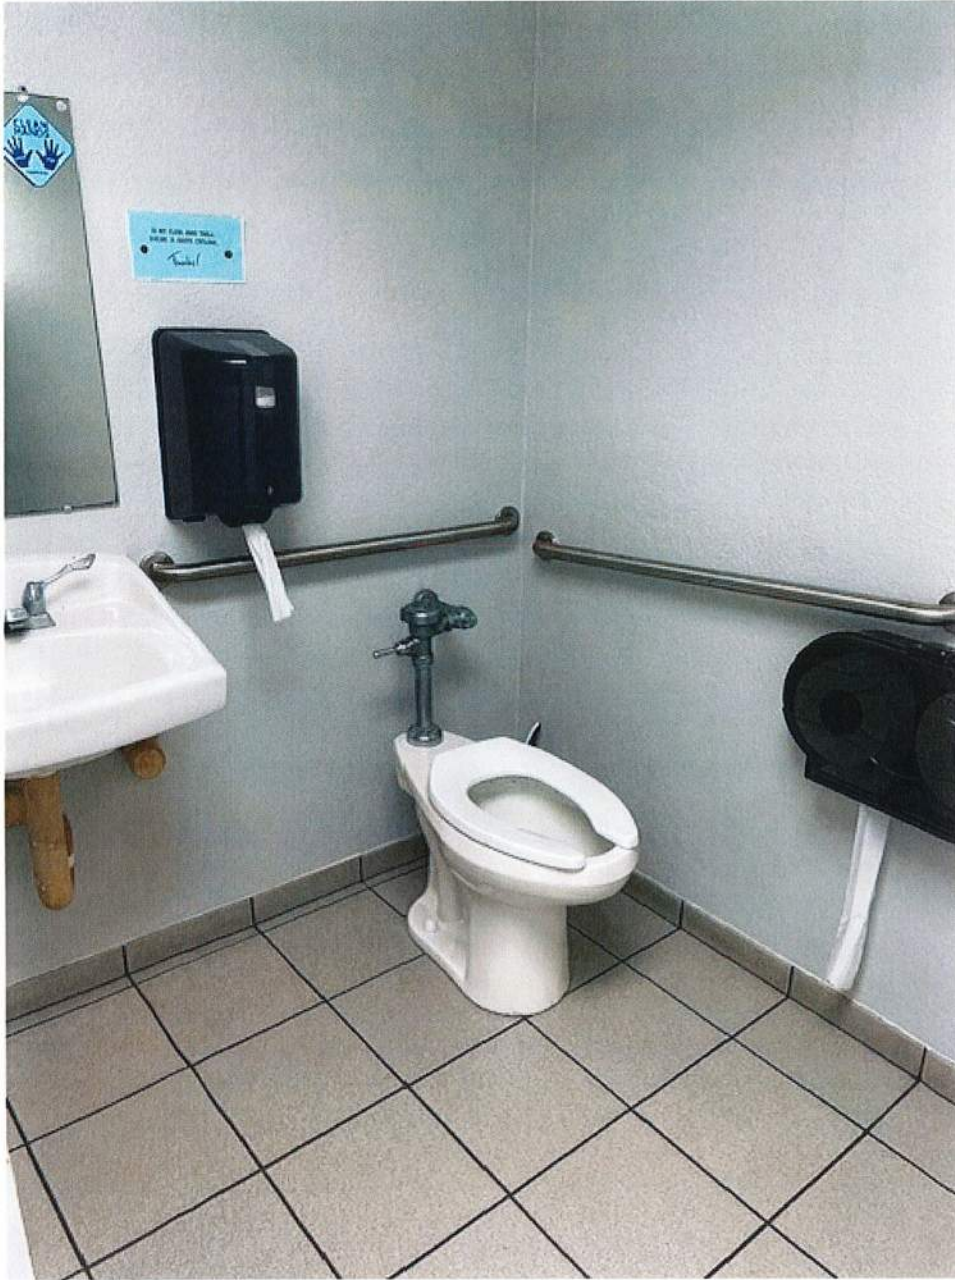
Men's Toilet Room - Plumbing fixtures - dimensions - compliant

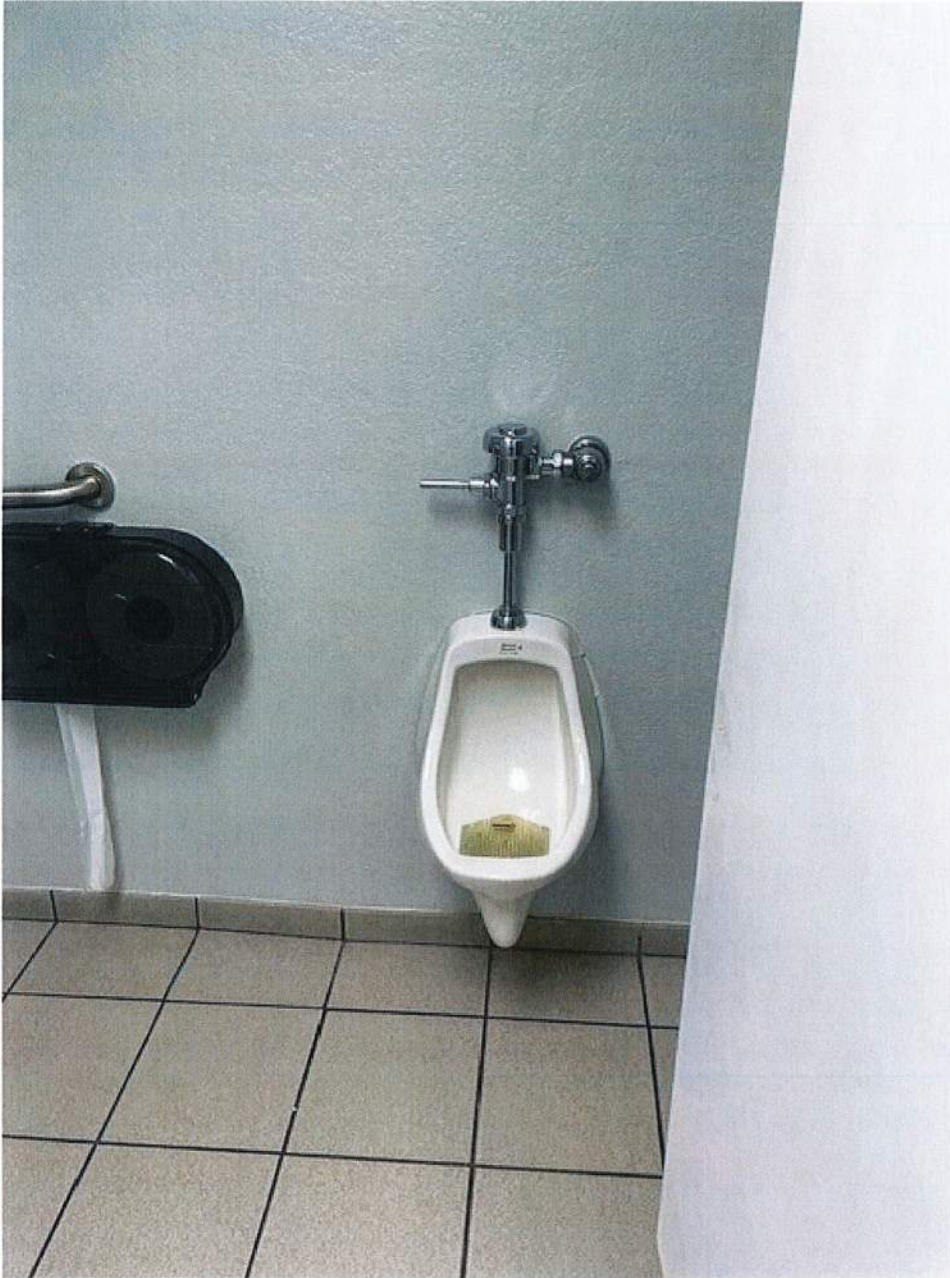
men's Toilet Room - Plumbing fixture - original dimensions compliant

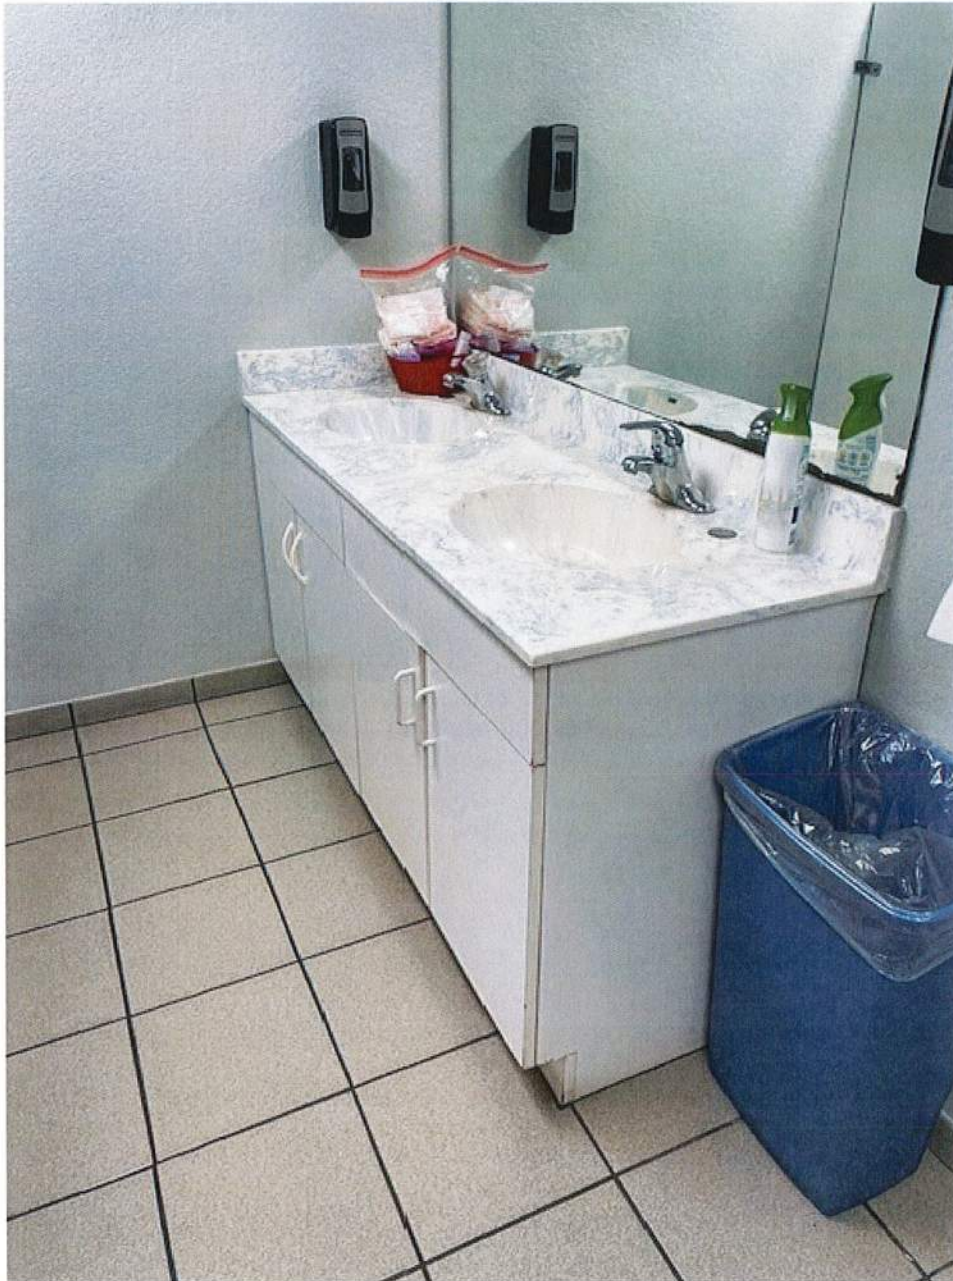
Women's Toilet Room. — non compliant lav's
clearance / dimension for ADA
access to lav's only 30 inches
ADA Code requires 60 inches

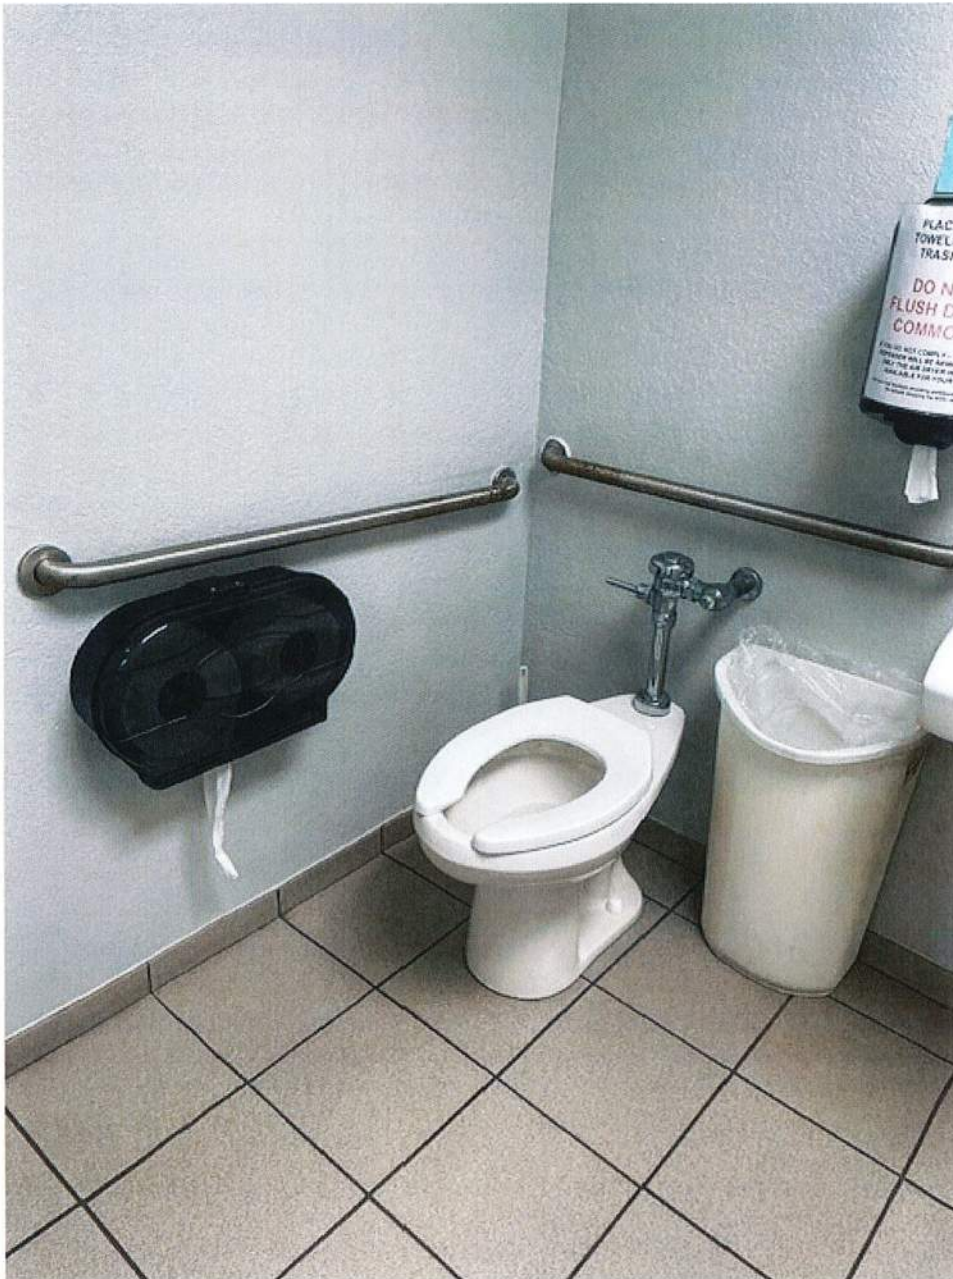
Women's Toilet Room — Plumbing fixtures
ADA compliant

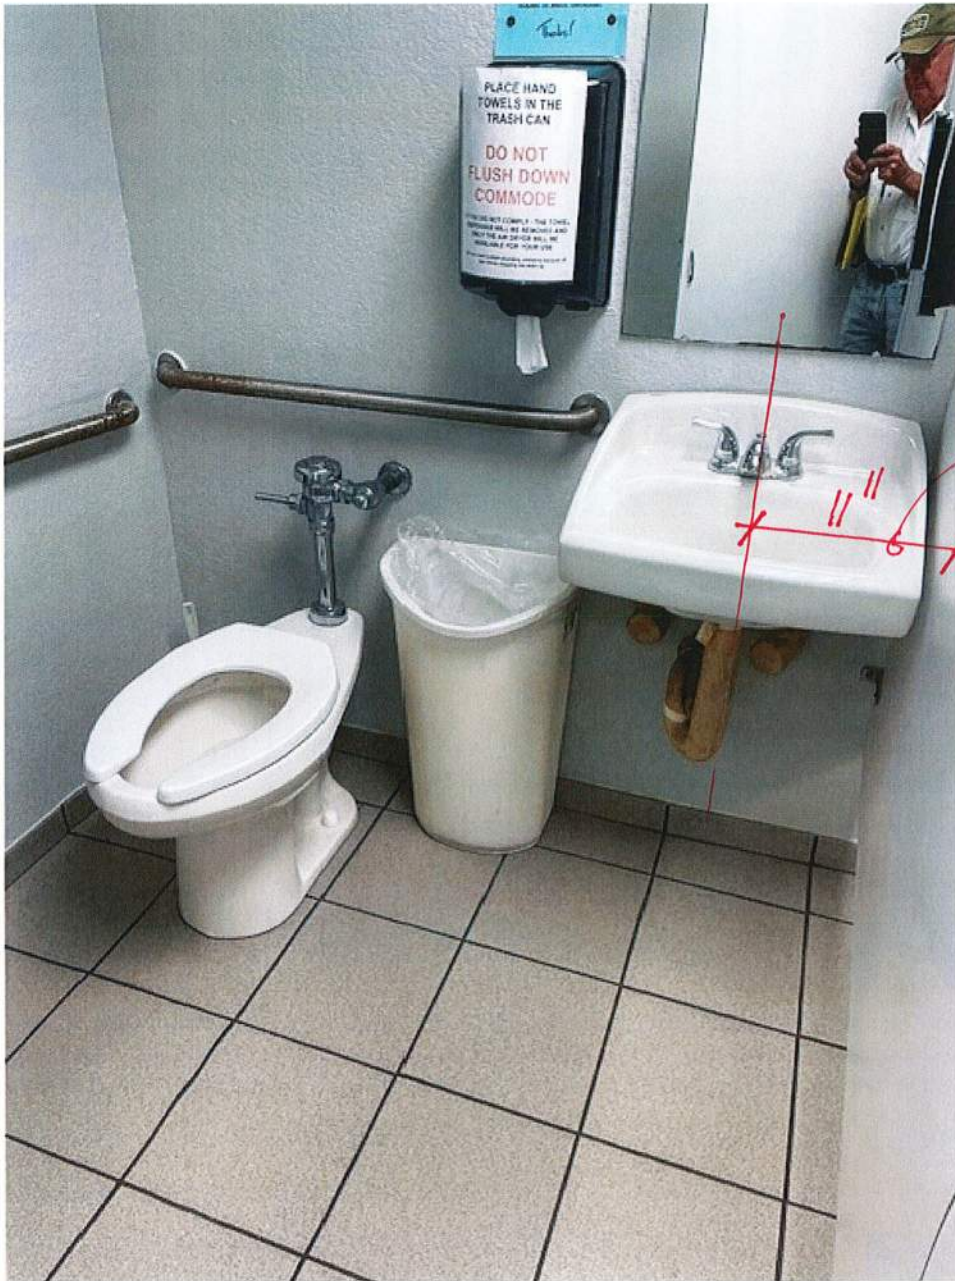
ADA code
requires 1'-3"
clearance & low
to side wall(s)

Womens Toilet Room - non-compliant lavatory

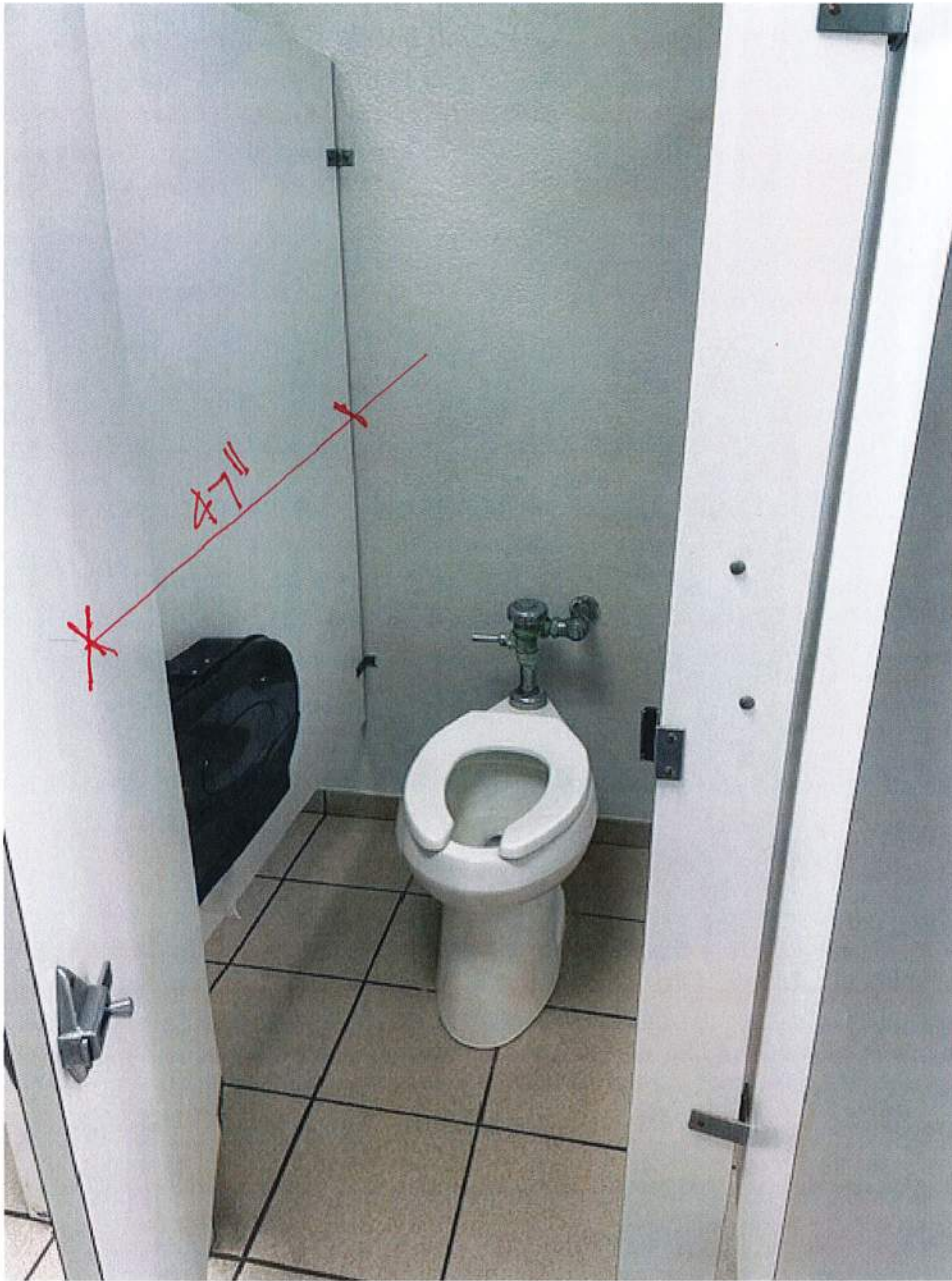
Women's Toilet Room. - Water Closet - non code
Compliant = 60 inches depth

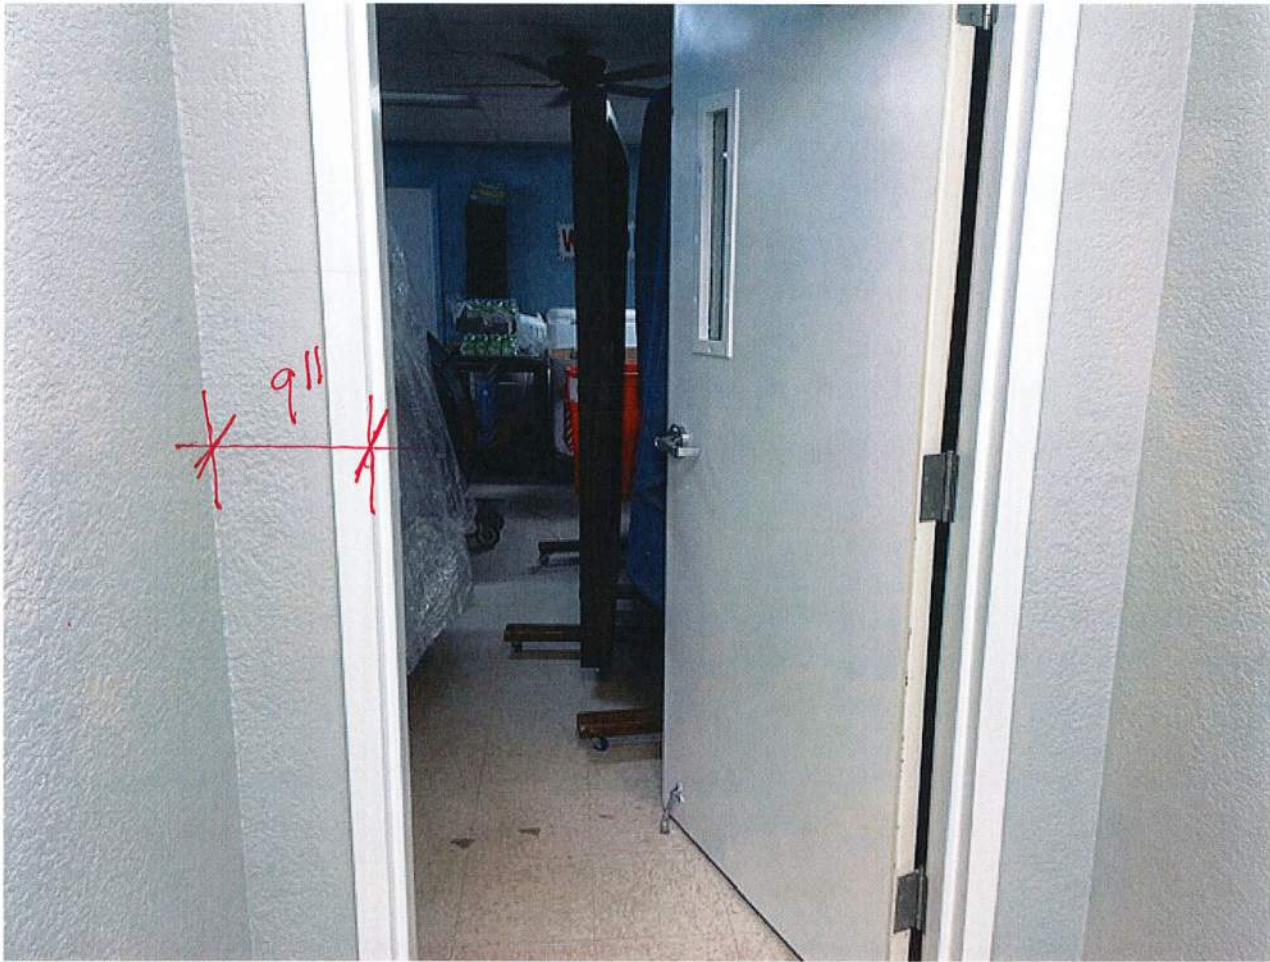
Corridor leading into Awaken Church (section B)
non compliant (ADA)
clearance - push side
requires 24 inches

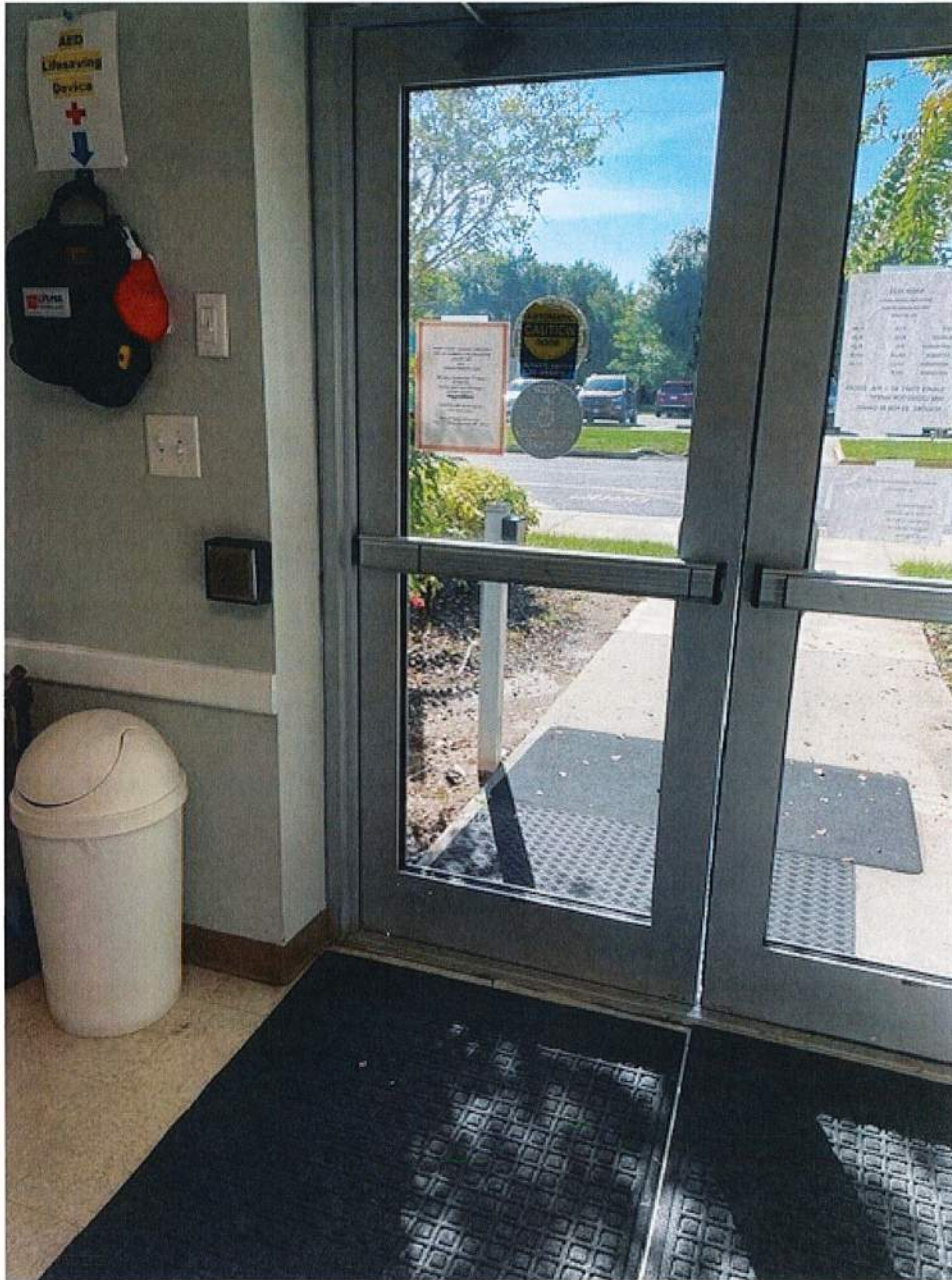
Community Ctr (Section A)

Exterior entry aluminum storefront
doors/glazing non impact rated
and does not seal for air
infiltration

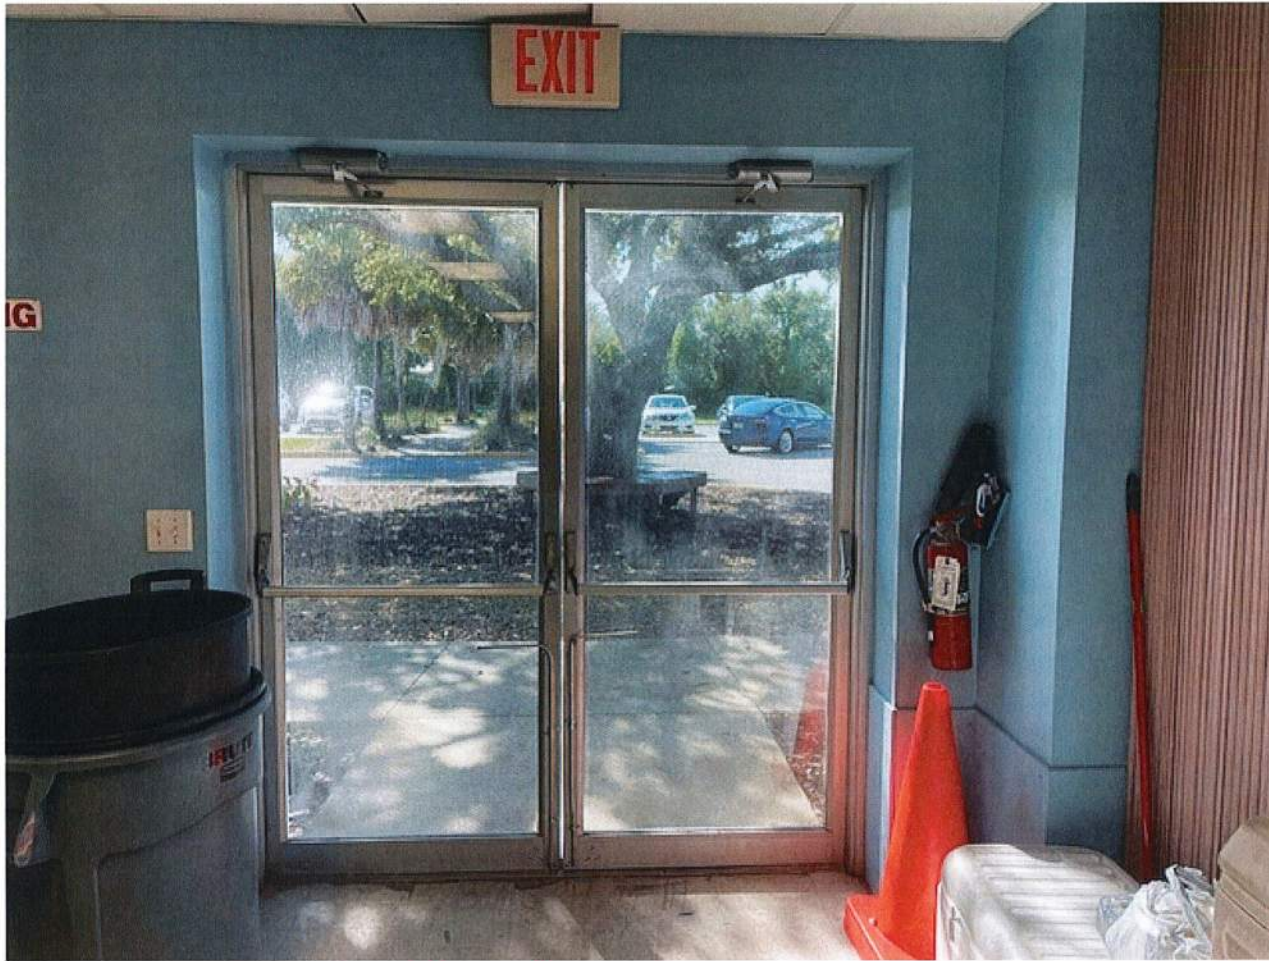
Awaken Church (Section B) Food Pantry area.
Exterior aluminum storefront
doors/glazing non impact rated
and does not seal for air
infiltration

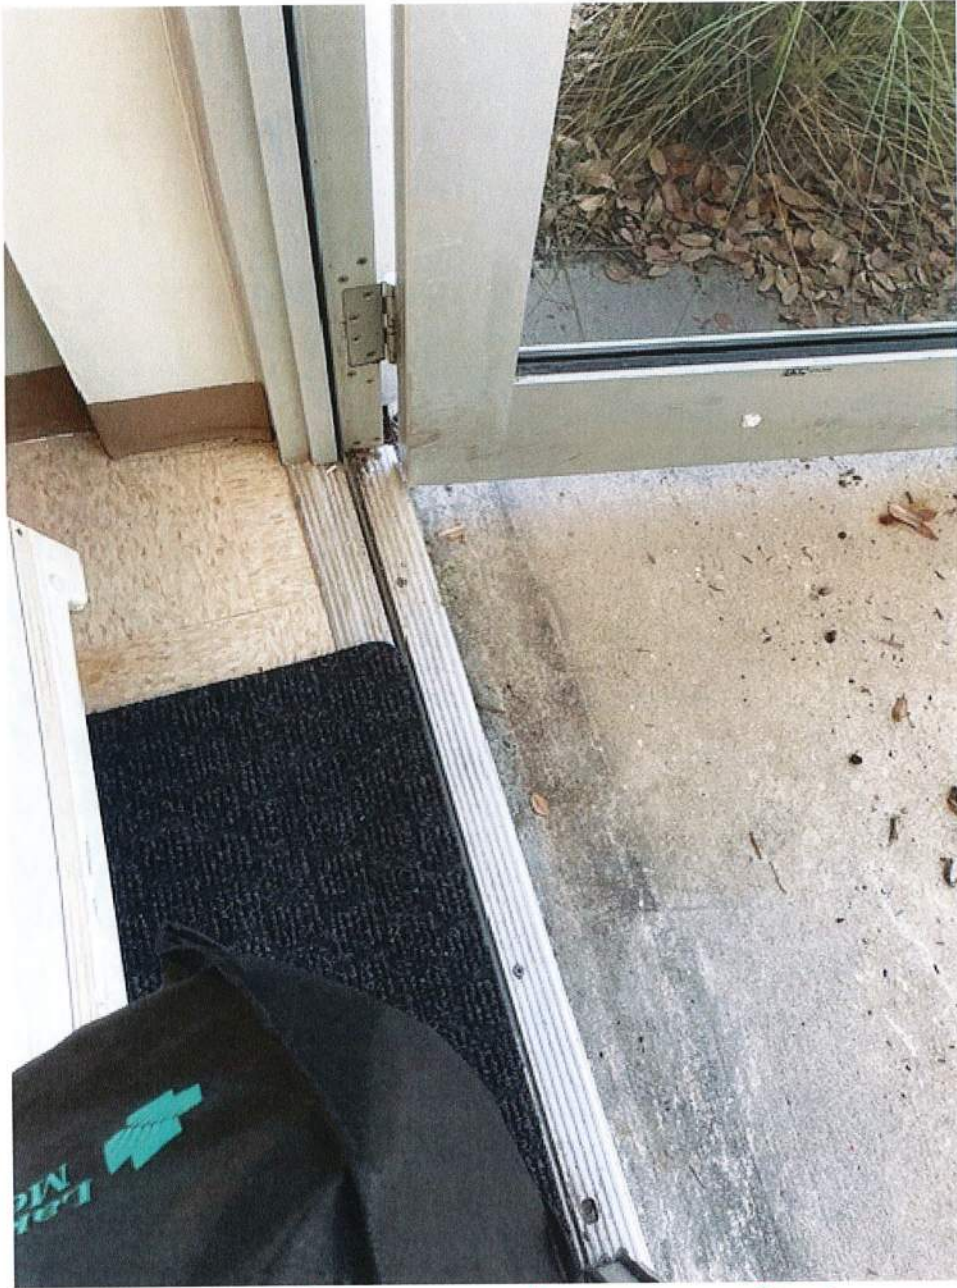
Community Ctr. Exterior Stonefront Entry - west facade
non-compliant (both Bldg Code & ADA)
threshold step is 2.5 inches.
Concrete walkway to be replaced and raised.

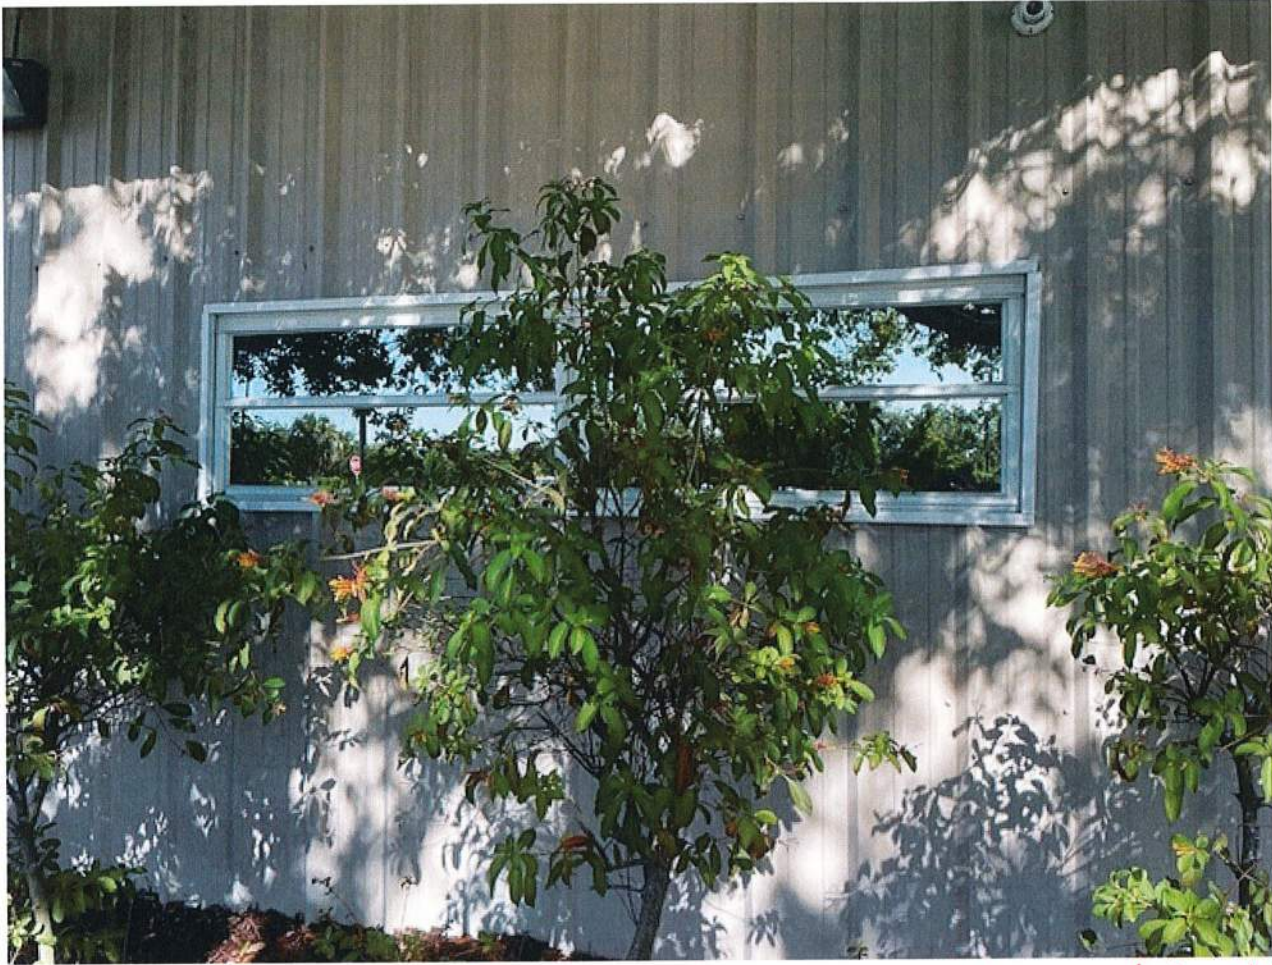
Awaken Church - (Section B) - Pre engineered building - east
· Existing aluminum curving windows
non impact rated - framing / glazing
