MEMORANDUM

Department of Public Works

SUBJECT: Community Services Facility - 4940 Pan American Boulevard

North Port Senior Center Site Observations from 8-13-2025 Field Visit

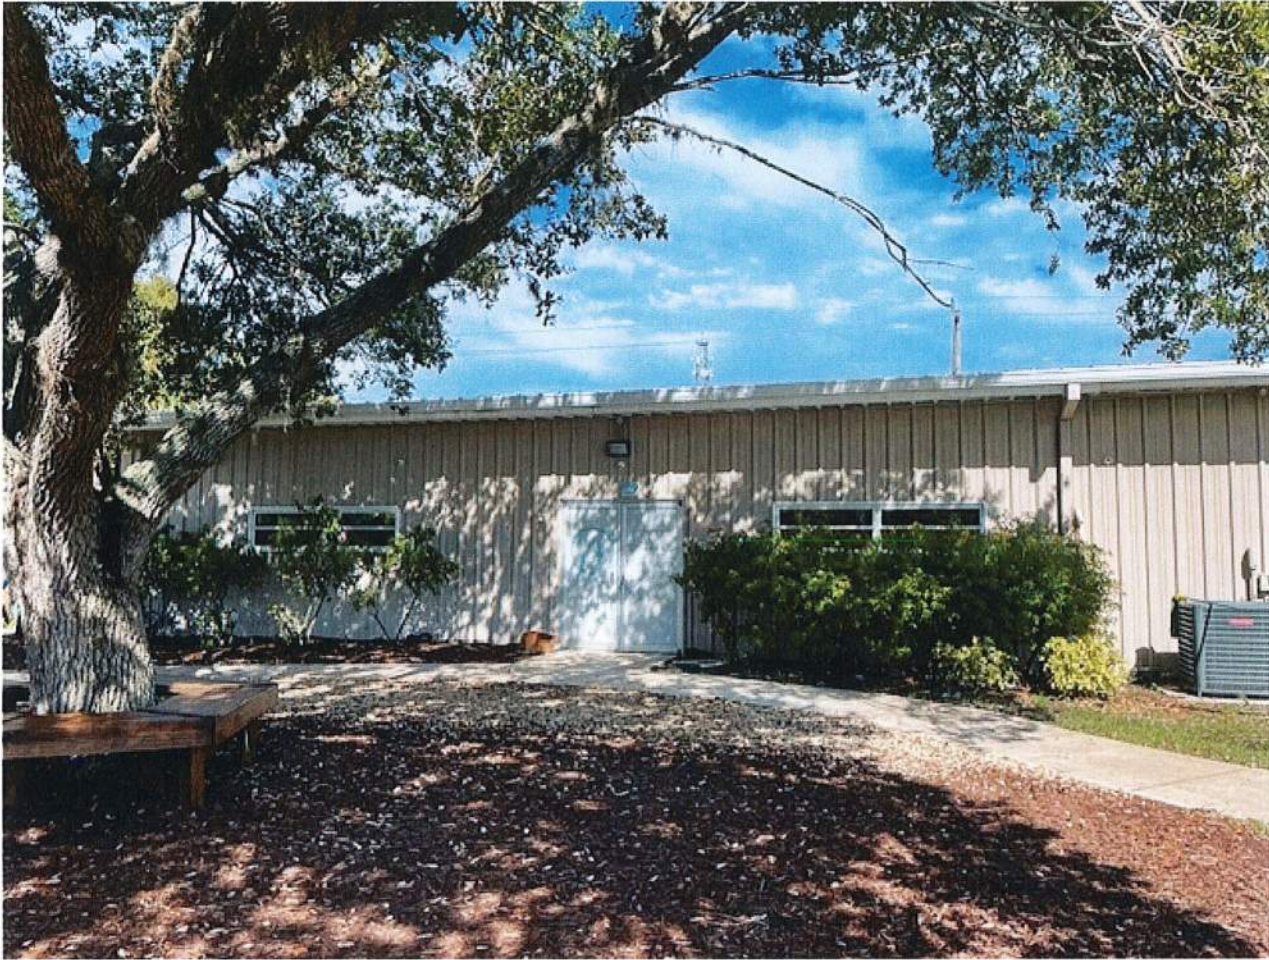
Awaken Church (Section B) - Pre-engineered building - east
• Existing aluminum windows and entry doors
non impact rated.

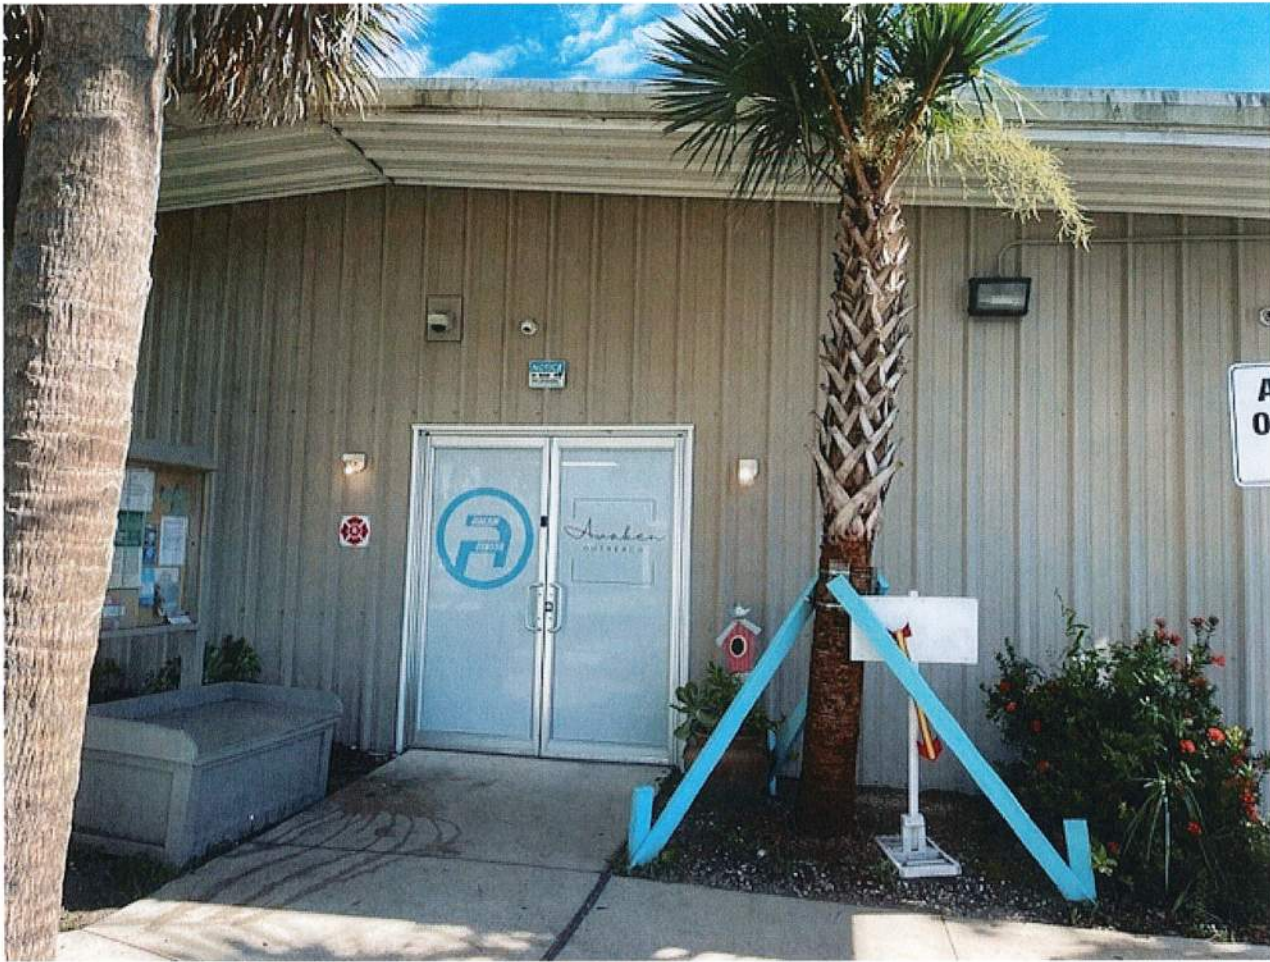
Awaken Church (Section B) Pre engineered building - south.

- Existing aluminum entry doors/frames non-impact rated. Door panels in frame do not seal properly — allows for air infiltration

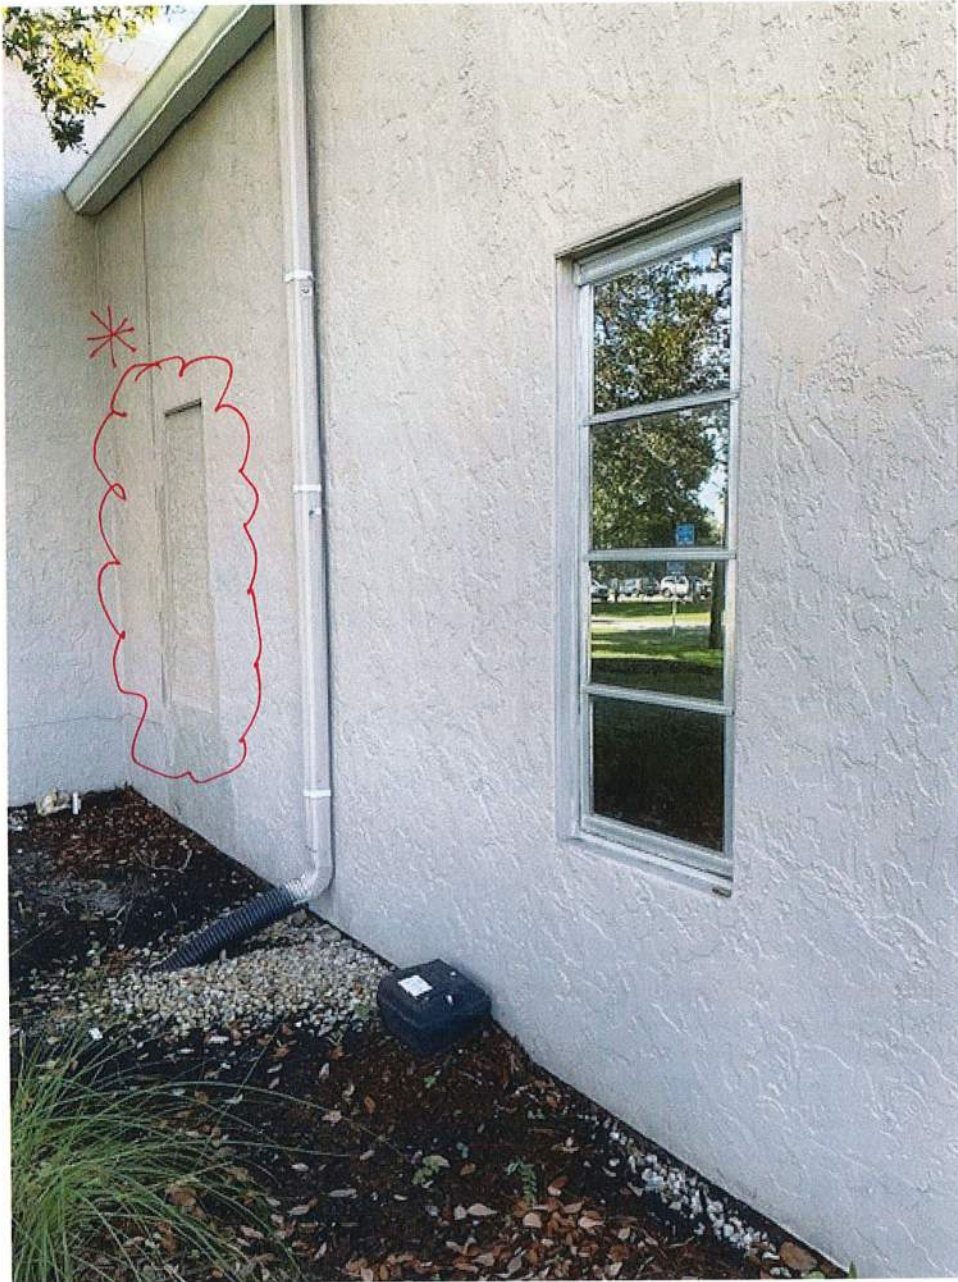
Community Center (Section A) - west facade

- Existing single hung windows
non-impact rated frame/glazing.
- Note * beyond in image -
existing window replaced with
stucco frame, wall on single board,
No insulation. Interior side
recessed shelving.

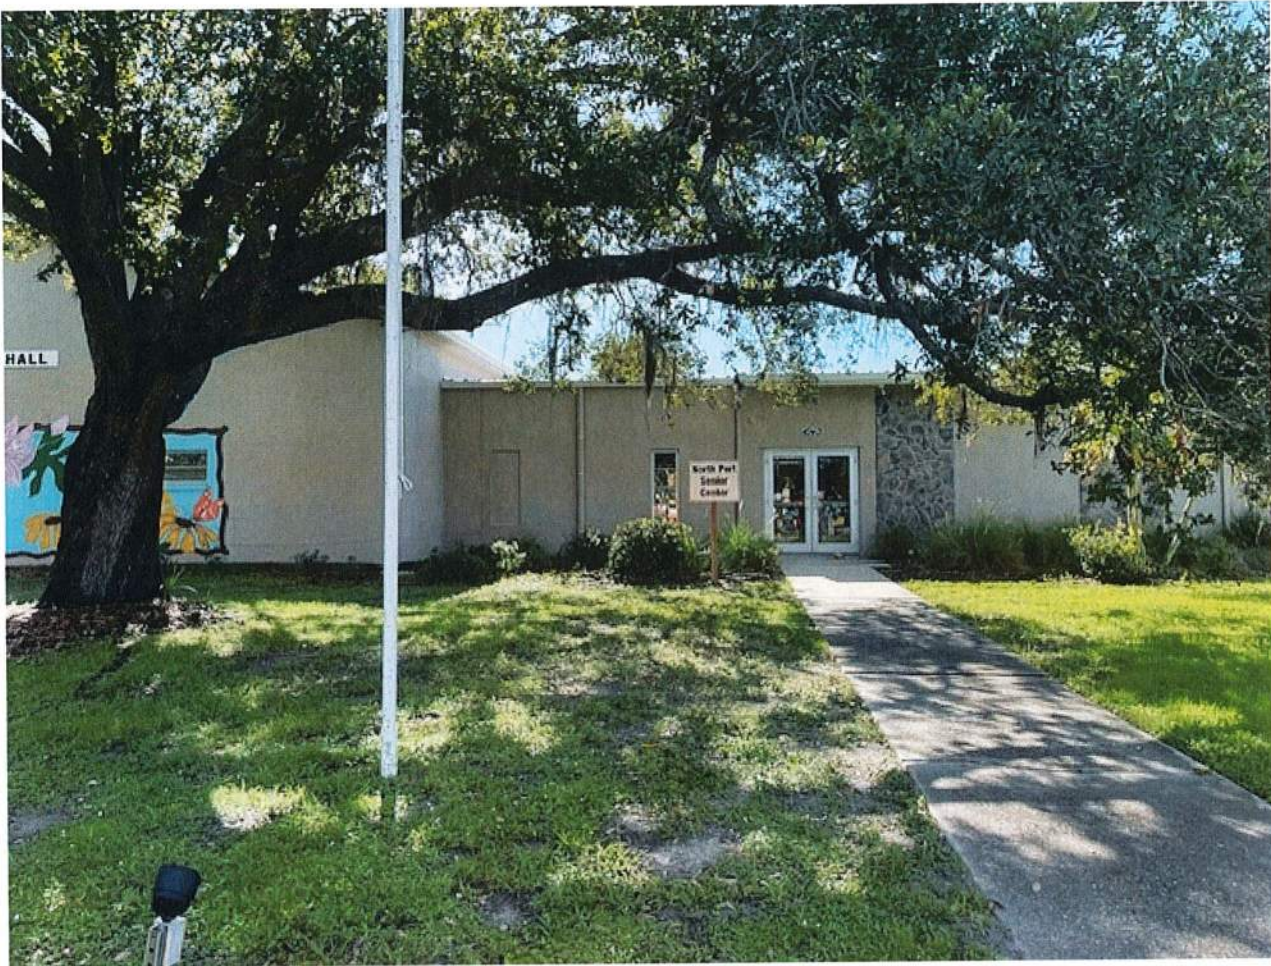
Community Ctr - (Section A) - west facade

- Existing aluminum windows and doors - non impact rated for window and door assemblies

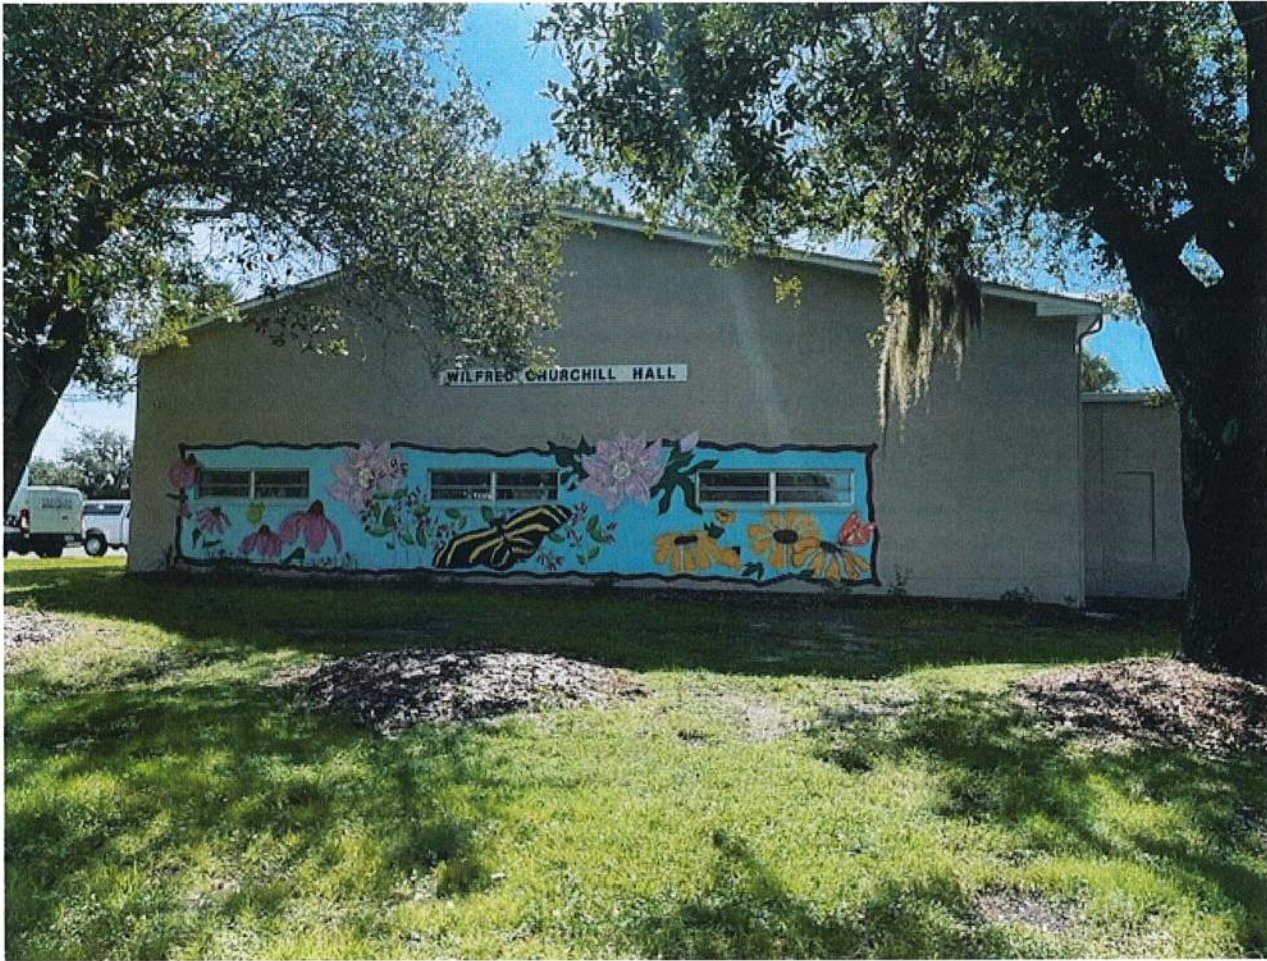
Community Center (Hall Section) - west facade.

- Existing Hall construction concrete masonry / wooden trusses for roof framing! Refer to structural report for assessment.
- Existing aluminum windows - awning non-impact rated assemblies

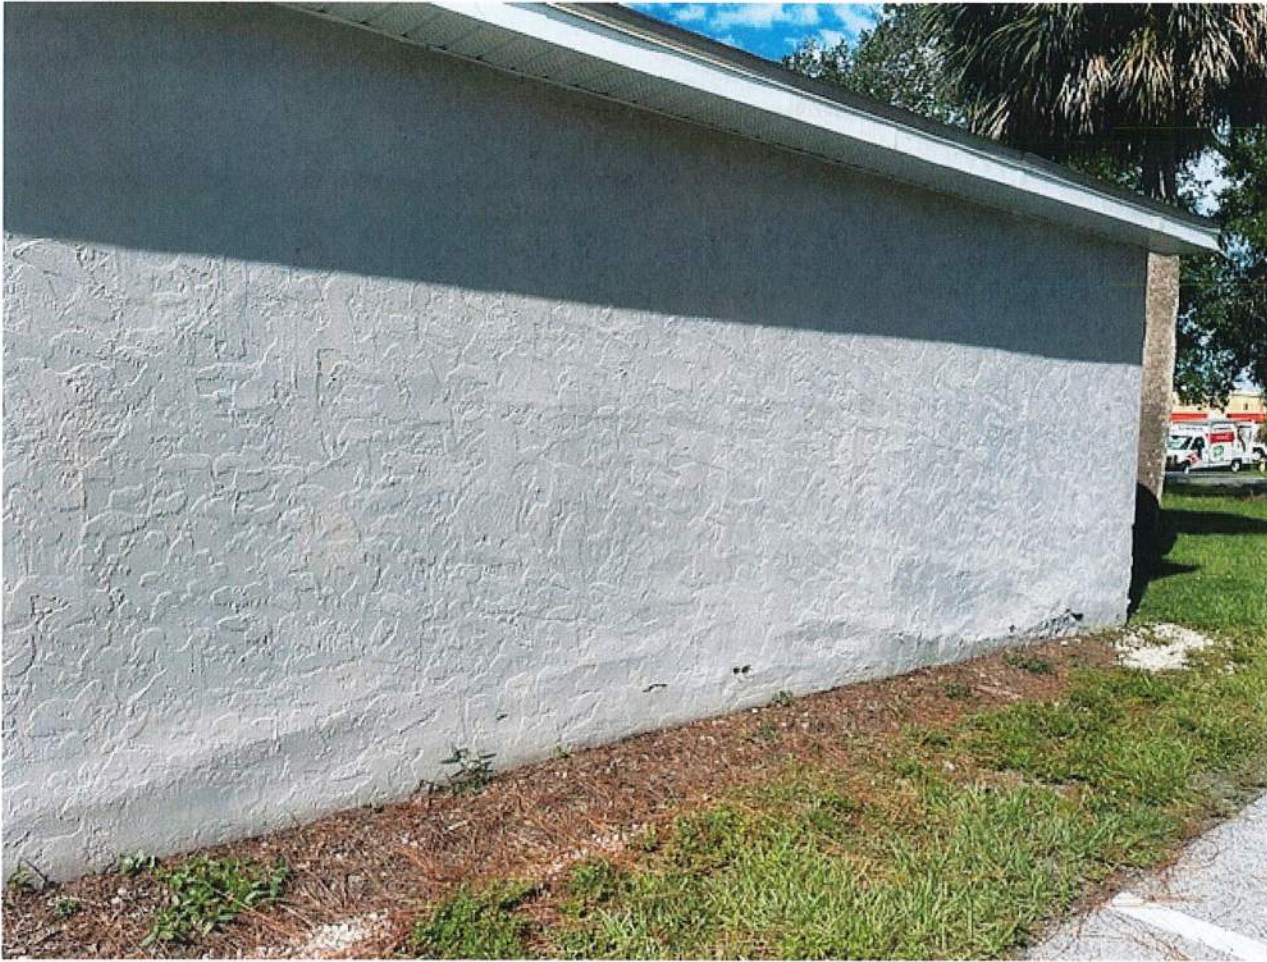
Community Center (Hall Section) - north facade.
• Added wood frame construction for storage room - note delamination of stucco/metal lathe along entire length of wall.

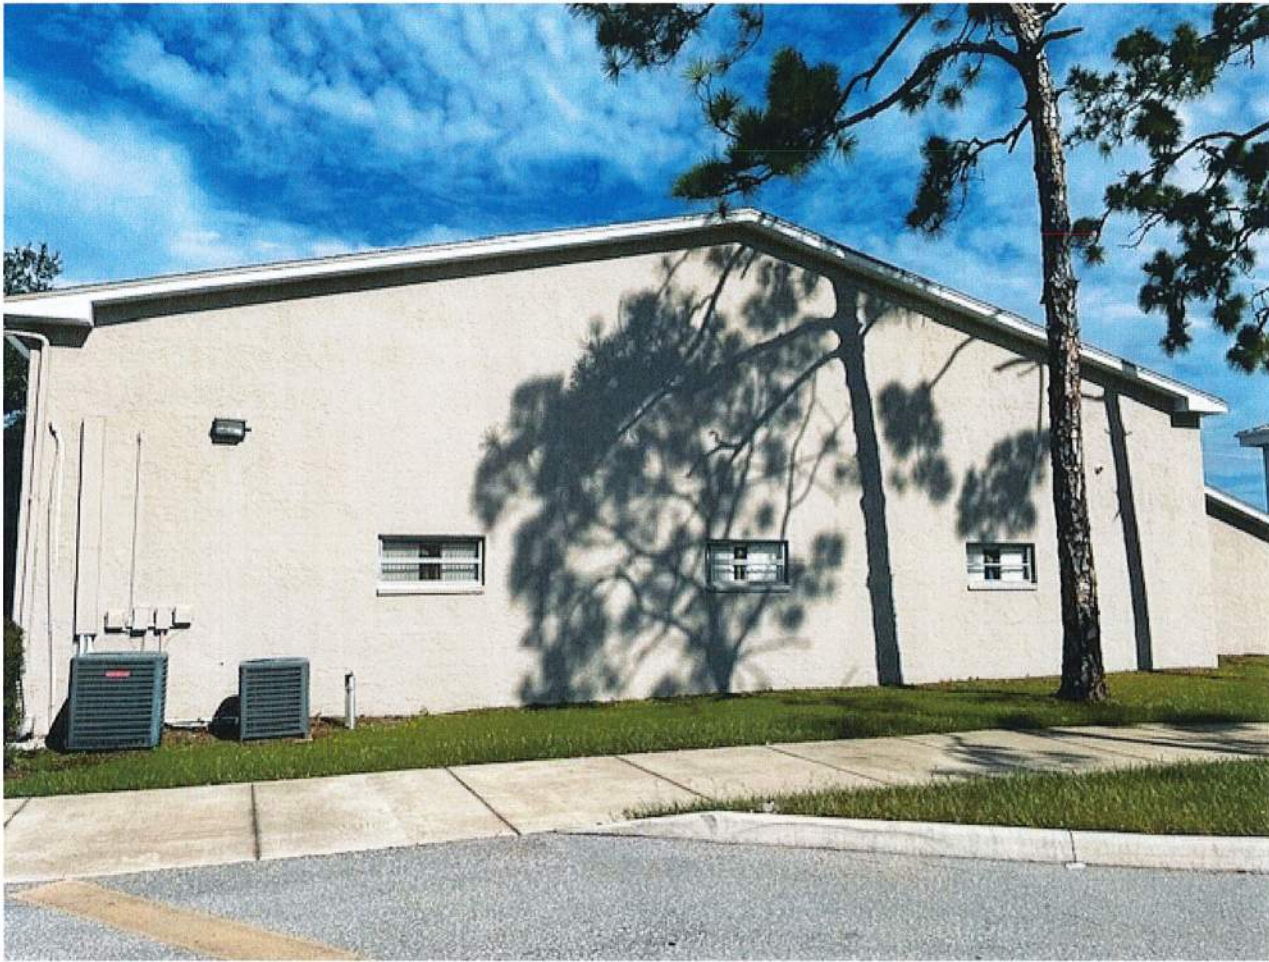
Community Center (Hall) - east facade.

- Existing aluminum awning windows non impacted rated assemblies
