Damage Assessment Report

Warm Mineral Springs Park Clubhouse 1

Address: 12200 San Servando Ave, North Port, FL 34287

SITE INSPECTION REPORT

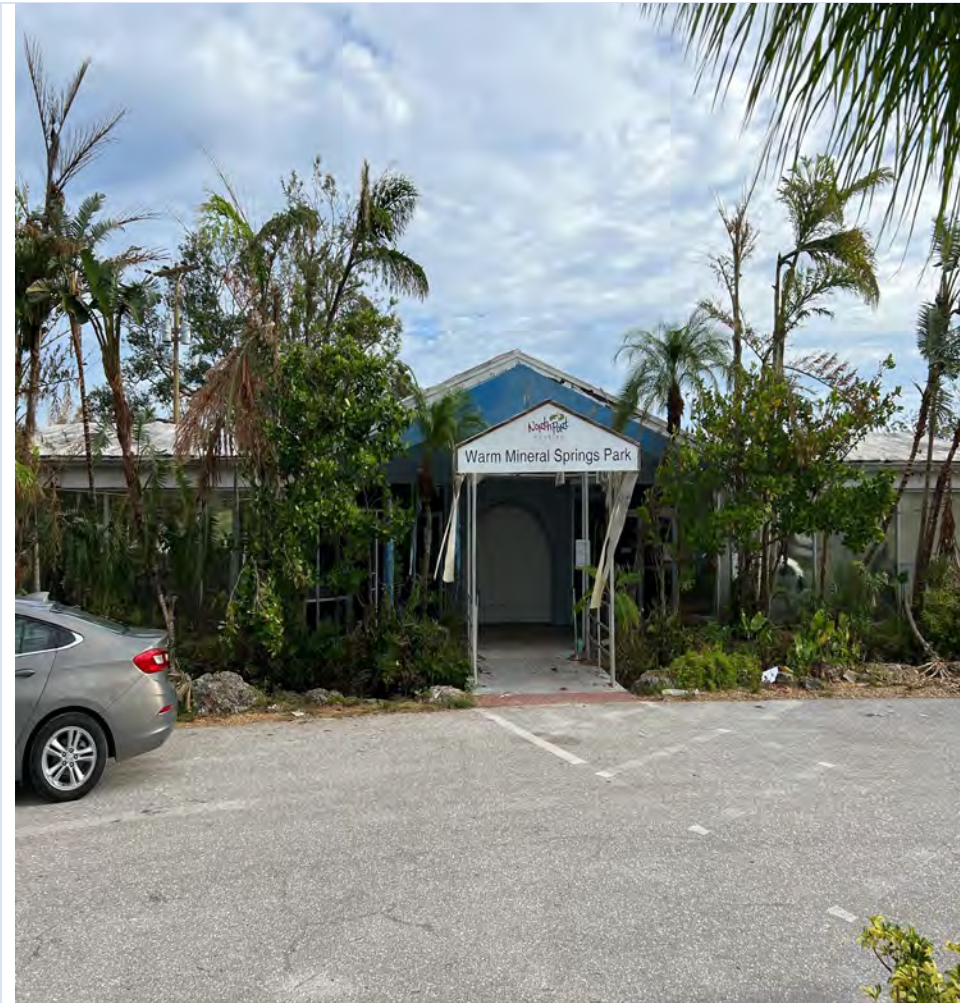
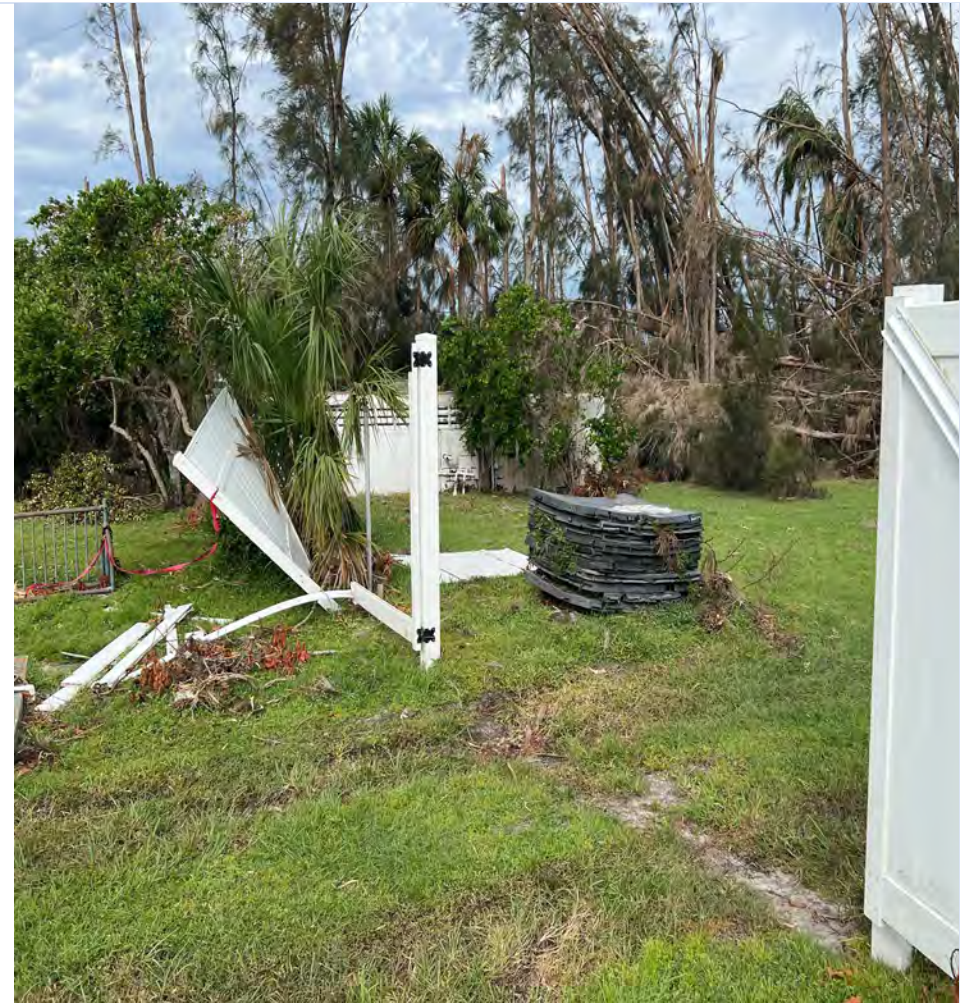
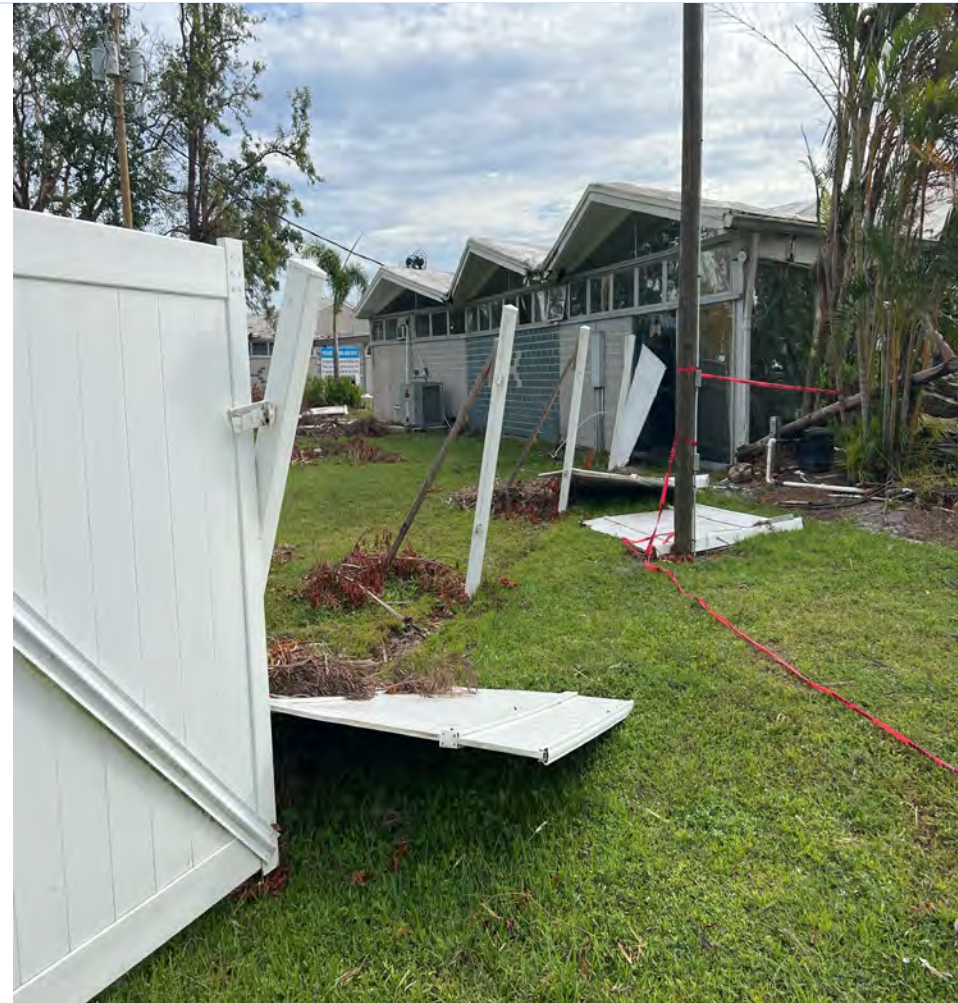
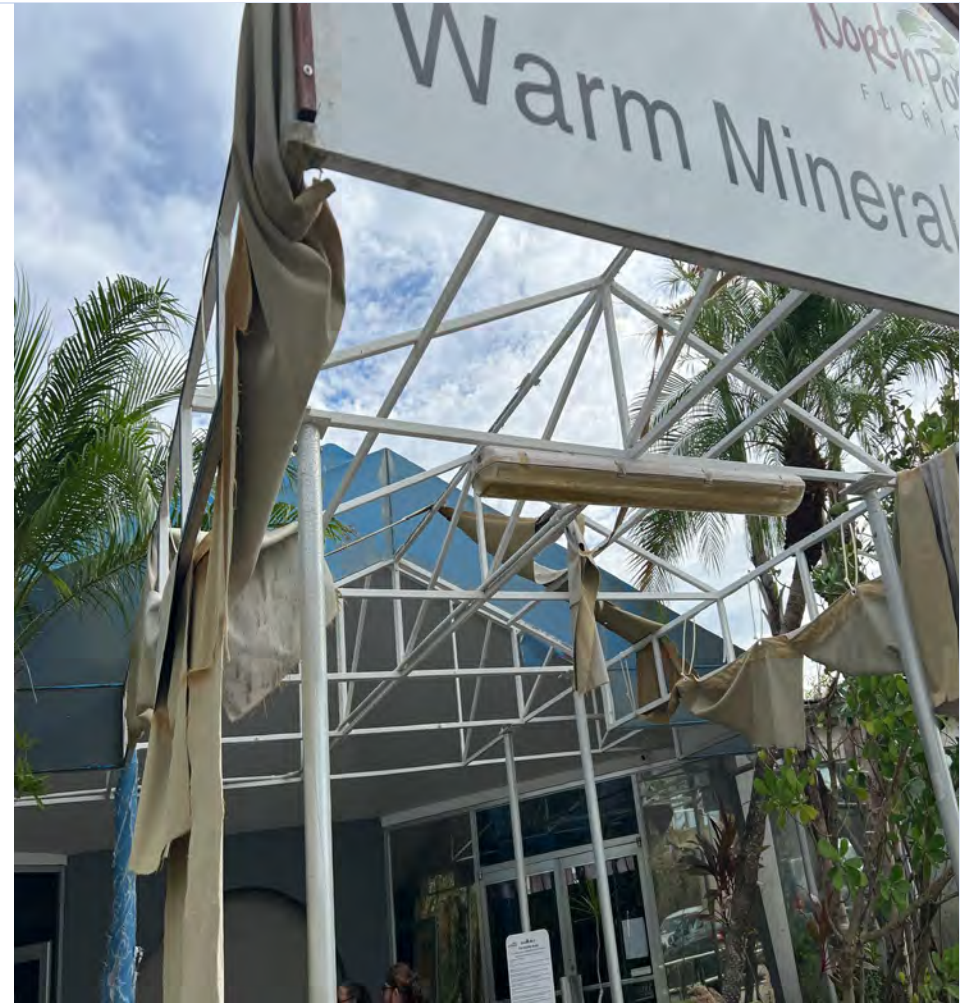
Elevation: South

Wall, Site work

125 SF Beige Tarpaulin
232 SF Blue Tarpaulin
96 LF Vinyl Fencing 6'
8 EA Vinyl Fence Post 8' 4" x 4"
2 EA Vinyl Fence Posts 5"x 5" x 10'
4 EA Gate Hinge Painted Galvanized Steel
42 LF Vinyl Fence Gate Frame

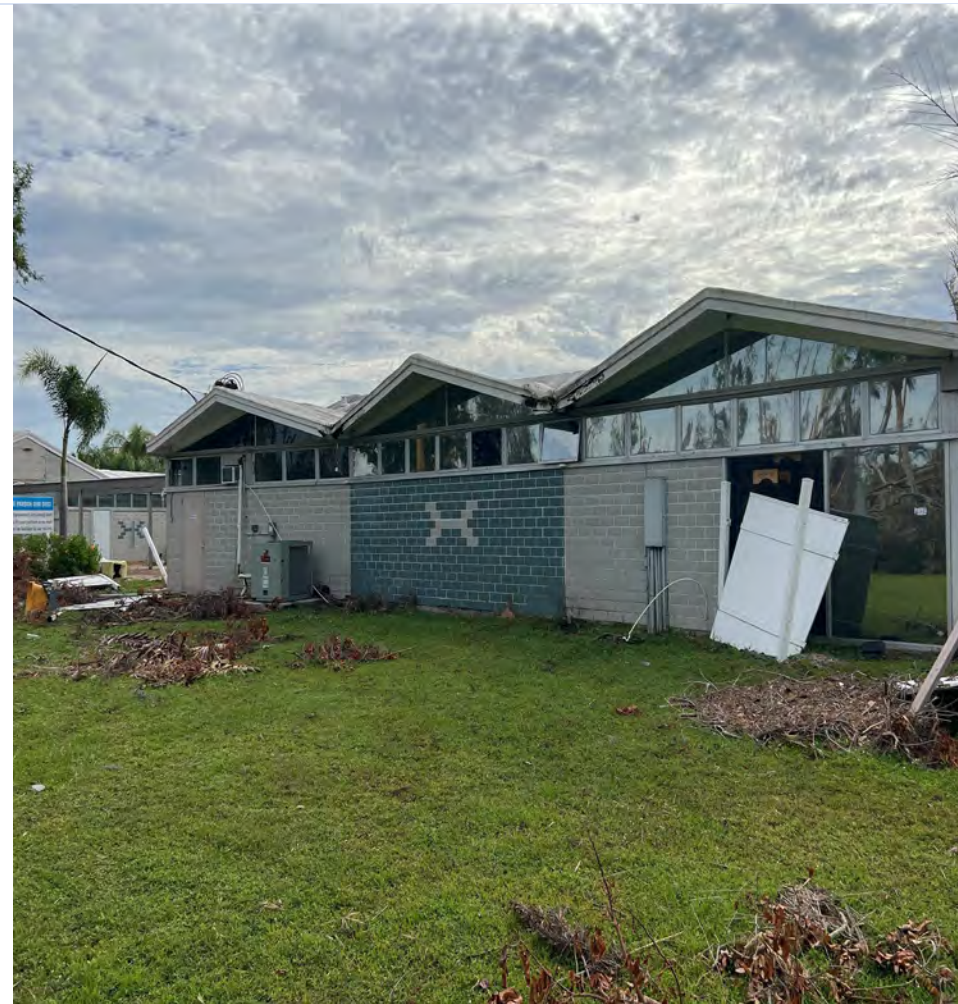
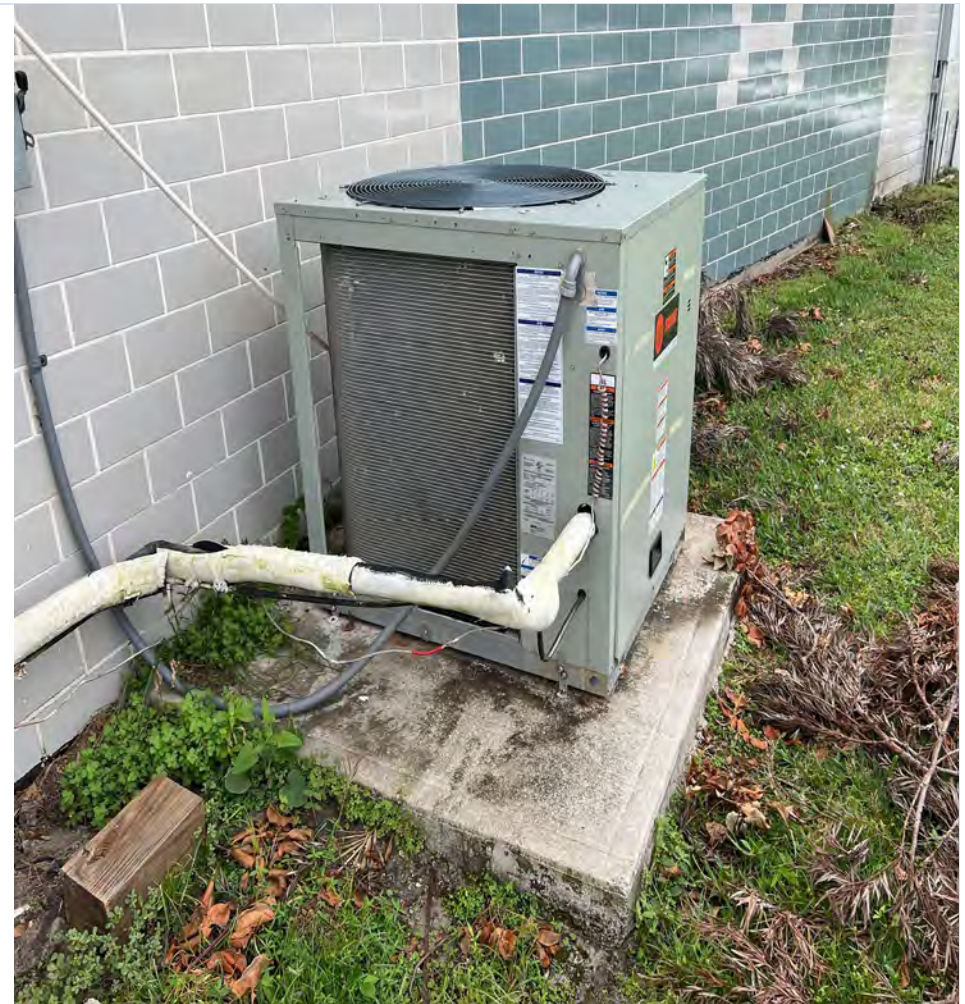
Elevation: West

Wall

- 1 EA AC needs inspection
- 1 EA Aluminum Hinged Window 2' x 3'
- 1 EA single Pane Tinted Window 9 SF

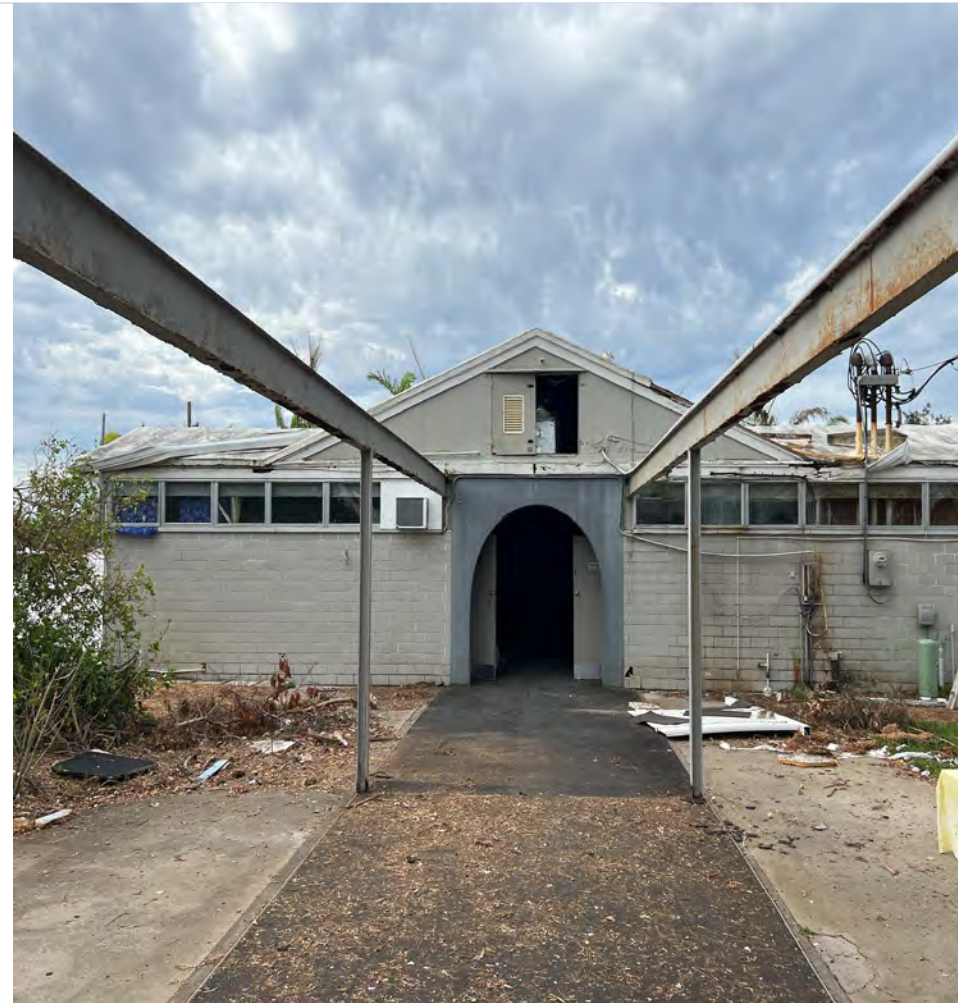
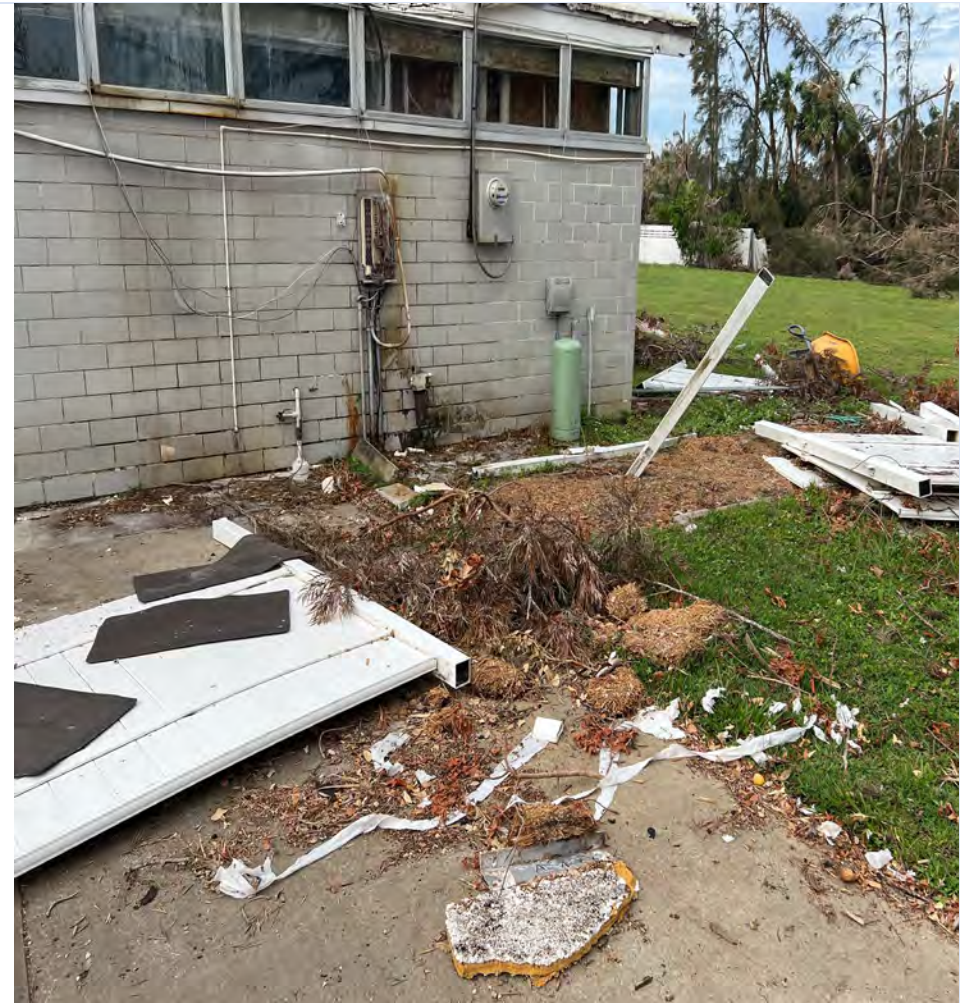
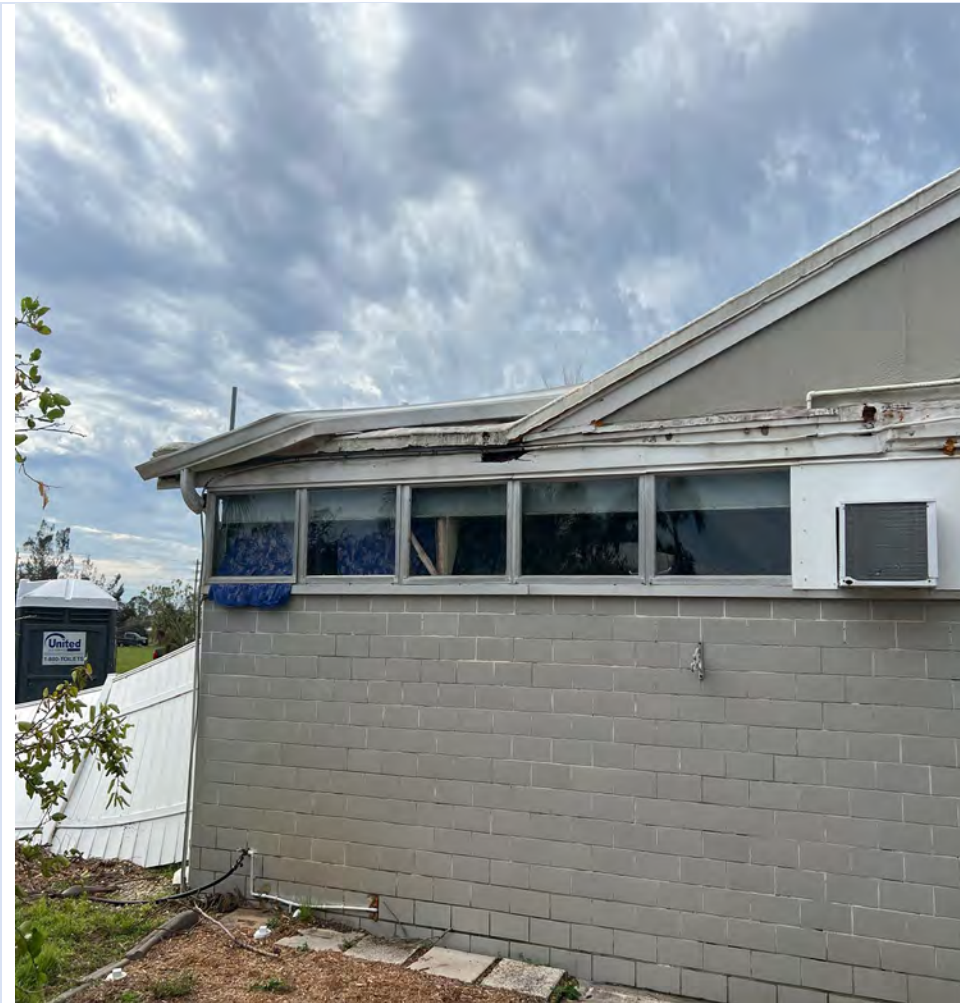
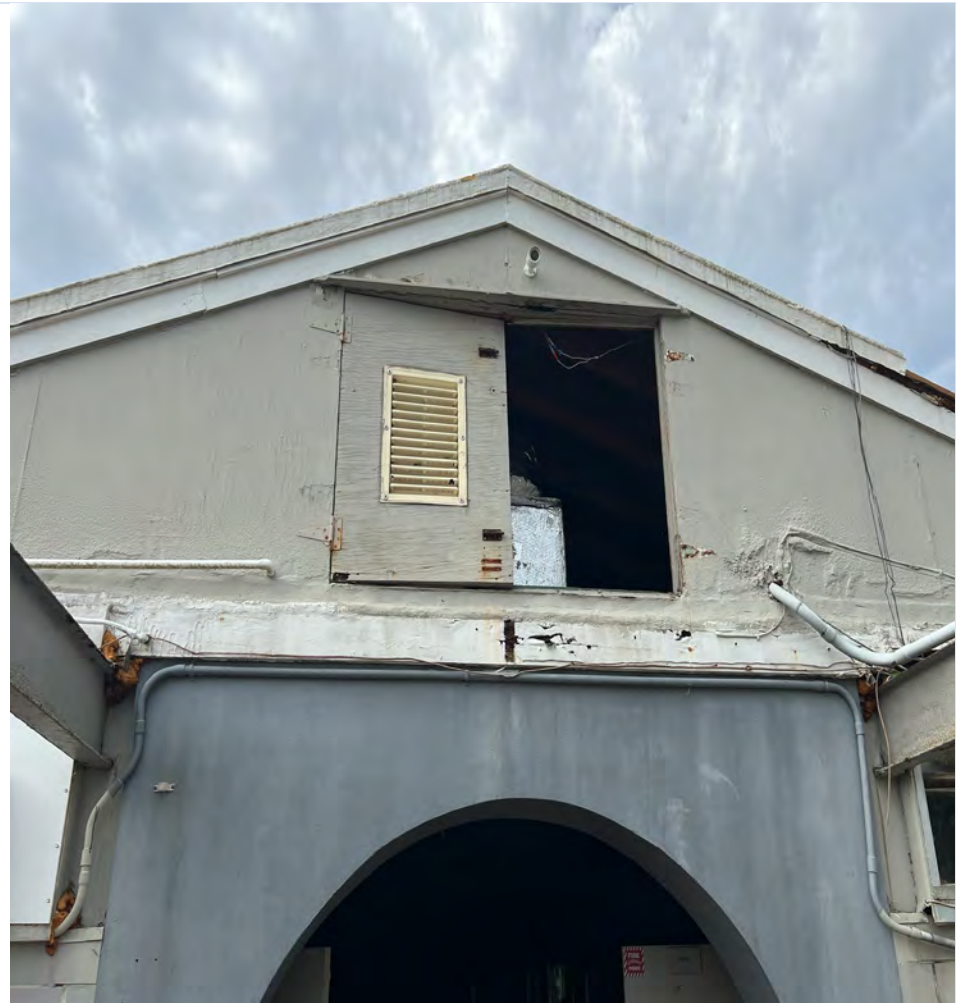
Elevation: North

Wall, Site work

1 EA plywood Swing Door 1.25" x 2.5' x 3'

48 LF Aluminum K Style Gutter 3" x 4"

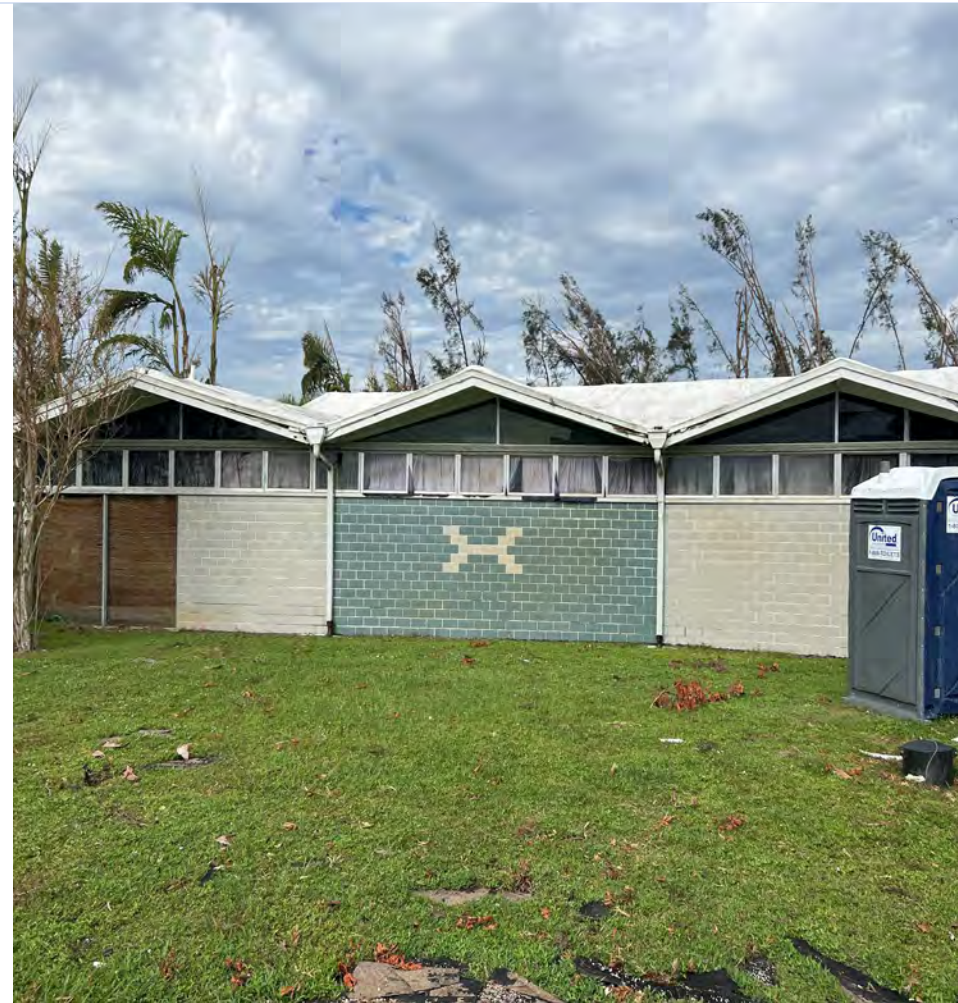
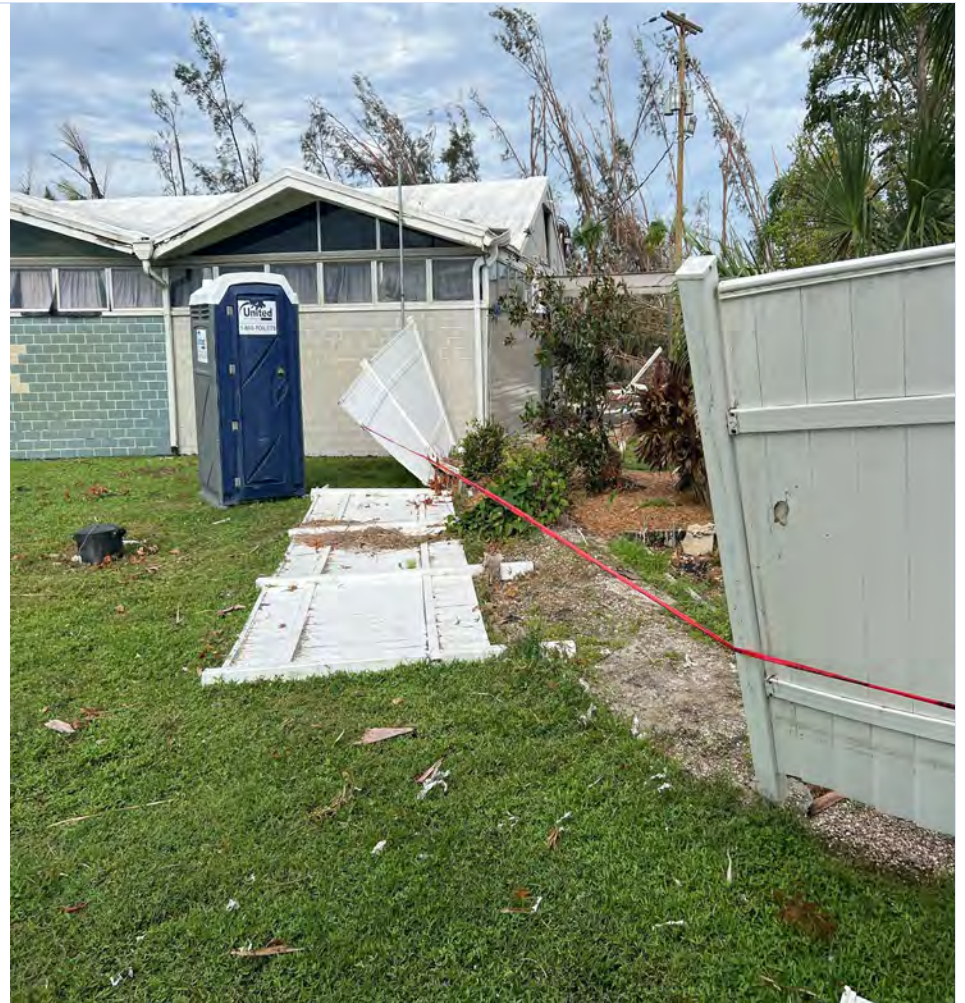
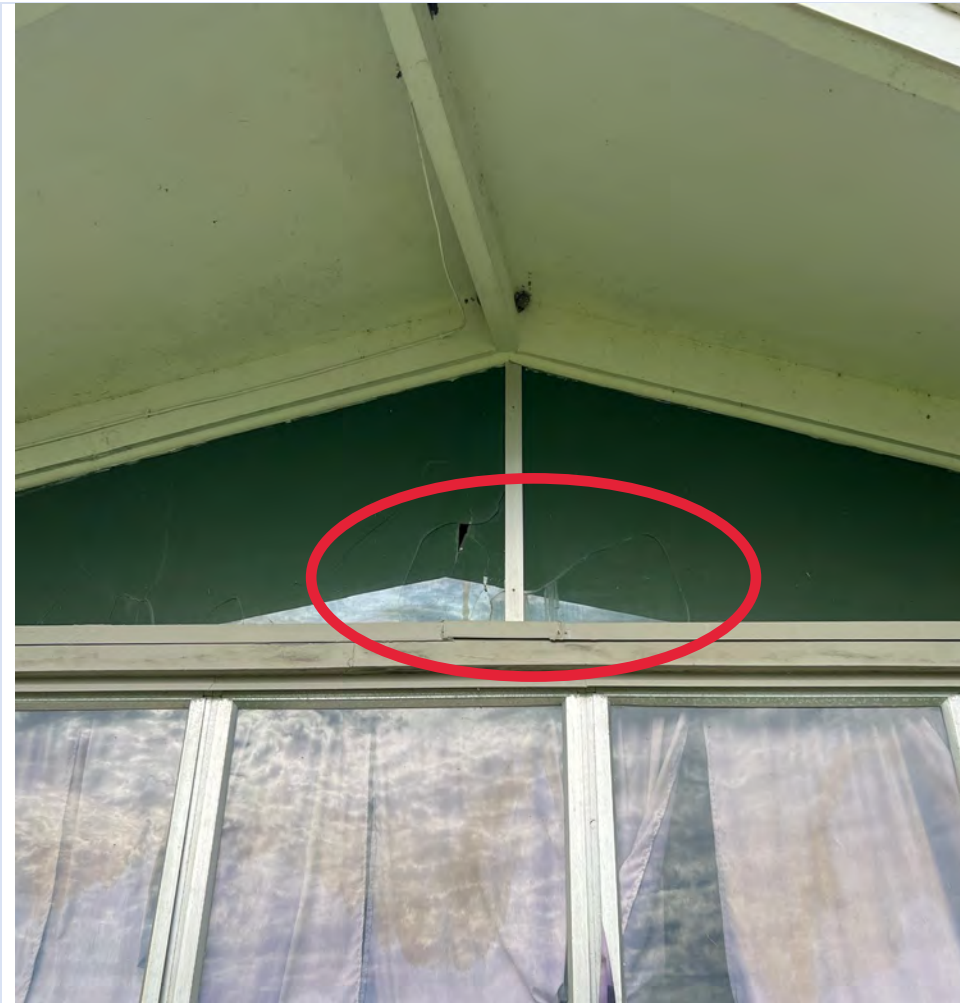
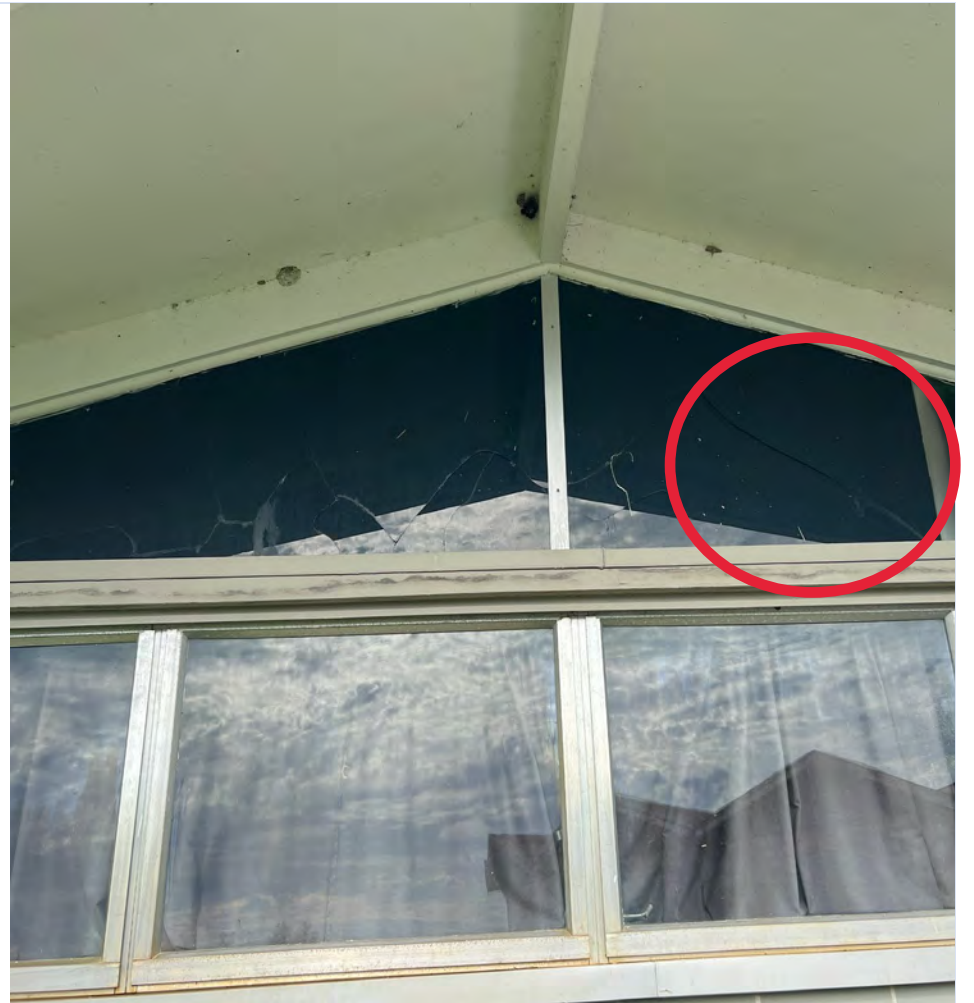
Elevation: East

Wall, Site Work

6 EA Single Pane Tinted Window 9 SF

38 LF Vinyl Fencing 6'

9 EA Vinyl Fence Post 4" x 4" x 10'

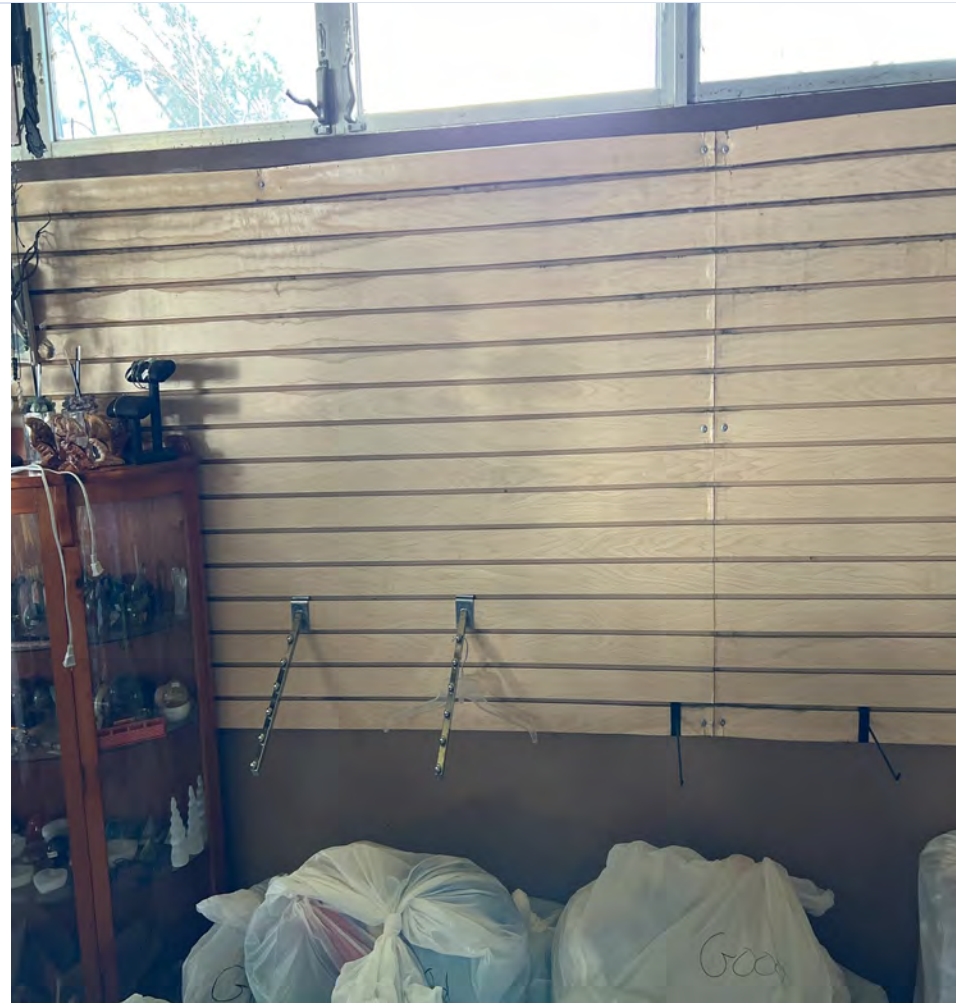
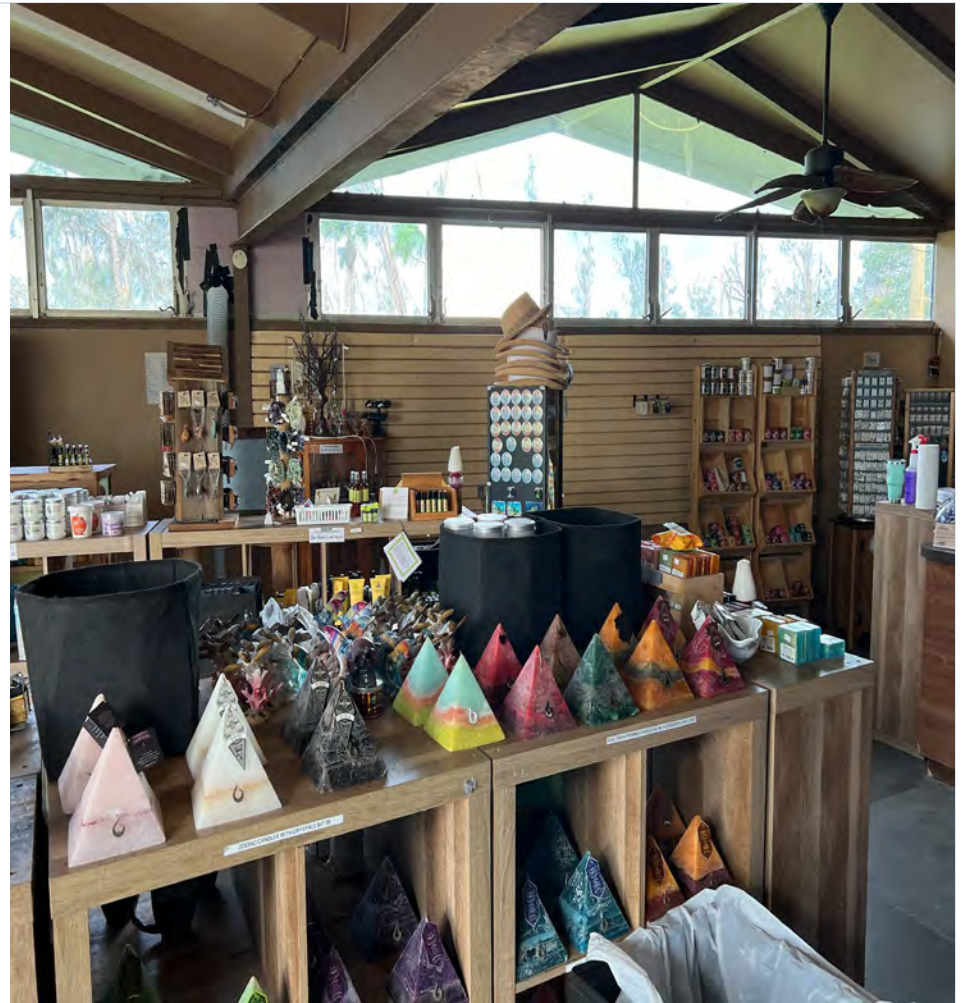
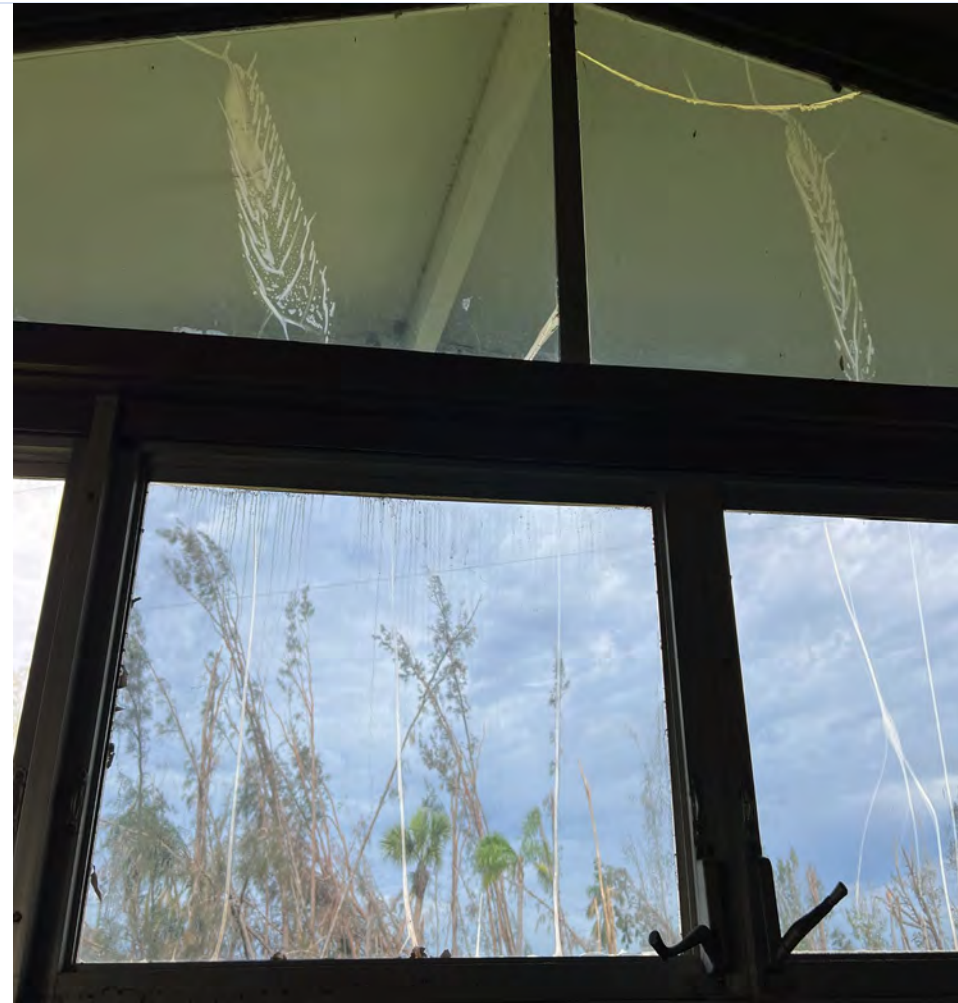
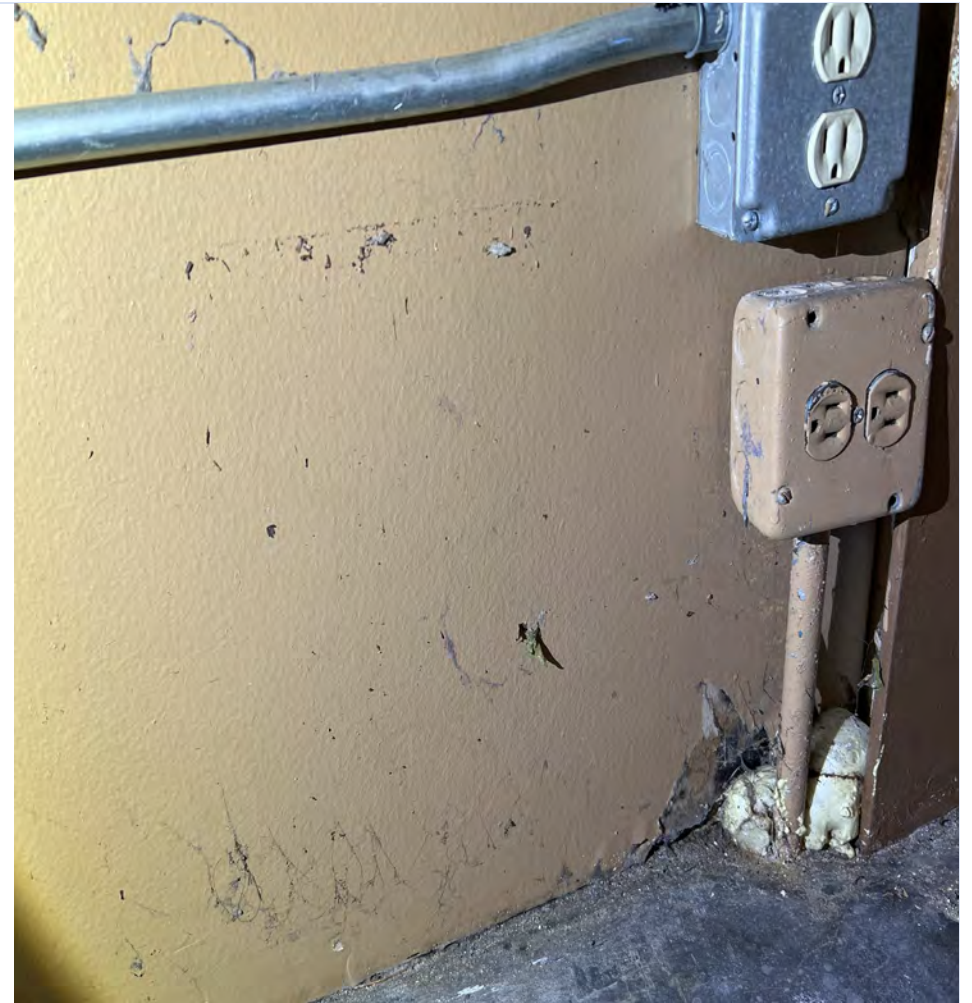
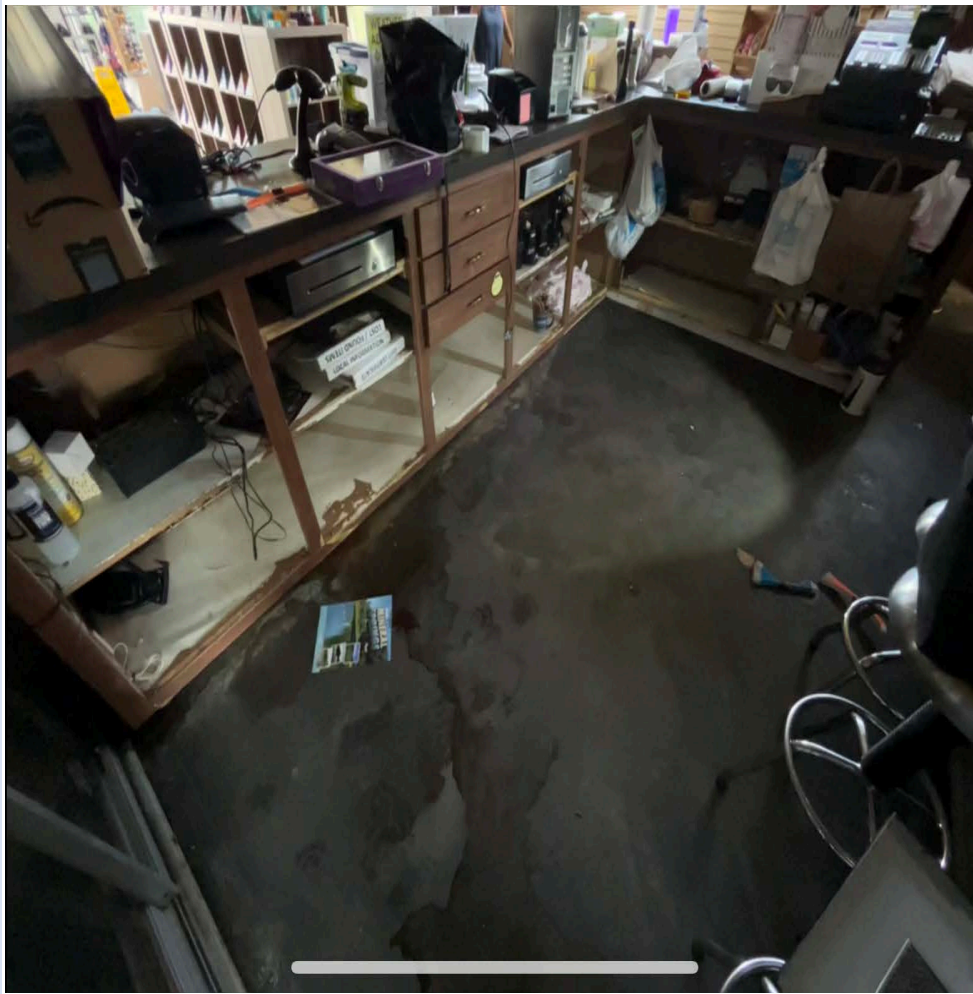
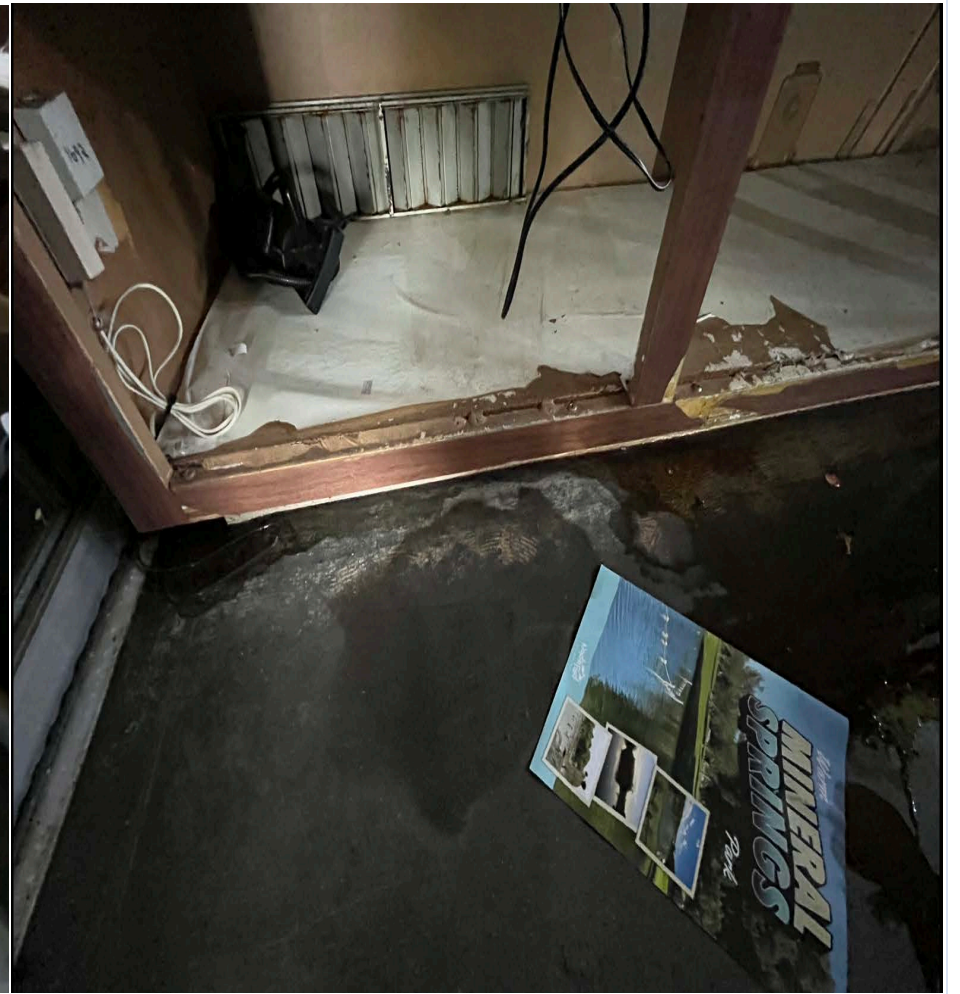
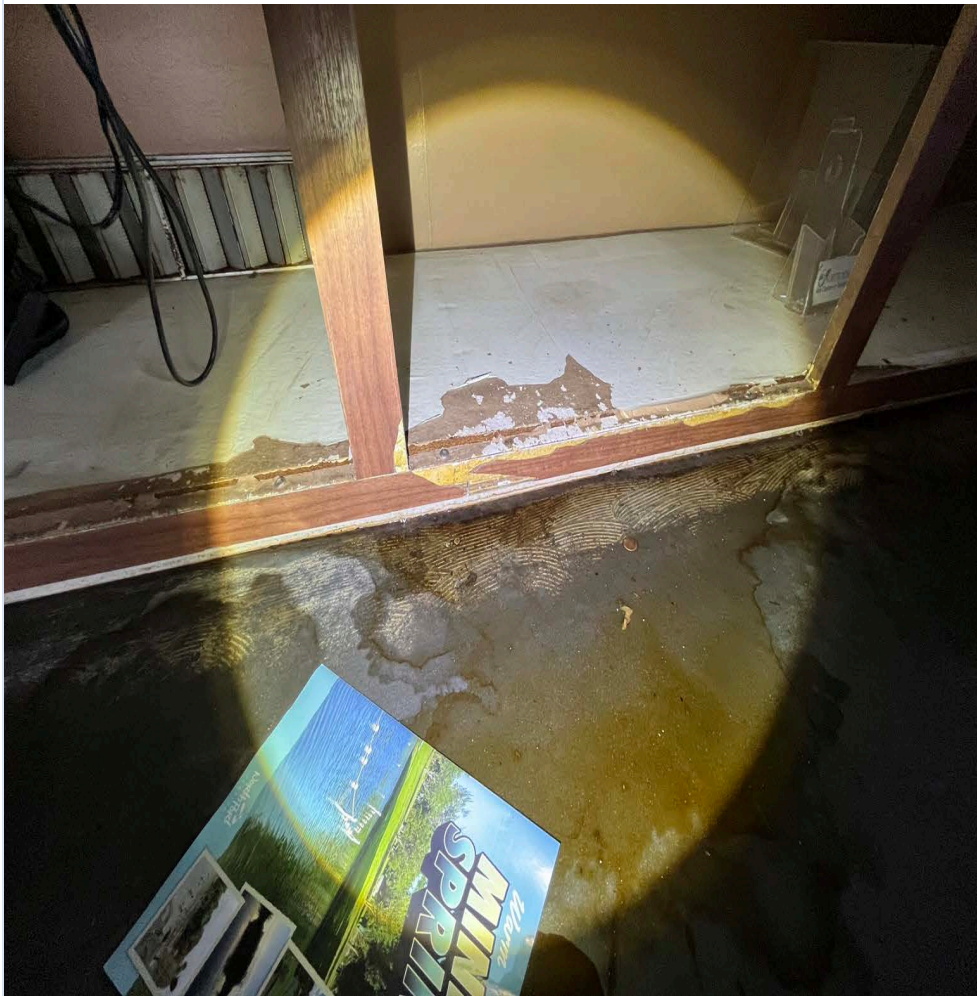
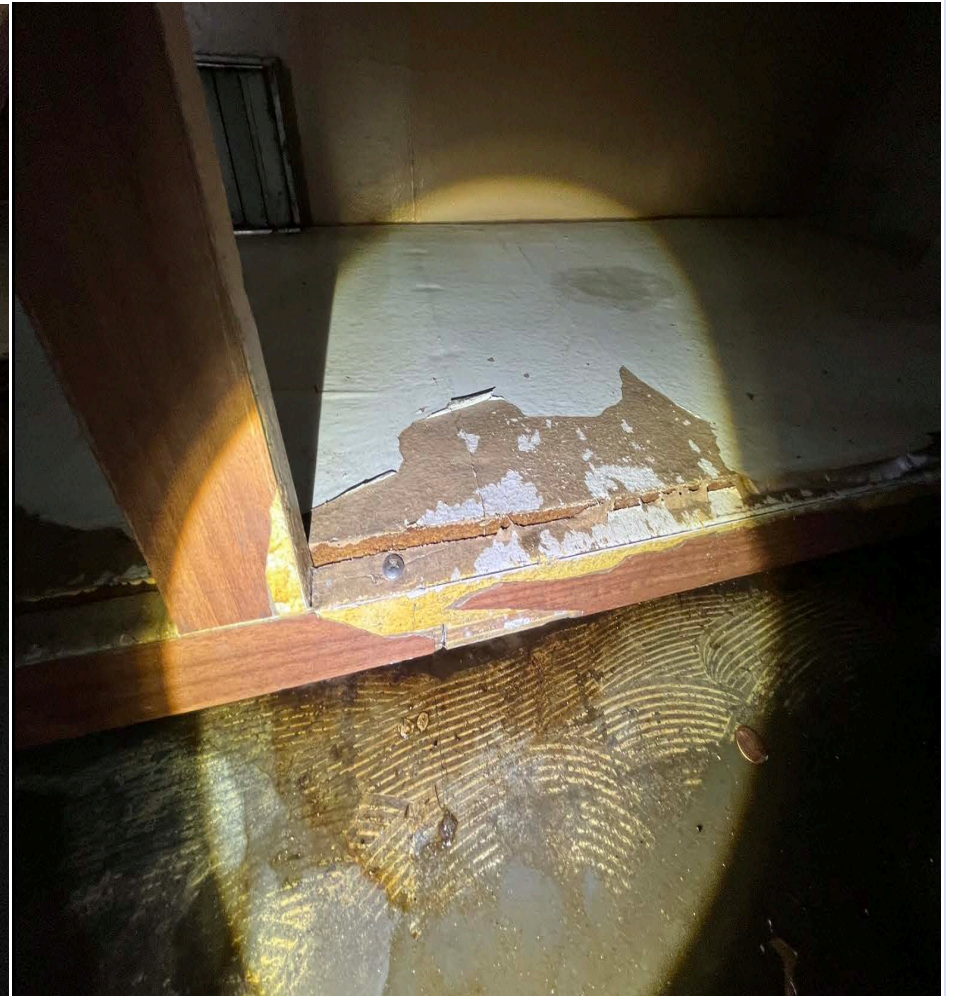
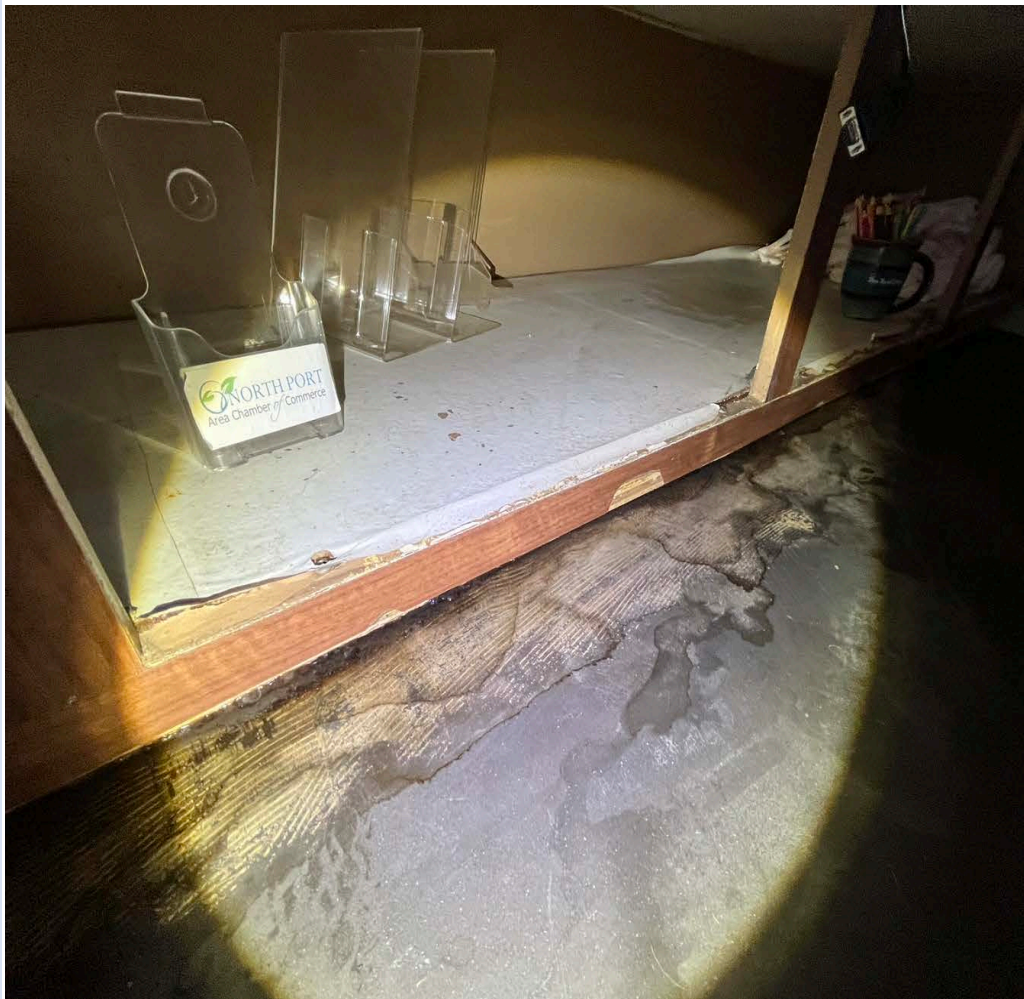
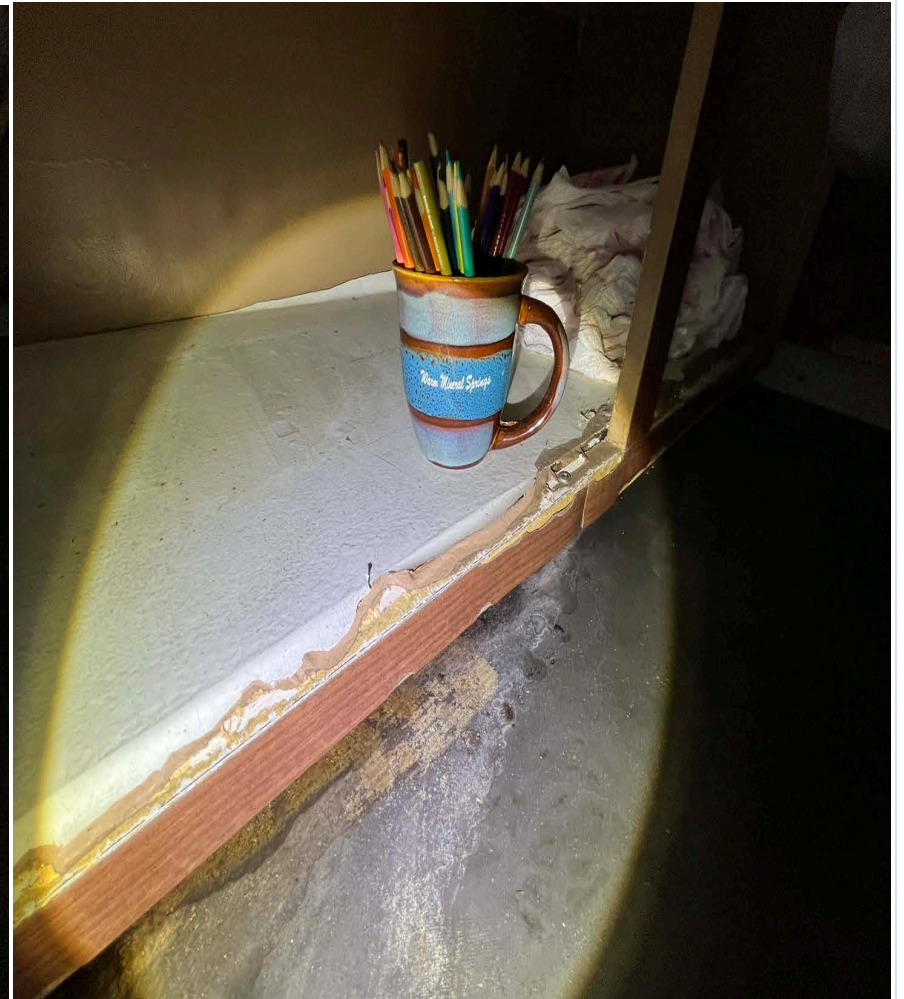
Room #: Gift Shop

Wall, Opening

392 SF Drywall 5/8"

48 SF MDF Slat Wall Panel 1/2"

2 EA Tinted Single Pane Glass 9 SF

1 EA Cabinet wood grain veneer laminate 21' x 2' x 39.5"
