Damage Assessment Report

Warm Mineral Springs Park Clubhouse 1

Address: 12200 San Servando Ave, North Port, FL 34287

SITE INSPECTION REPORT

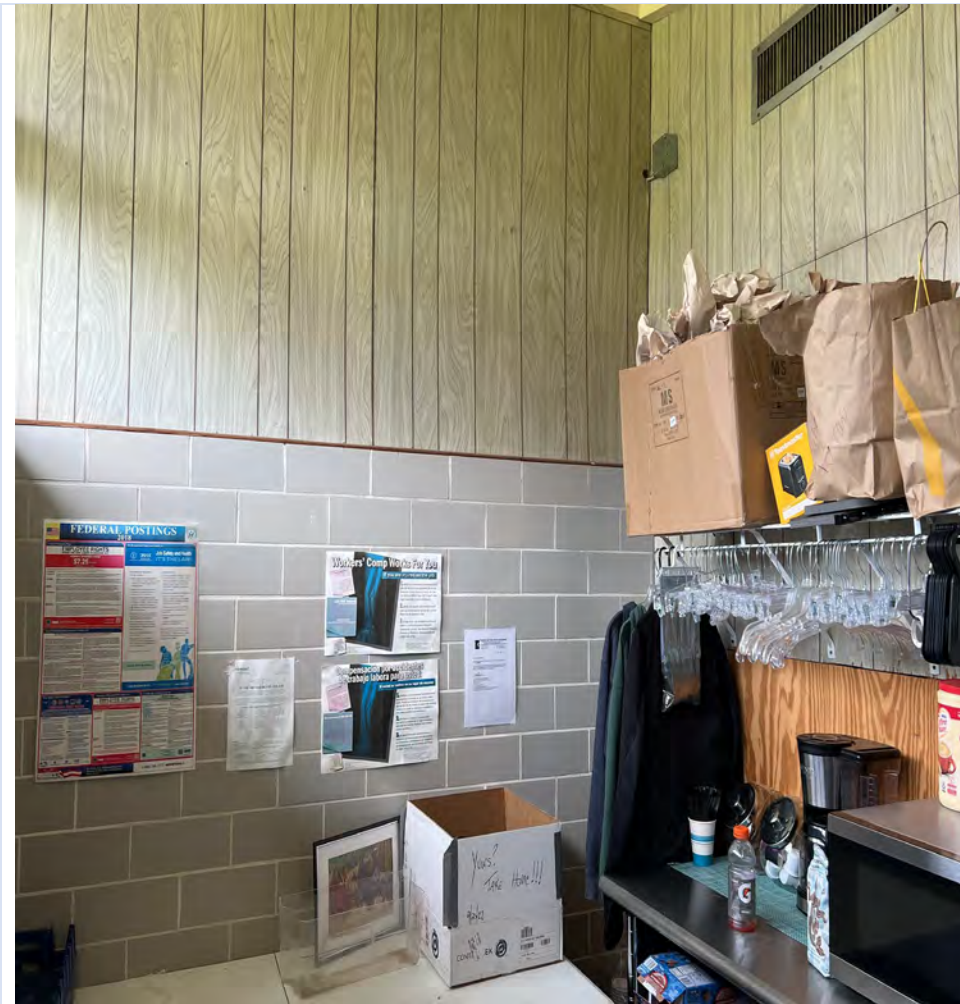
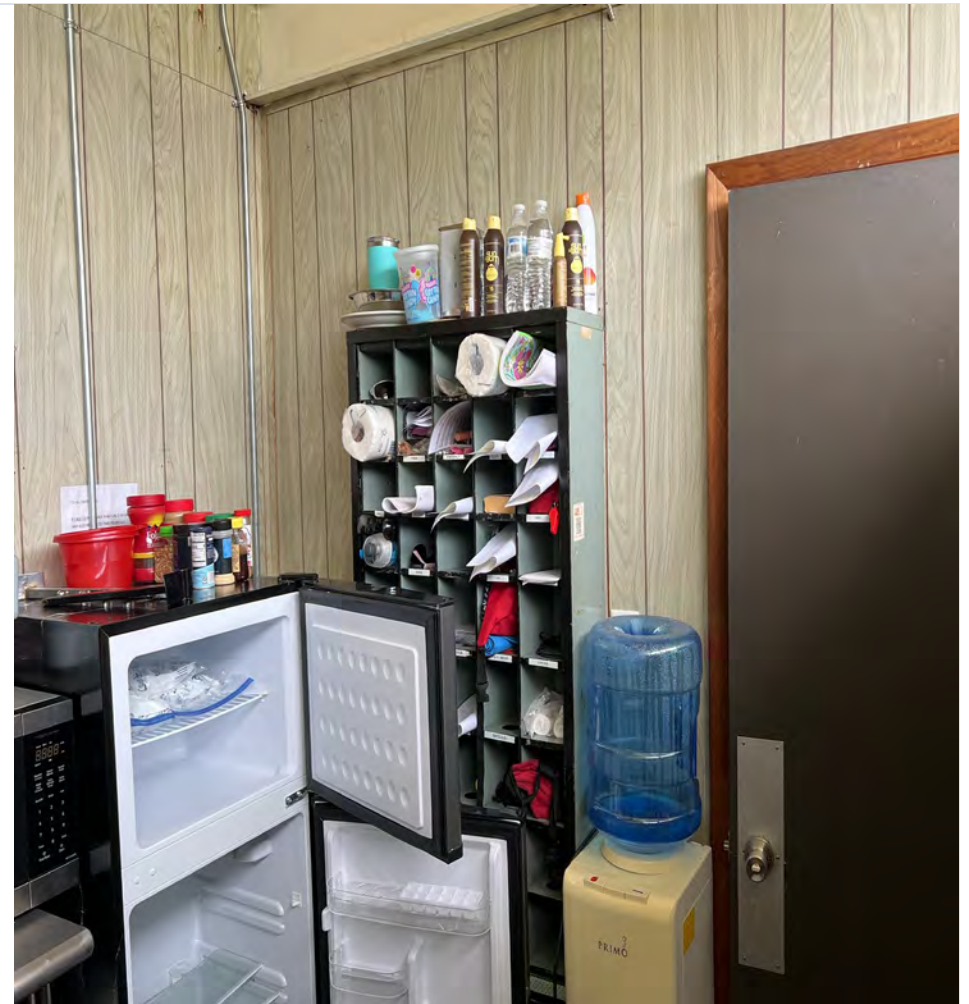
Room #: Office 1

Wall

1 EA Hollw Wood Door 28" x 81"

1 EA Door Casing 3' x 7'

148 SF Wood Grain Paneling

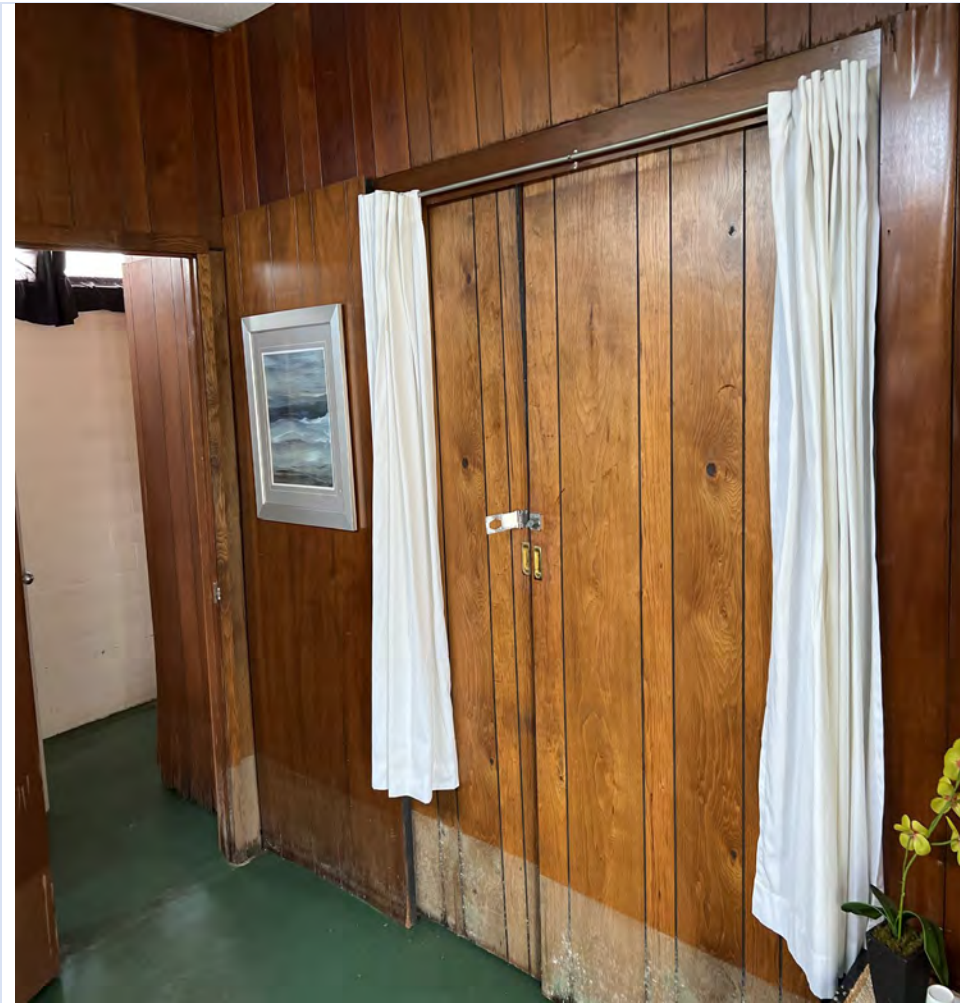
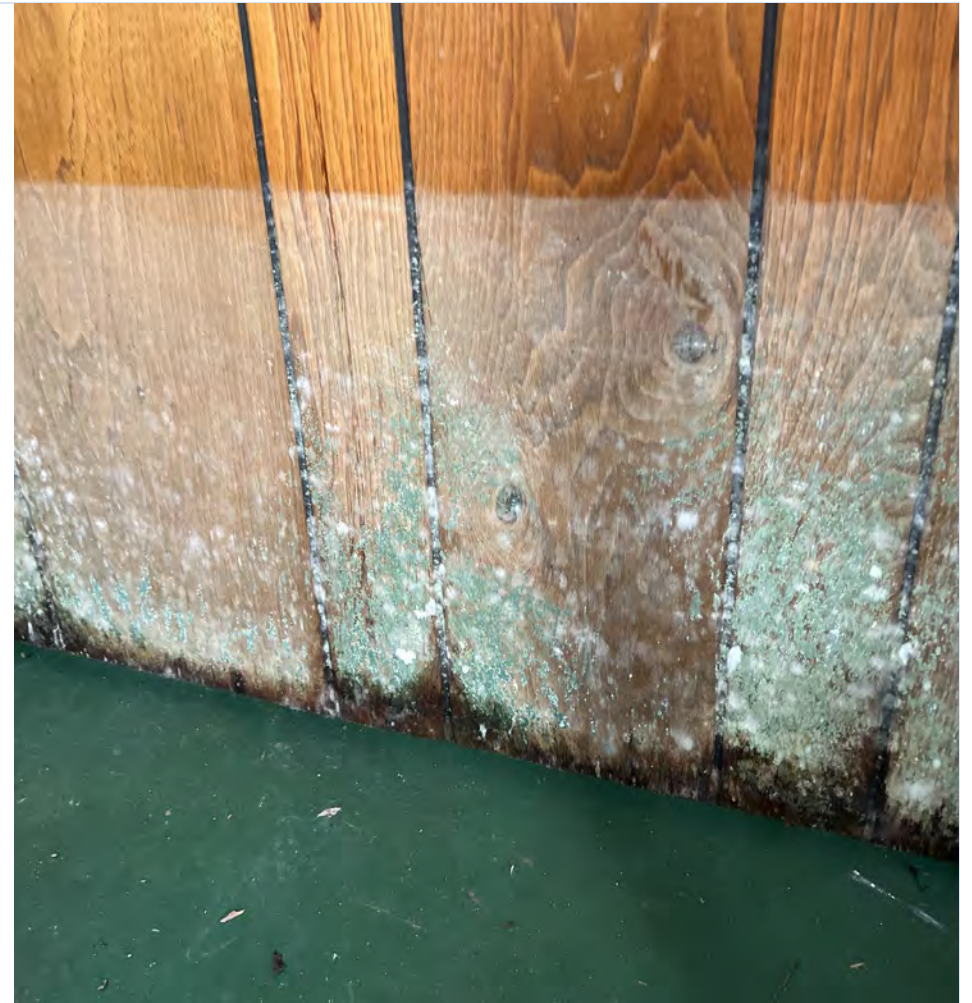
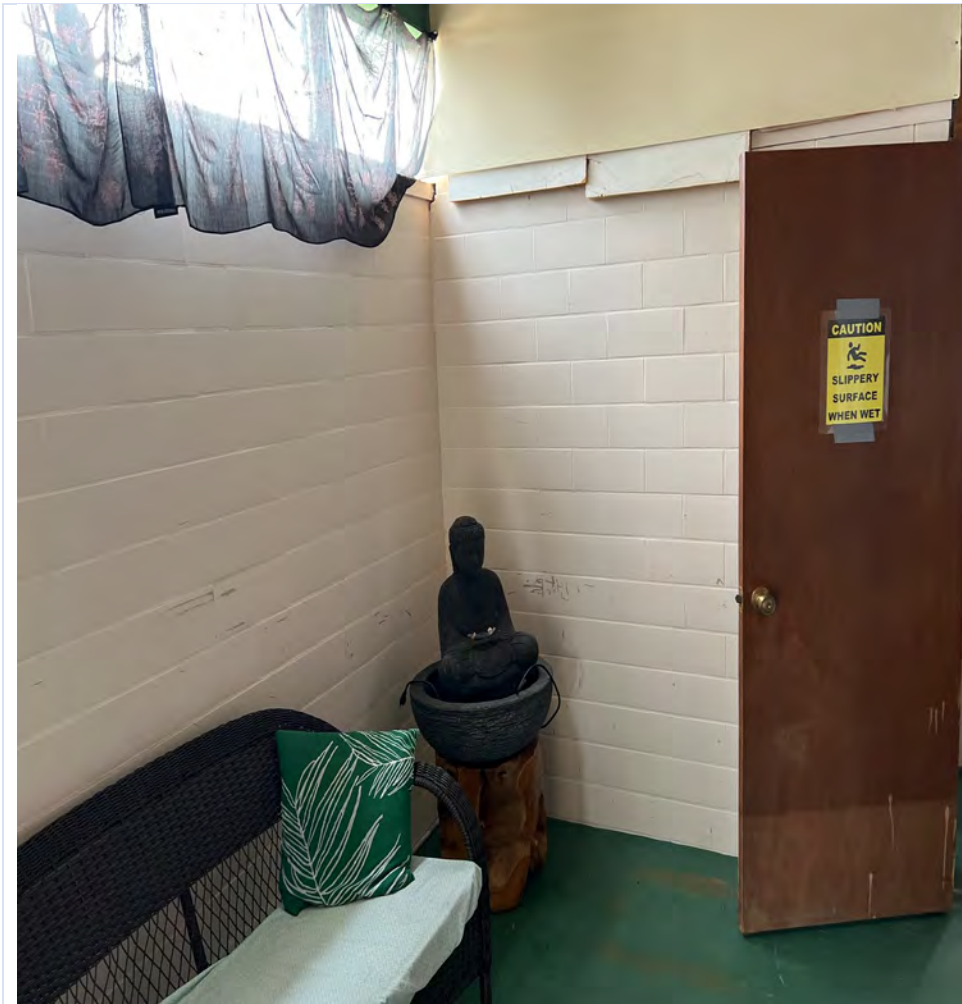
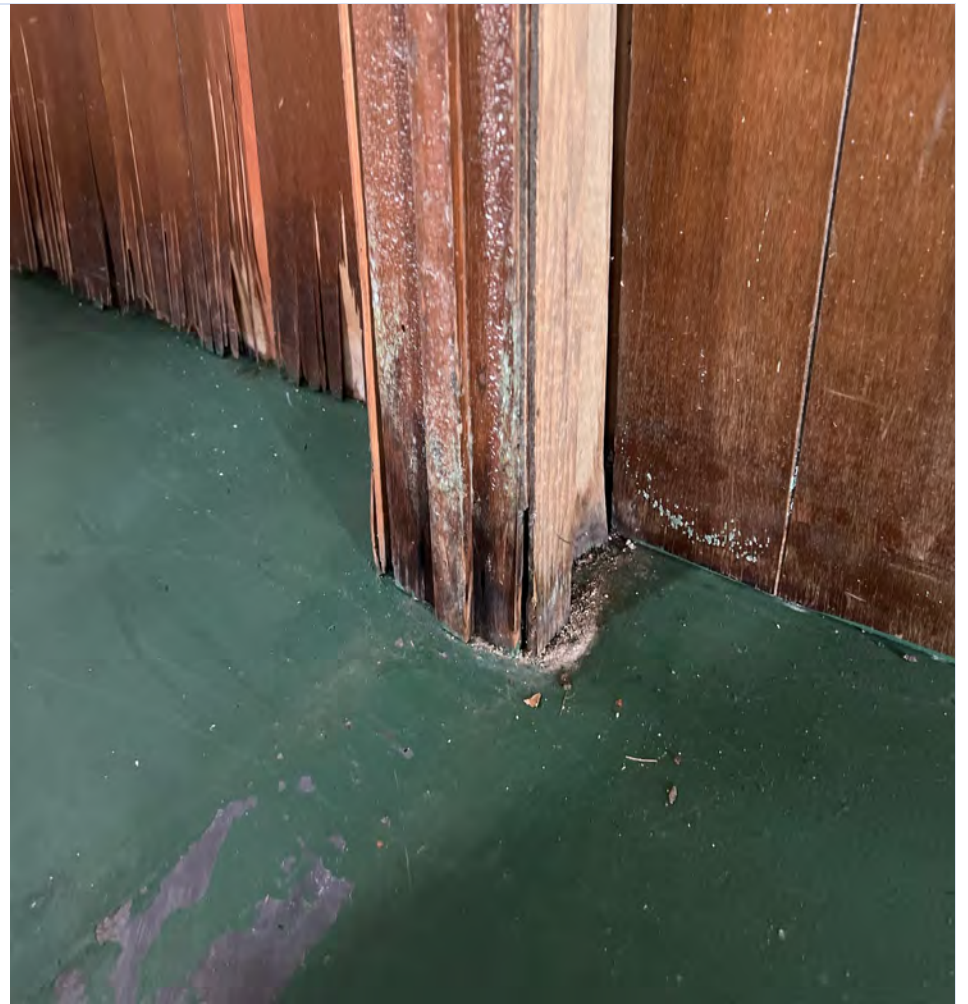
Room #: Massage Entry
Room Dimensions: 12' x 9' x 8'

Wall

108 SF ACT 2' x 4'
88 SF Wood Grain Paneling
2 EA Wood Grain Paneled Pocket Door 3' x 6'
1 EA Hollow Wood Door 30" x 77.5"
1 EA Door Casing 3' x 7'

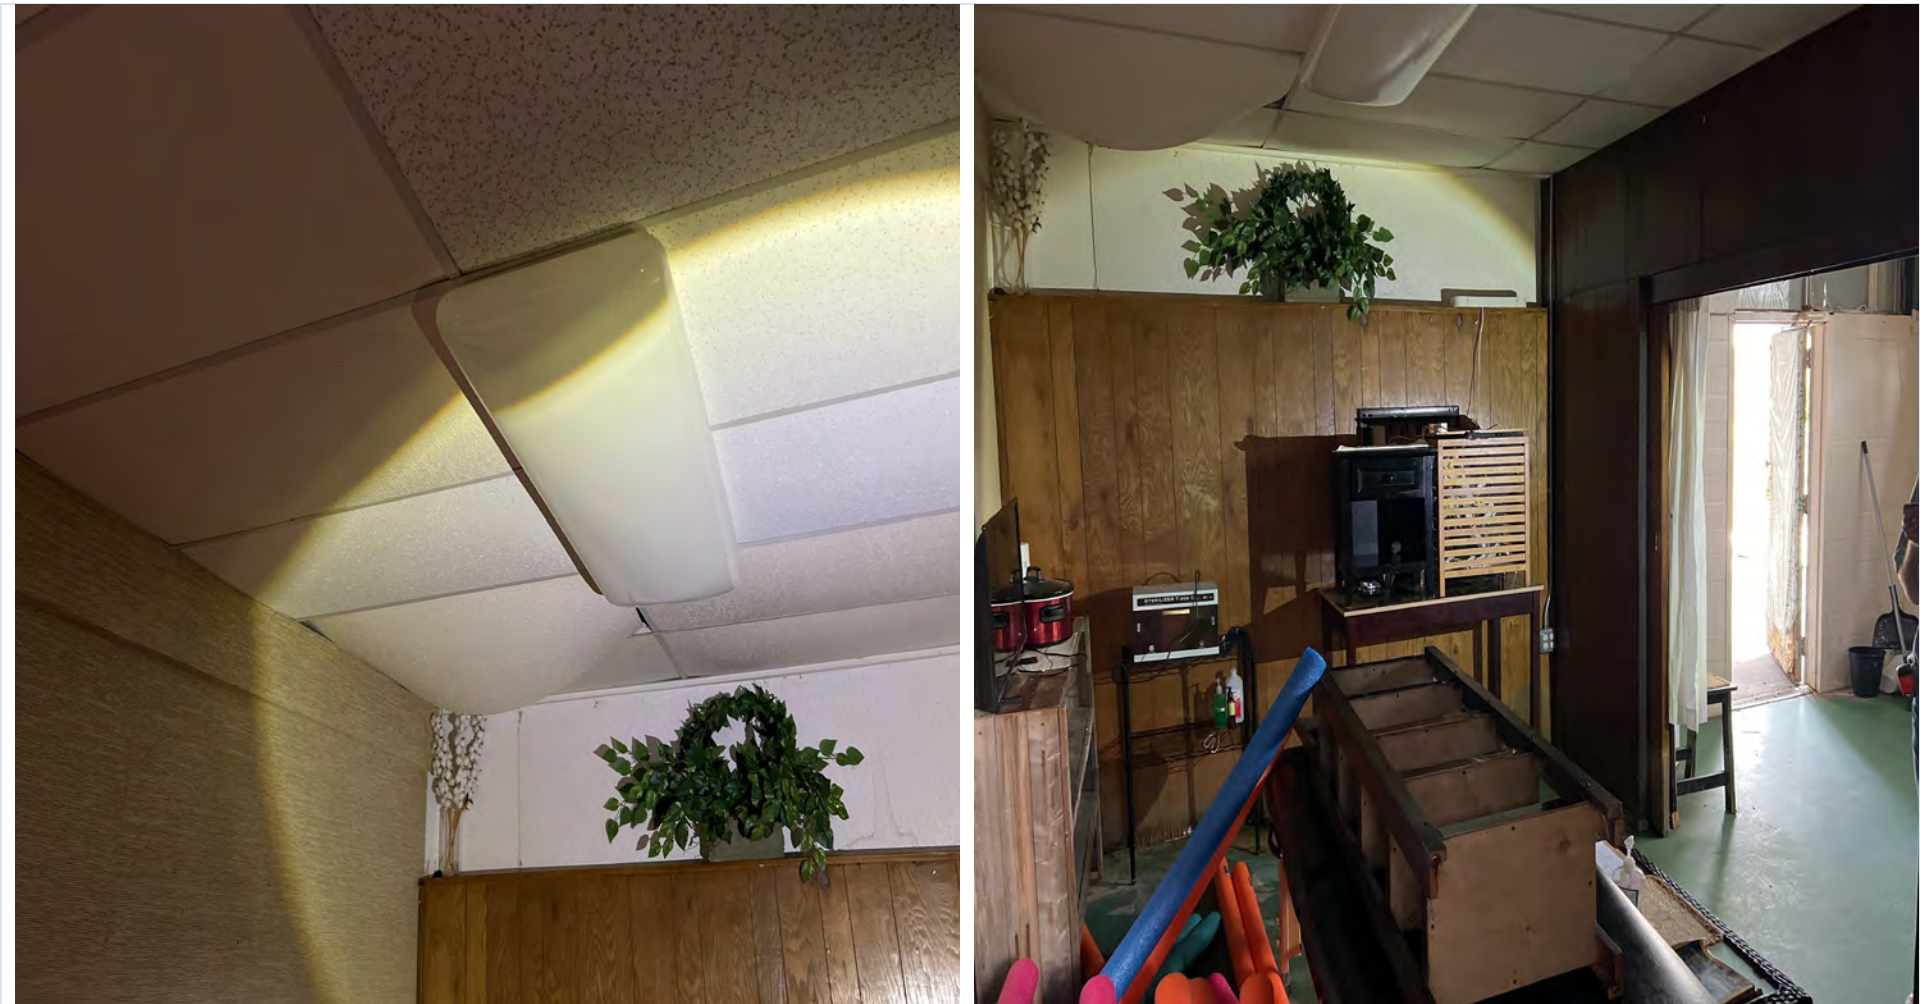
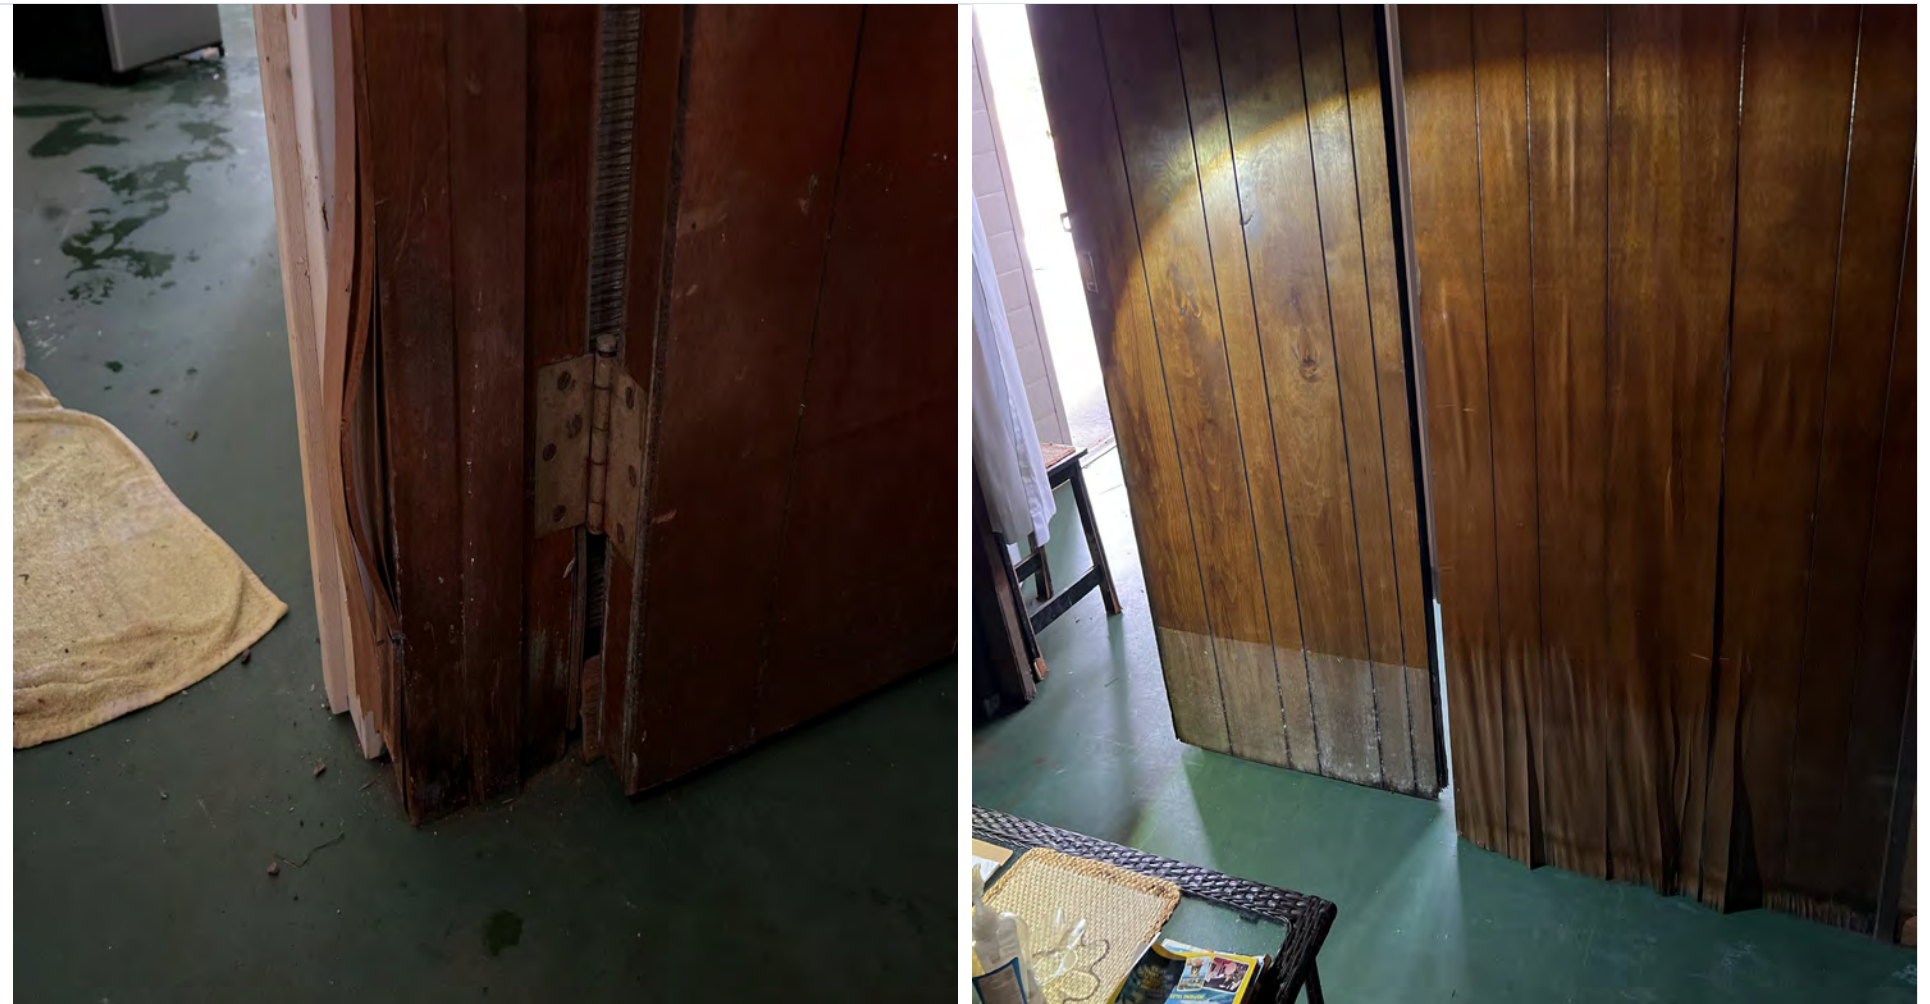
Room #: Massage Table Room

Wall, Ceiling, Door

142 SF Wood Grain Paneling

200 SF Drywall 5/8 w/ textured wallpaper

126 SF ACT 2' x 4'

1 EA Surface amount Flourescent Light 1.5' x 4'

22 LF Wood Base Board 1.75"

1 EA Door Casing 3' x 7'

1 EA Custom Hollow Wood Door 76" x 3'

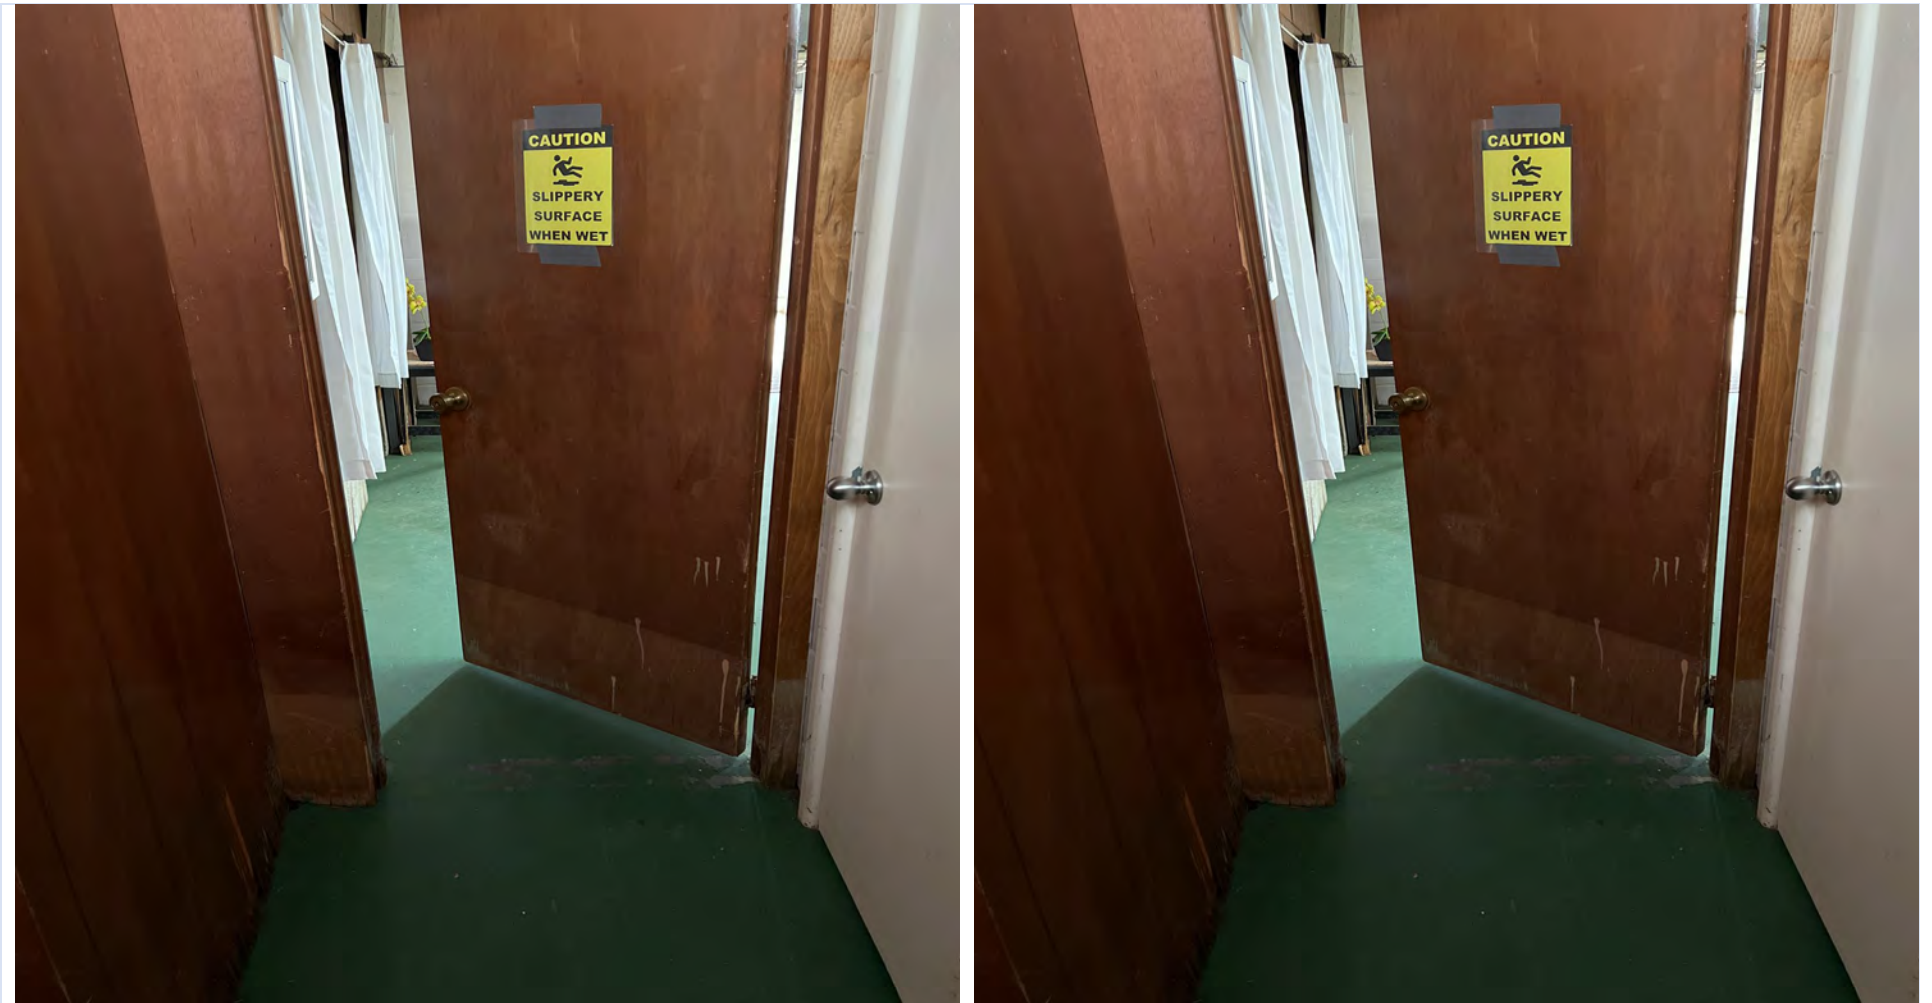
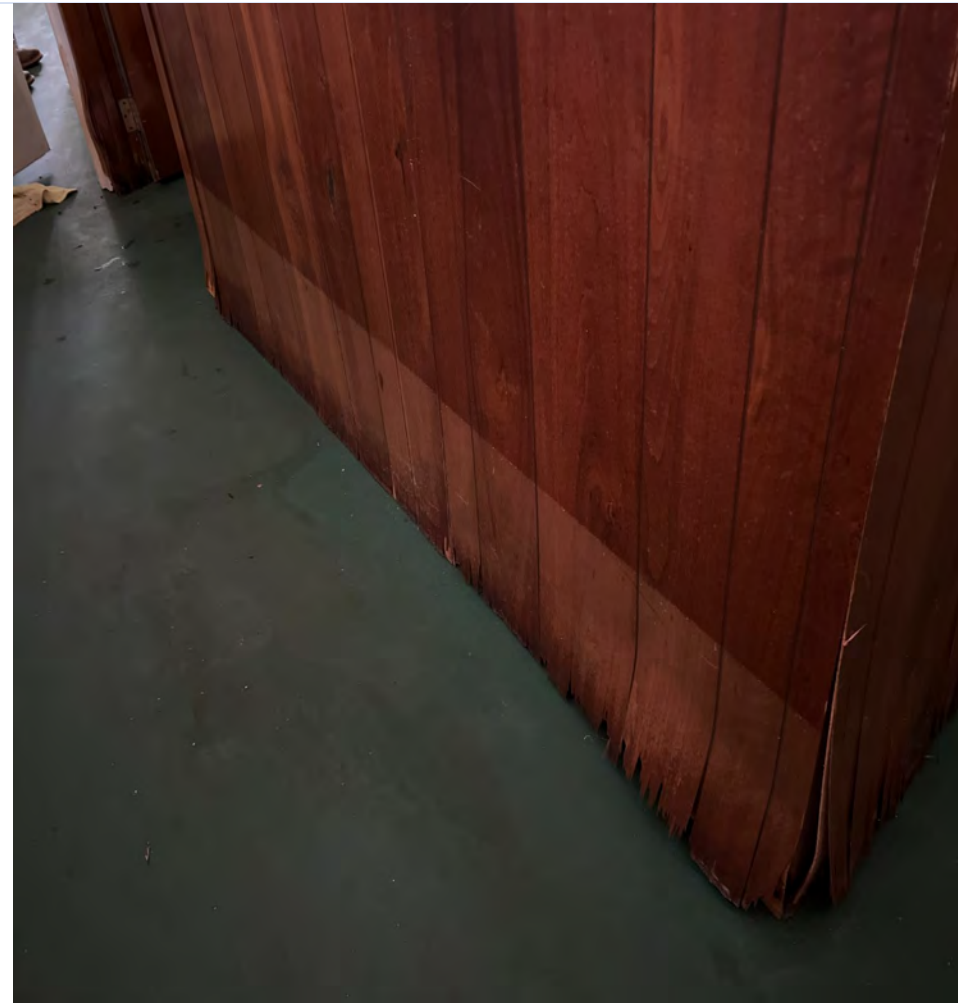
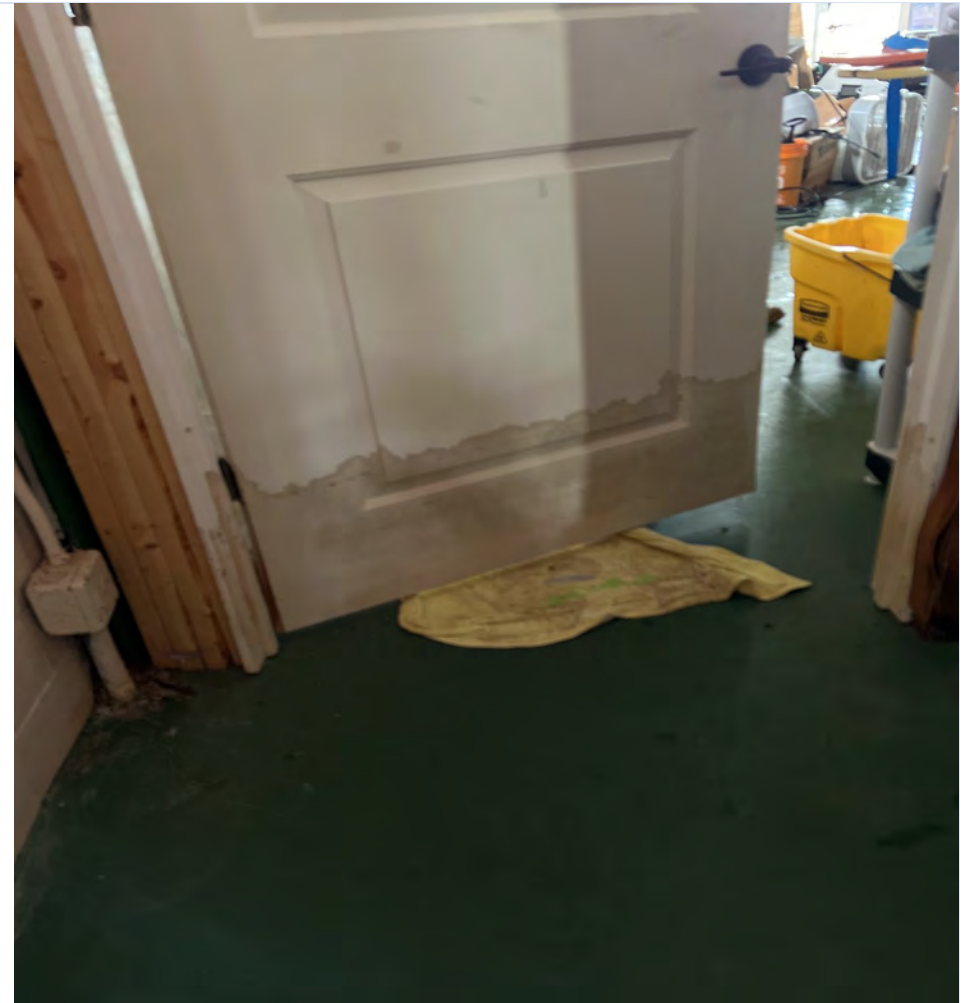
Room #: Hall 1

Wall, Door

64 SF Wood Grain Paneling

1 EA Hollow Wood Door 3' x 6'

1 EA Wood Door Casing 3' x 6'

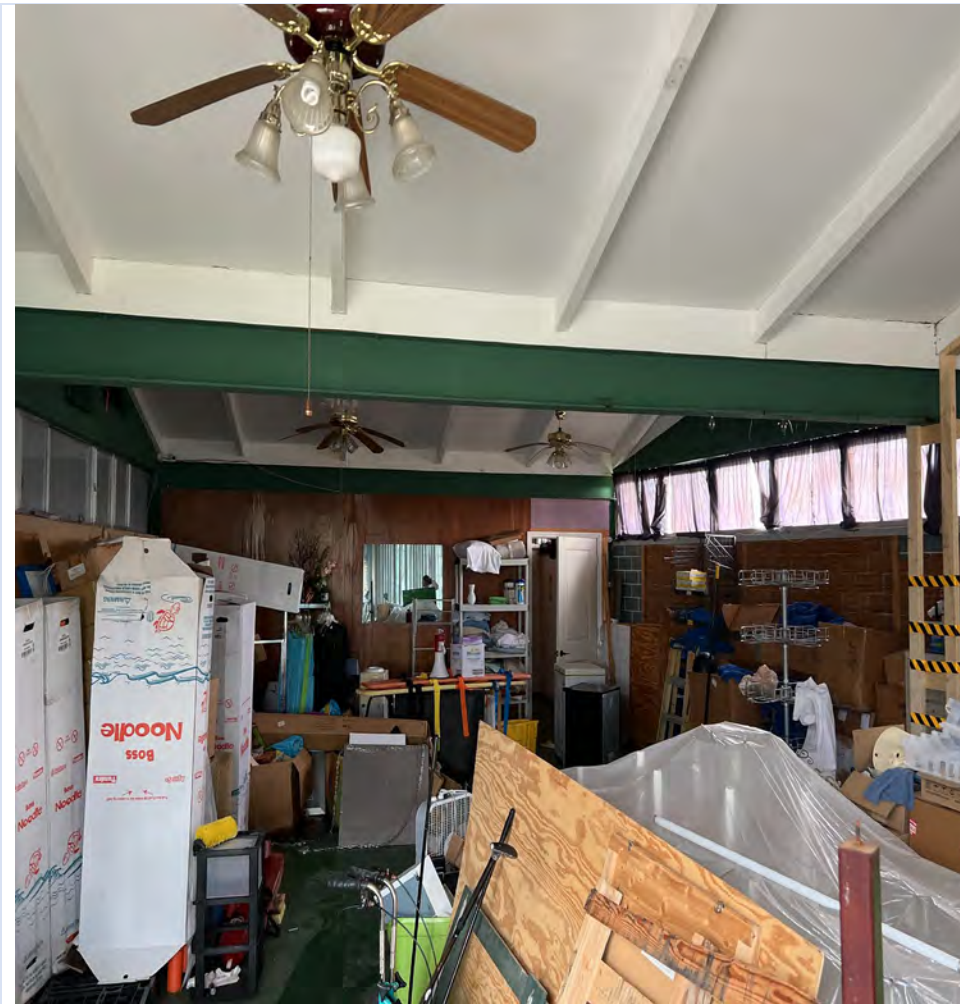
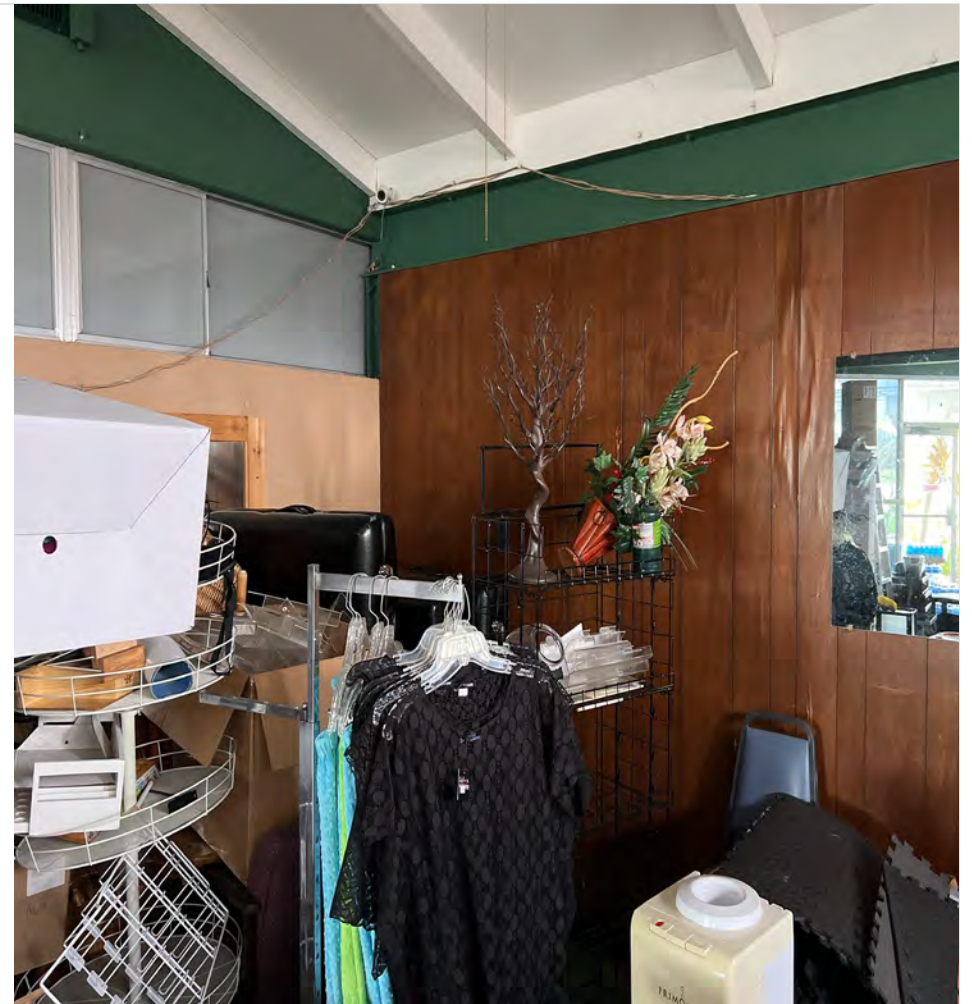
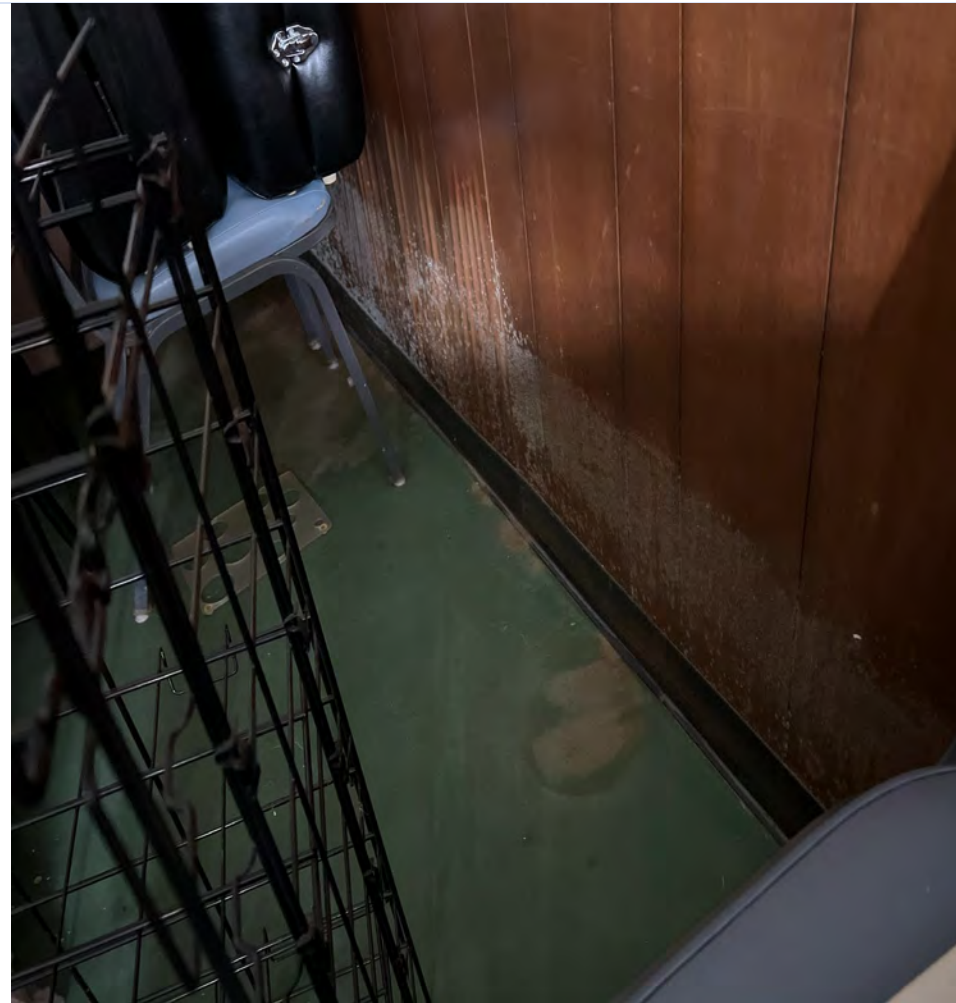
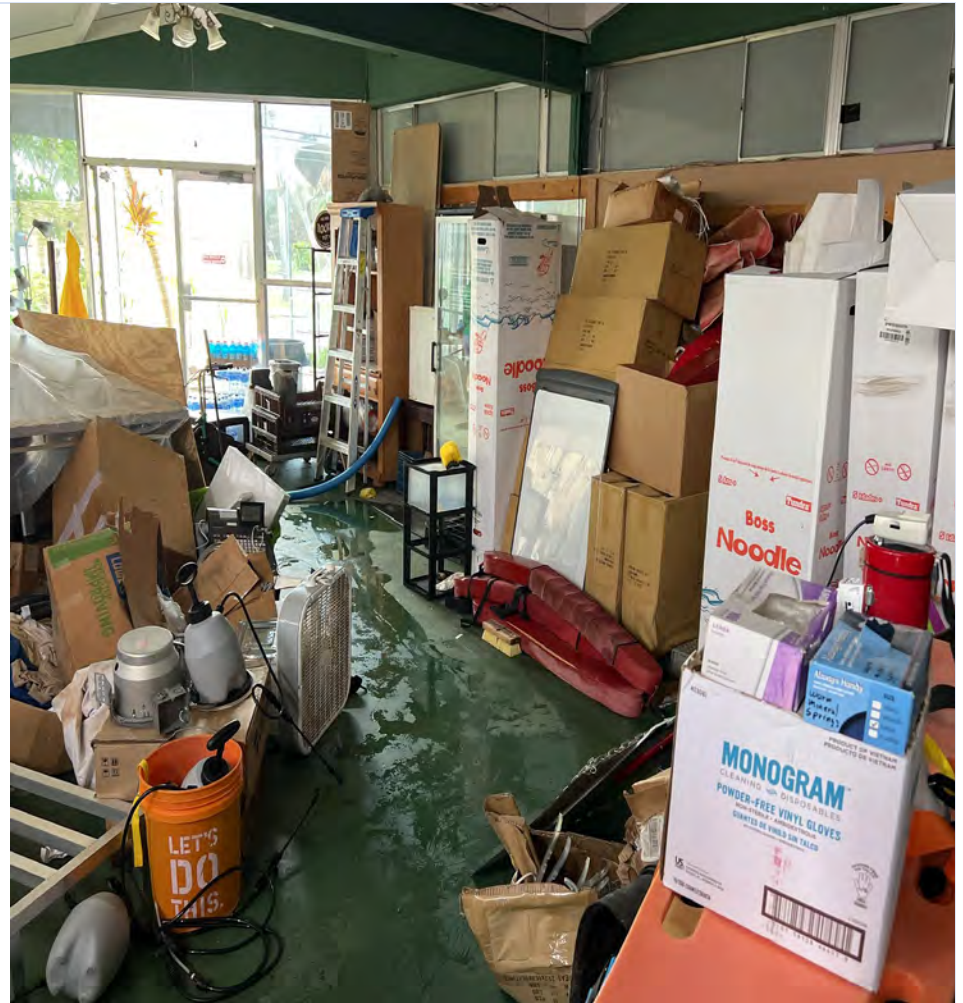
Room #: Storage

Wall

120 SF Wood Grain Paneling

15 LF Vinyl Cove Base 4"
