February 28, 2024

Re: **Warm Mineral Springs (WMS) Building Complex
Post-Storm Assessment and Options Report**

Re: Mechanical, Electrical and Plumbing Systems Post Hurricane Assessment for Warm Mineral Springs

RE: Warm Mineral Springs Existing Facilities Observation Report

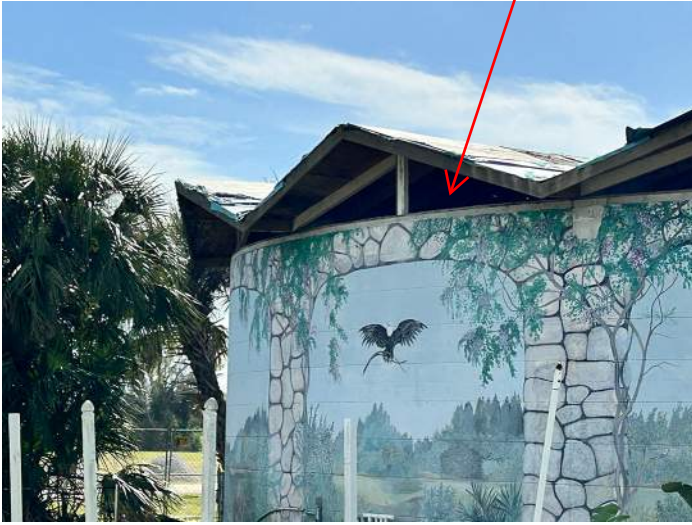
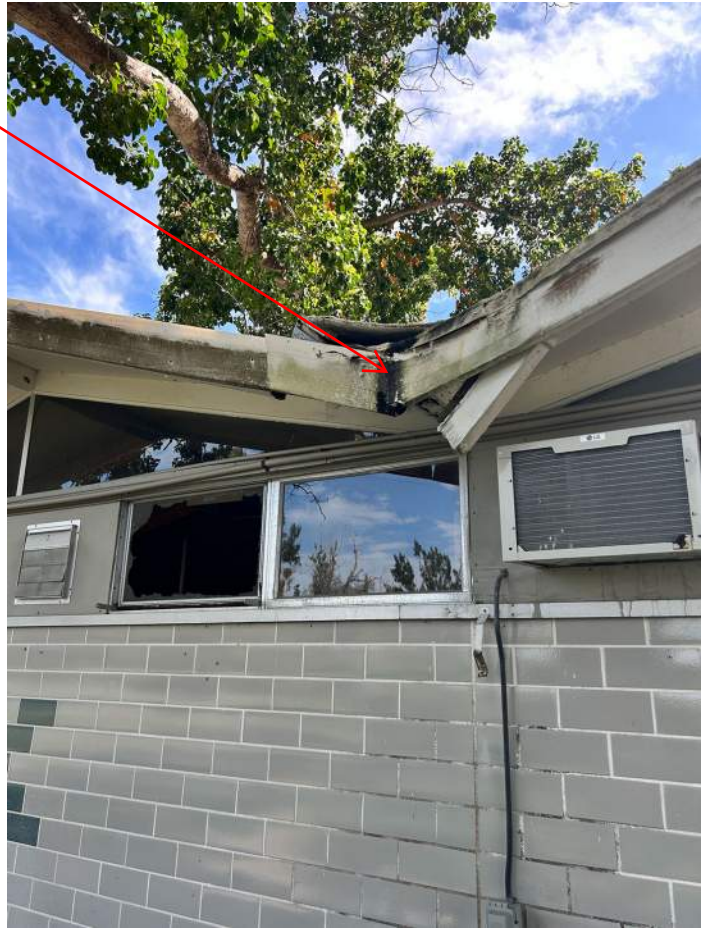
Roof, soffit and fascia damage from Hurricane Ian

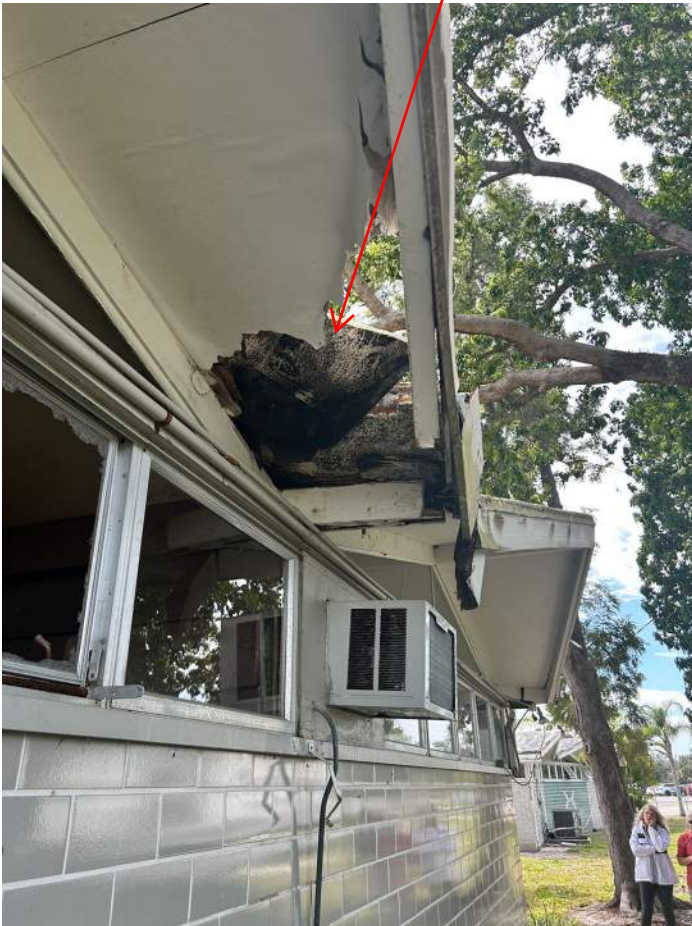
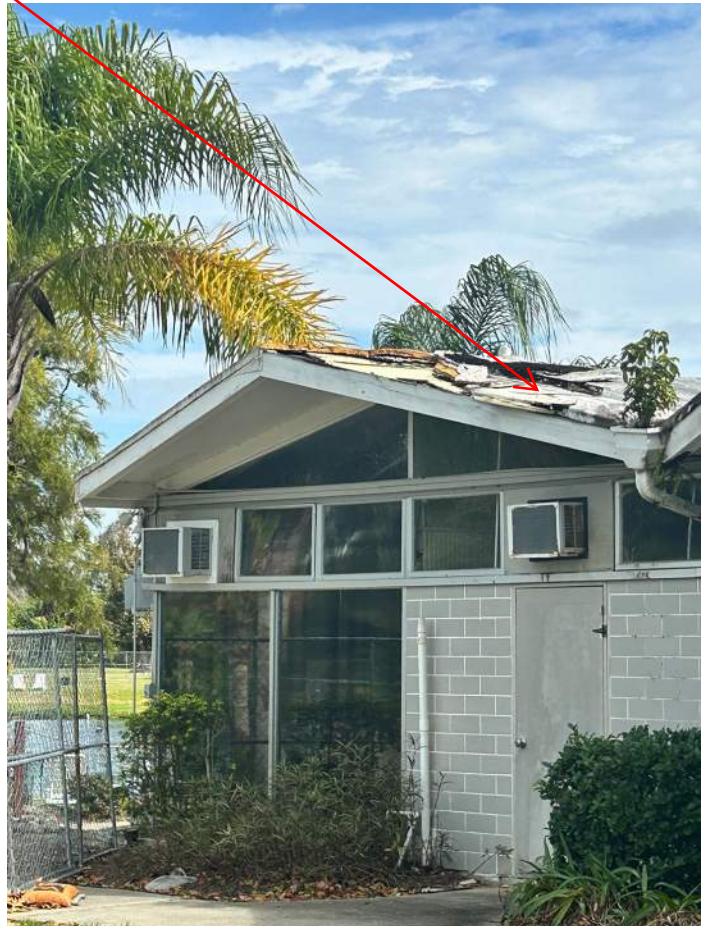
Roof, soffit and fascia damage from Hurricane Ian

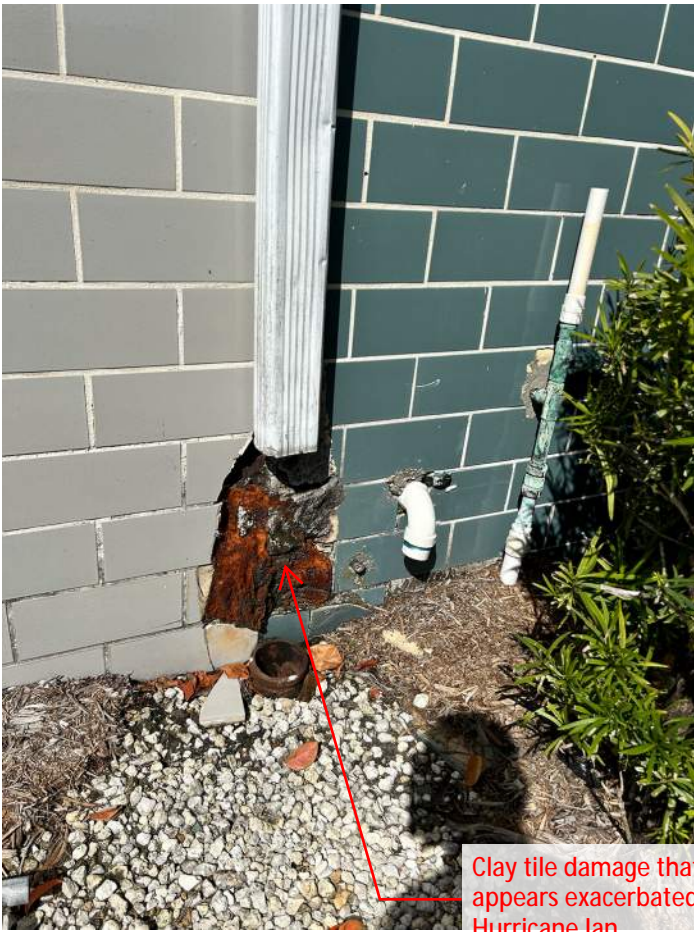
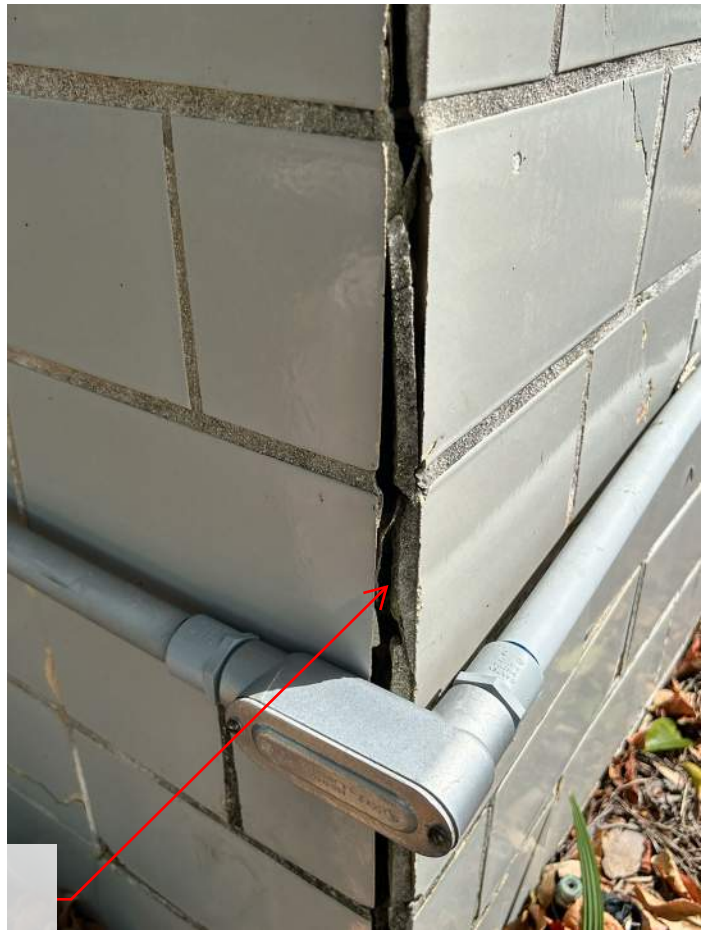
- Post-storm assessments revealed additional damage and cracking to the historic structural clay tile. Replacing damaged structural clay tile in an historically appropriate manner may be costly as it will likely require custom molds and fabrication from a specialty clay tile masonry company.

Clay tile damage that appears exacerbated by Hurricane Ian

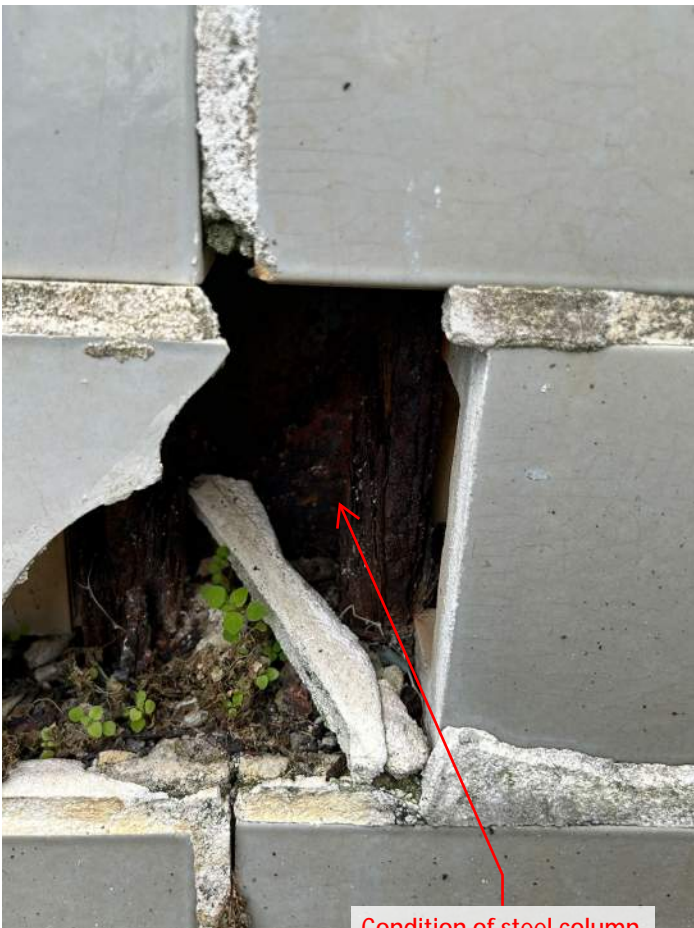
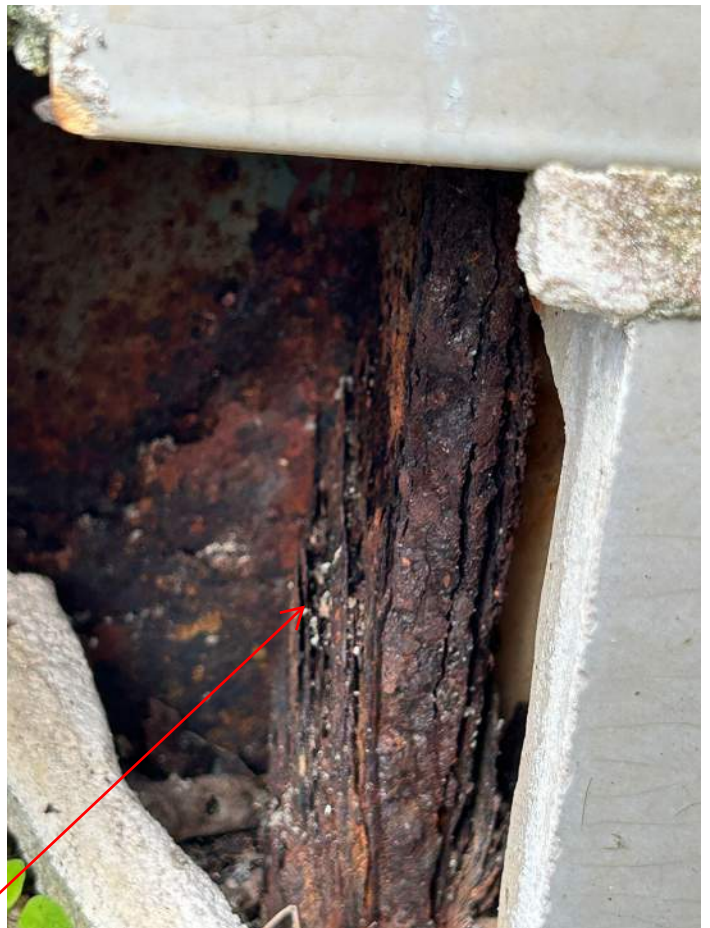
- Structural roof damage is more extensive now than it was in 2018-2019.
 - Standing flood waters appear to have further deteriorated exposed structural steel columns. Many of these columns were assumed to be maintained in the original renovation project. Based on current conditions, more of these steel columns may require replacement. In some cases, the steel columns are partially concealed within the structural clay tile, which may require further removal of clay tile to replace the steel.

Condition of steel column embedded in clay tile wall

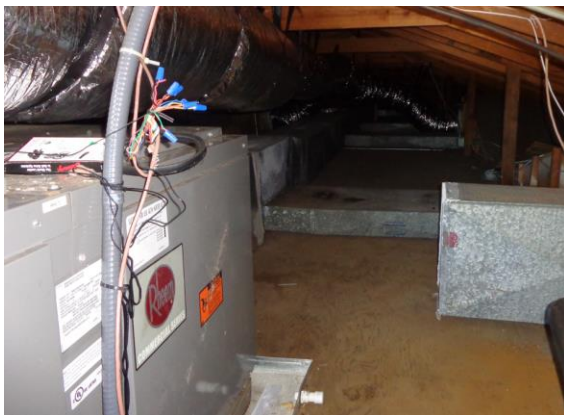
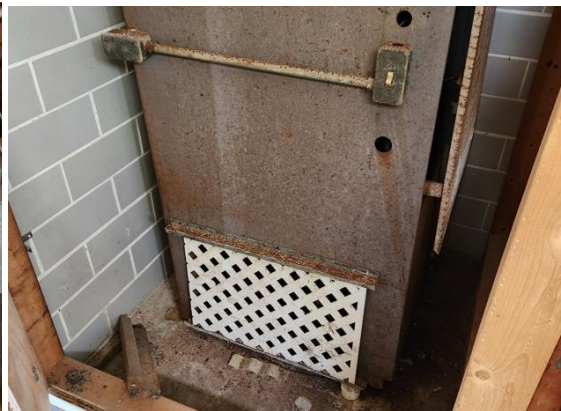
The entry/admission building is served by a 7 ½ ton central air conditioning system with the air handler installed over the central corridor and the condensing unit on grade. The Trane condensing unit was manufactured in November of 2021 but was partially submerged after hurricane Ian. The Rheem air handler and metal duct are installed in the attic space and were not subjected to floodwaters (see photo below). The furnace which is disconnected from the duct system is floor mounted and was subjected to flood waters (see photo below).

The Trane 7 ½ ton condensing in the entry/admission building has been replaced recently but due to floodwaters should not be reused. If the condensing unit must be replaced, the air handler must be replaced also to provide a matched set which is AHRI rated. The duct and furnace appear to be original and have outlived their useful life.

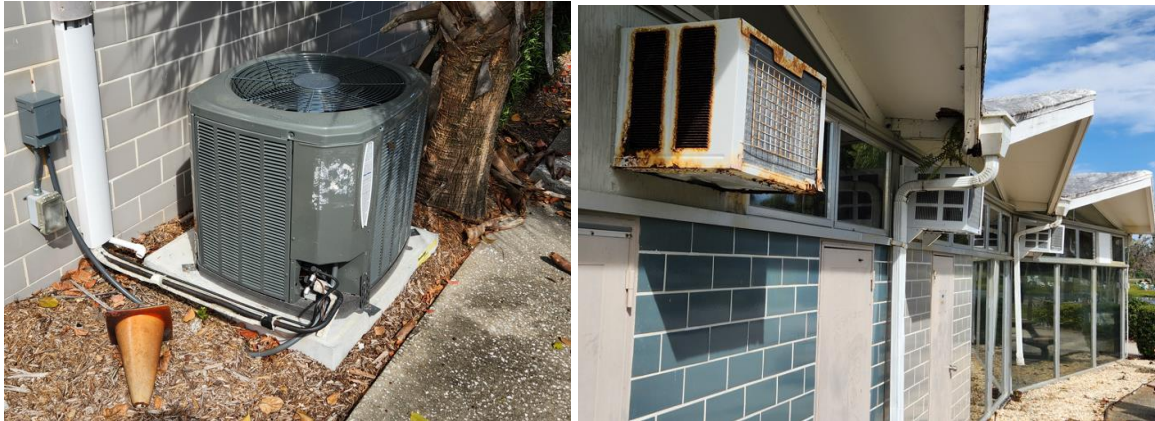
The spa building central air conditioning system has been replaced with several window units and a small split system. The window units are installed high in the exterior walls and but the split system condensing unit was installed on grade and was subjected to floodwaters (see photos below).

The condensing unit was recently replaced but due to floodwaters should not be reused. The window units are old and inefficient and should not be reused. Our previous renovation scope assumed complete MEP infrastructure replacement, with the exception of keeping the recently installed condensing units. However, due to Hurricane Ian damage, these units can no longer be reused.

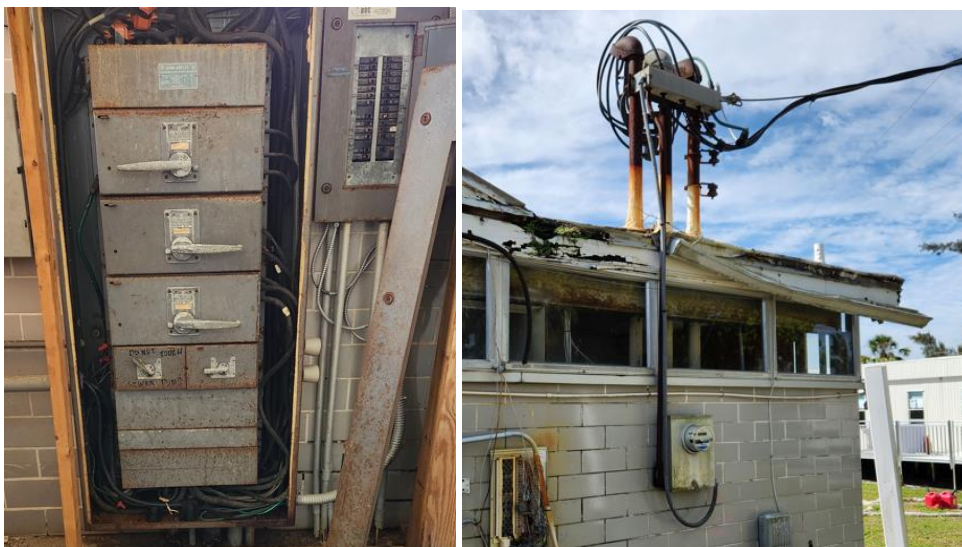
The existing overhead electrical service for all three buildings is a 600A, 208V, 3 phase. A MDP located in the entry/admission building feeds sub-panels in each building. The MDP appears to be original (see photo below) and has exceeded its useful life.

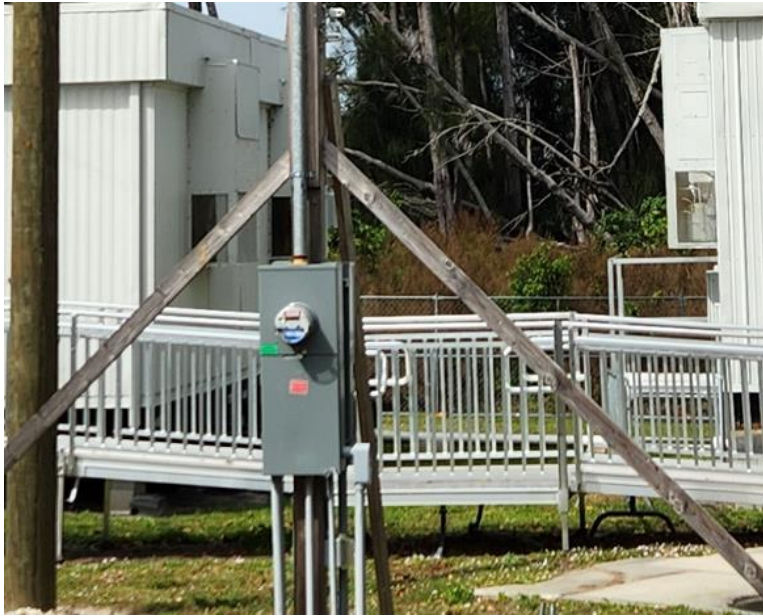
When the temporary buildings were brought into the site, a new electrical service was installed on a temporary pole (see photo below).

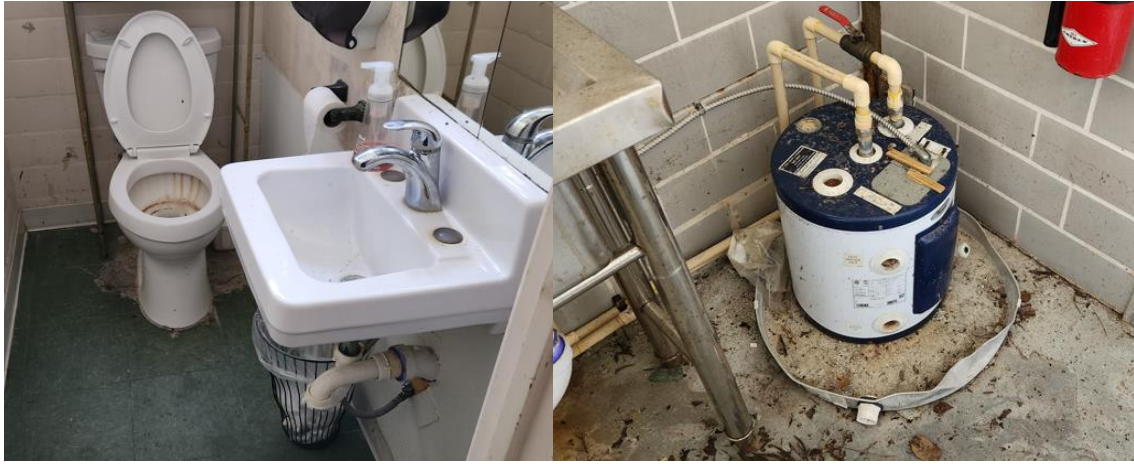
The entry/admission building has two bathrooms and a small water heater. The bathrooms are not ADA compliant and must be reconfigured. The water heater is floor mounted (see photos below) and was subjected to flood waters and should not be reused.

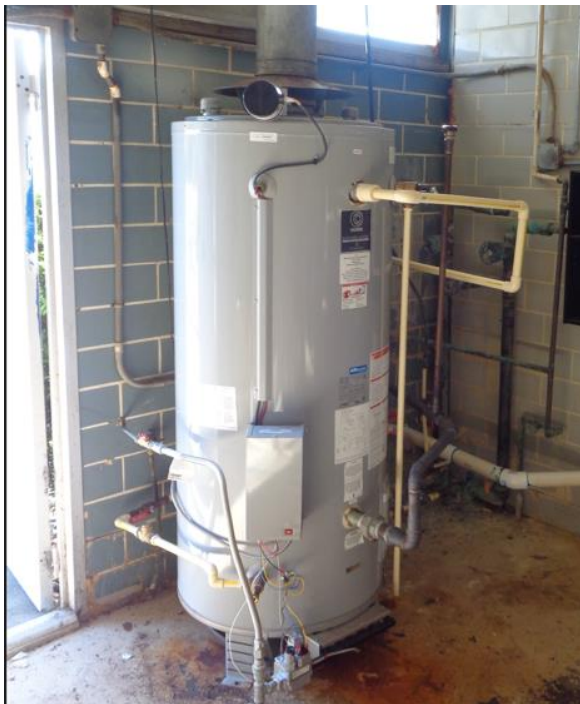
The spa building has a café with a gas water heater that was floor mounted (see photo below) and was subjected to floodwaters and should not be reused.
