Damage Assessment Report

Warm Mineral Springs Clubhouse 2

Address: 12200 San Servando Ave,
North Port, FL 34287

SITE INSPECTION REPORT

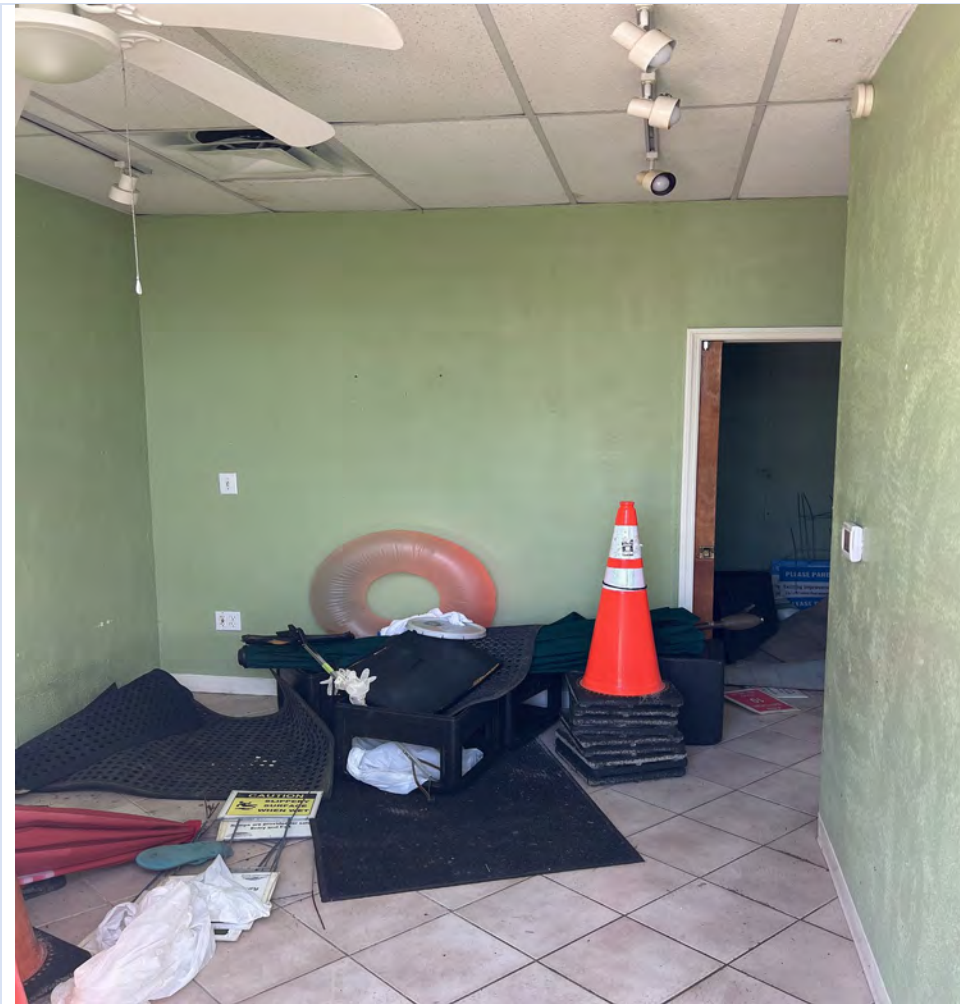
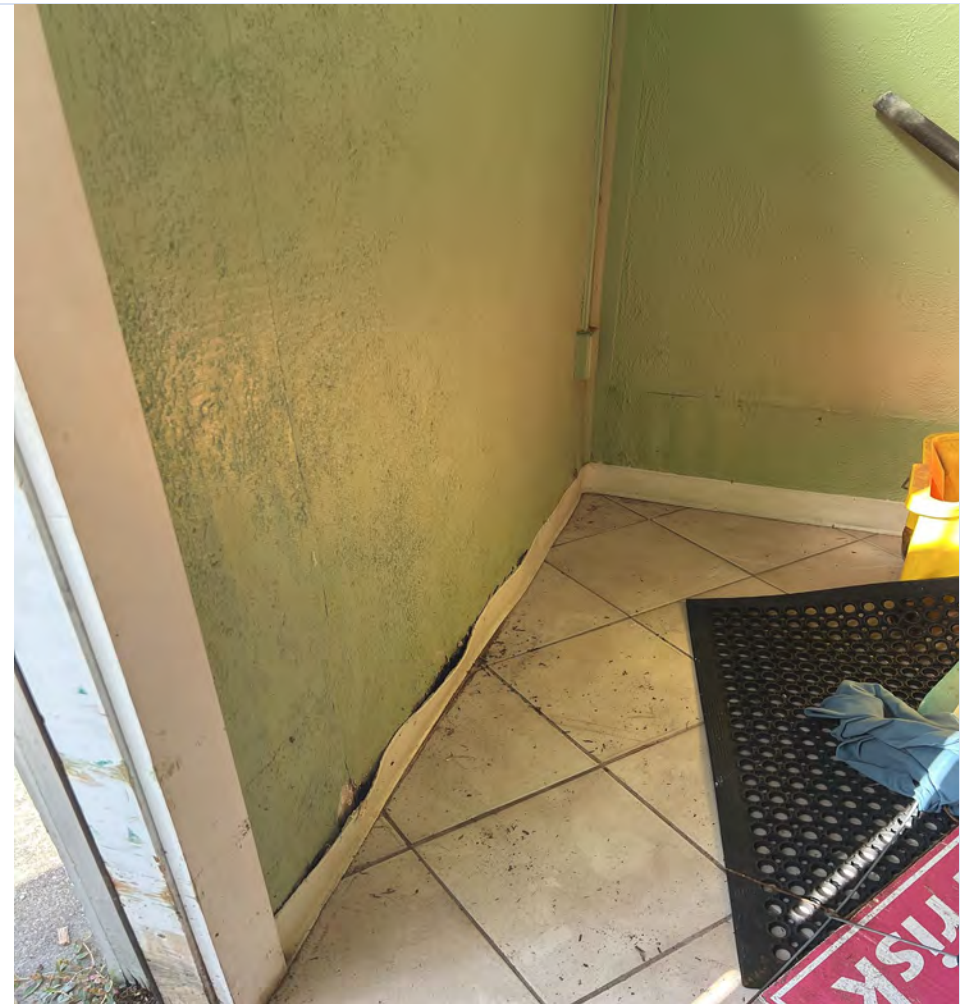
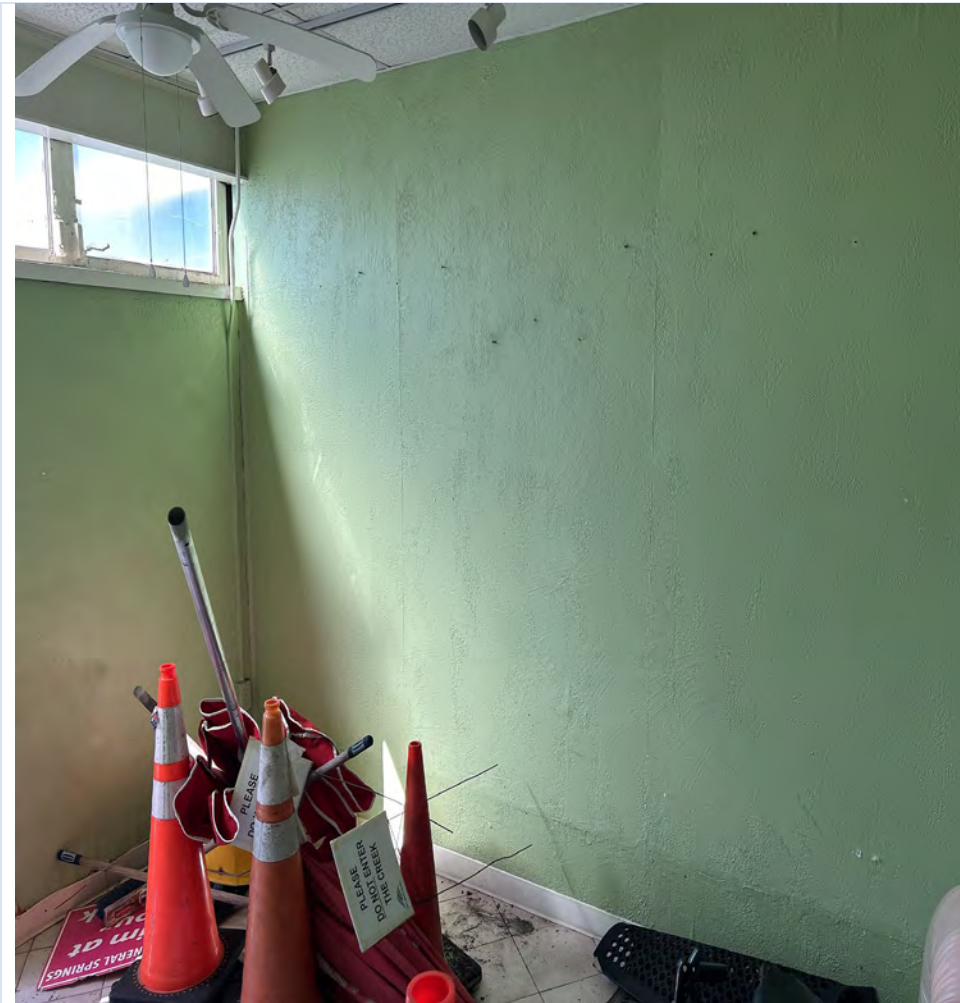
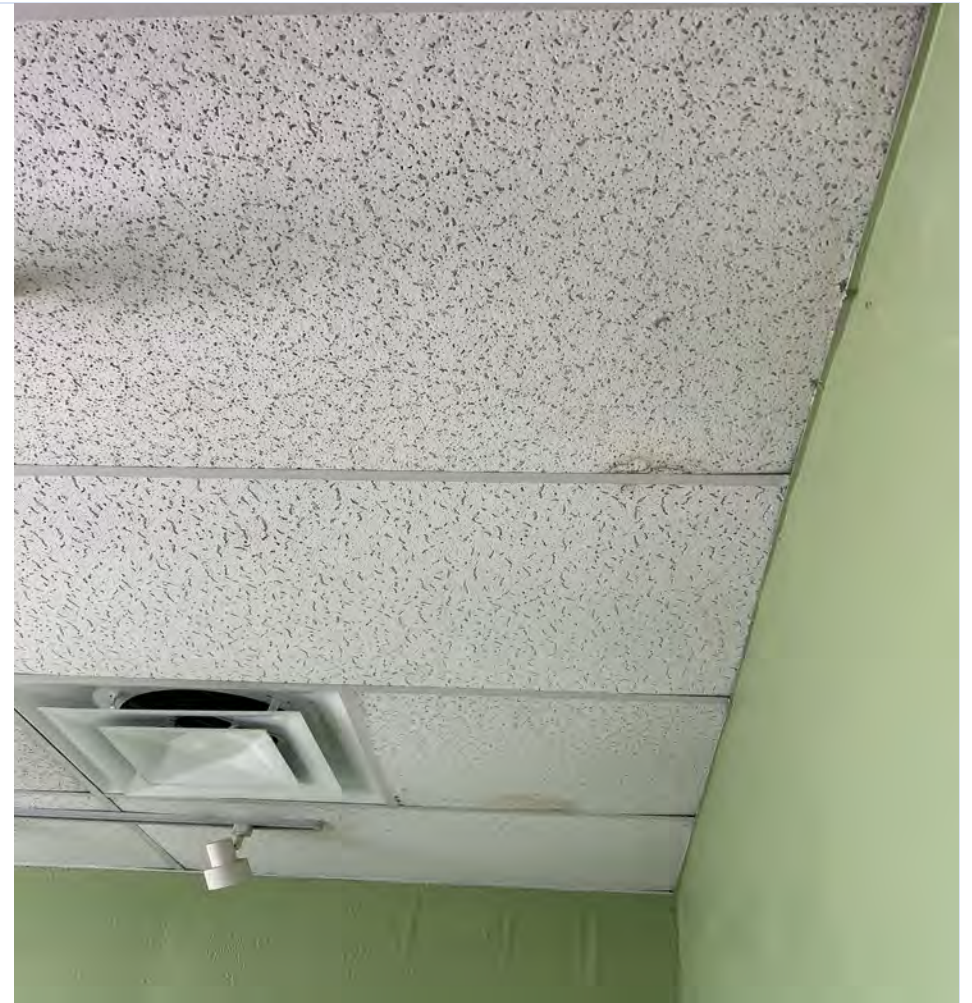
Room #: Main Area

Ceiling, Wall, Electrical (receptacle photos for reference)

270 SF drywall 5/8" (30' x 9')

270 SF batt insulation (30' x 9')

40 LF vinyl cove baseboard 4"

4EA ACT 2' x 4'

32 SF batt insulation 4" (8' x 4')

6 EA dual receptacles

48 LF metal conduit 1/2" and wiring

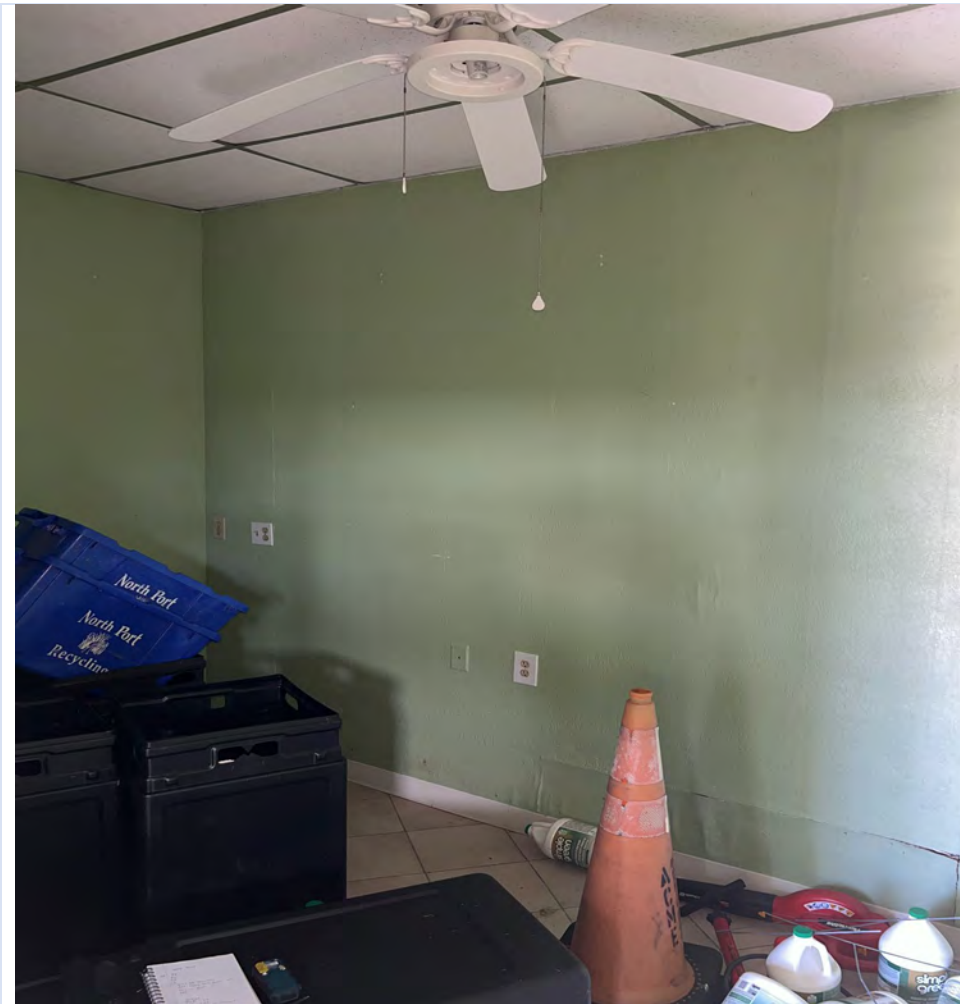
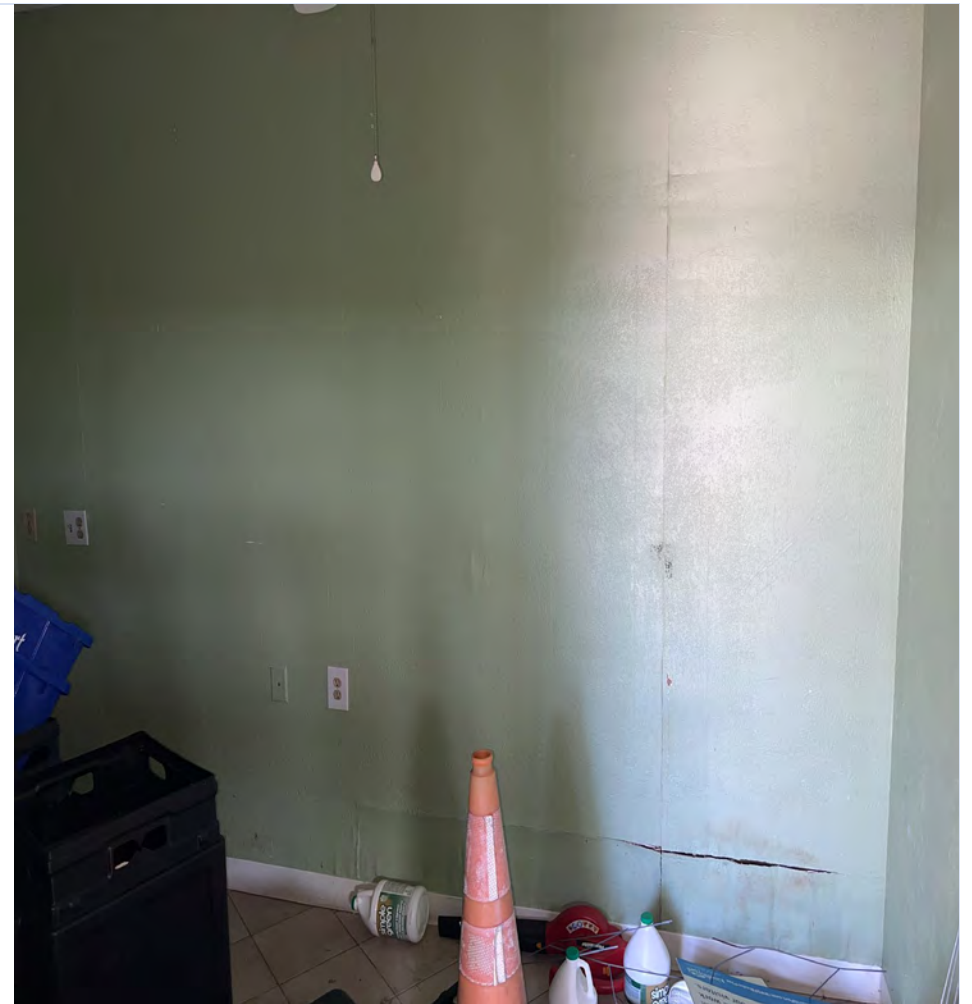
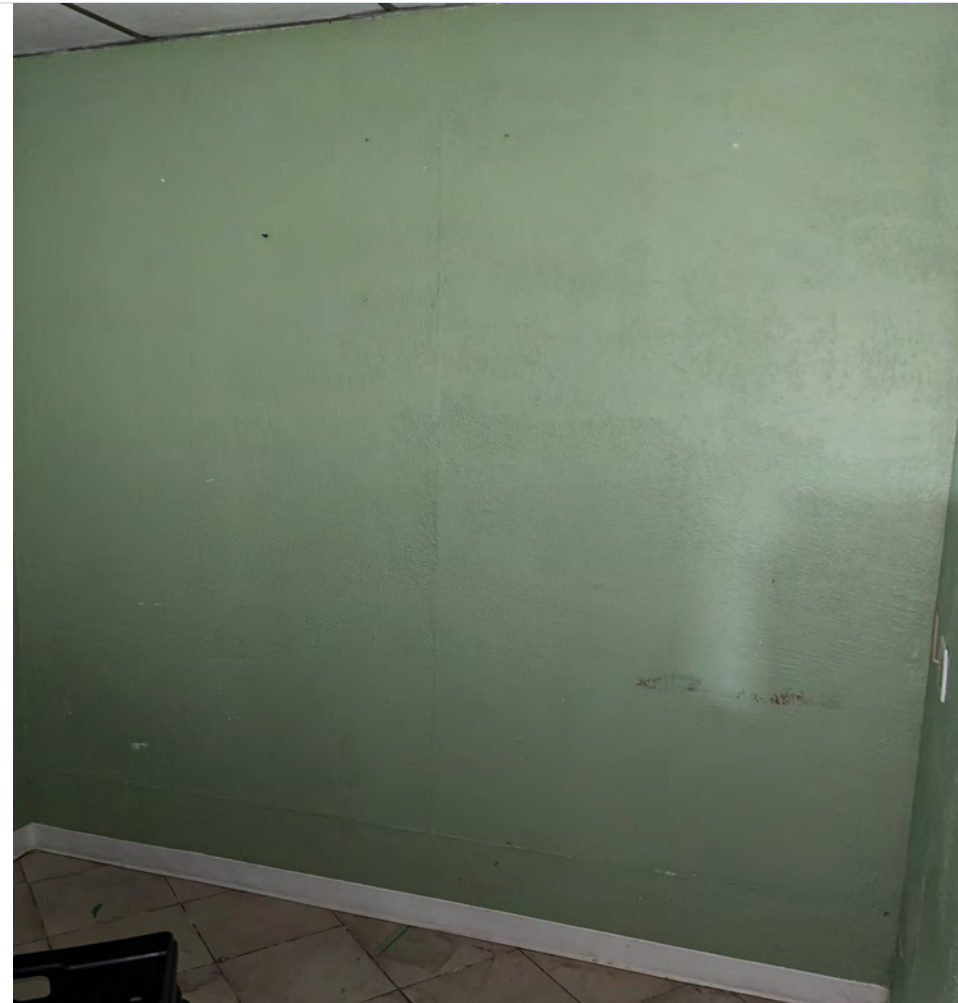
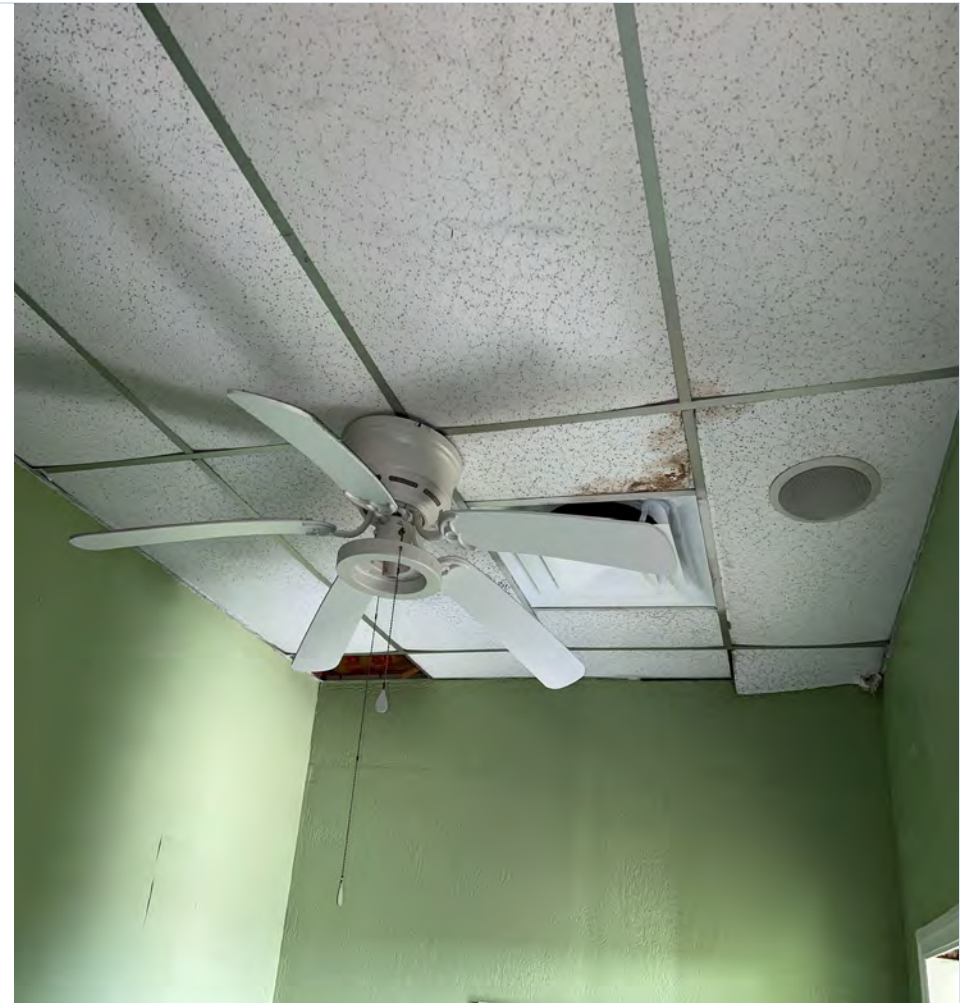
Room #: Laundry Storage
Room Dimensions: 12' x 8' x 9'

Ceiling, Wall, Electrical (receptacle photos for reference)

171 SF drywall 5/8" (19' x 9')
171 SF batt insulation 4" (19' x 9')
4 EA ACT 2' x 4'
32 SF batt insulation 4" (8' x 4')
6 EA dual receptacles

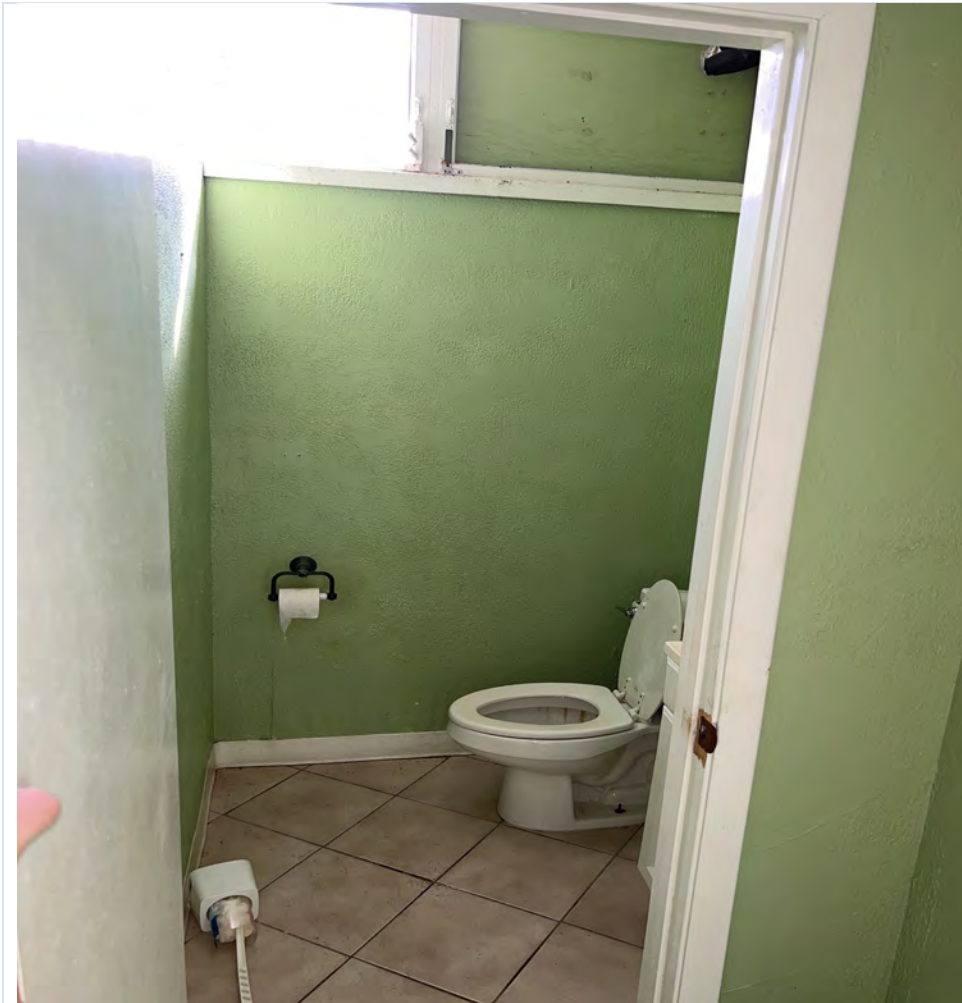
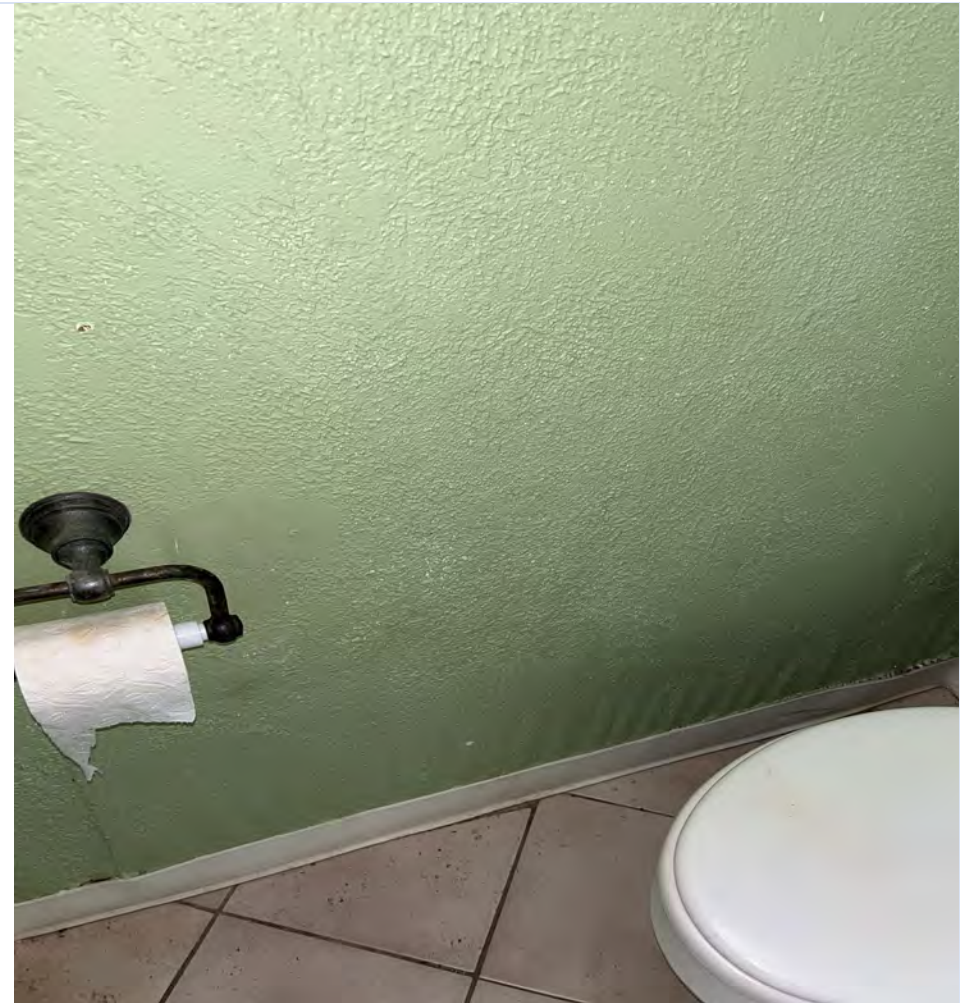
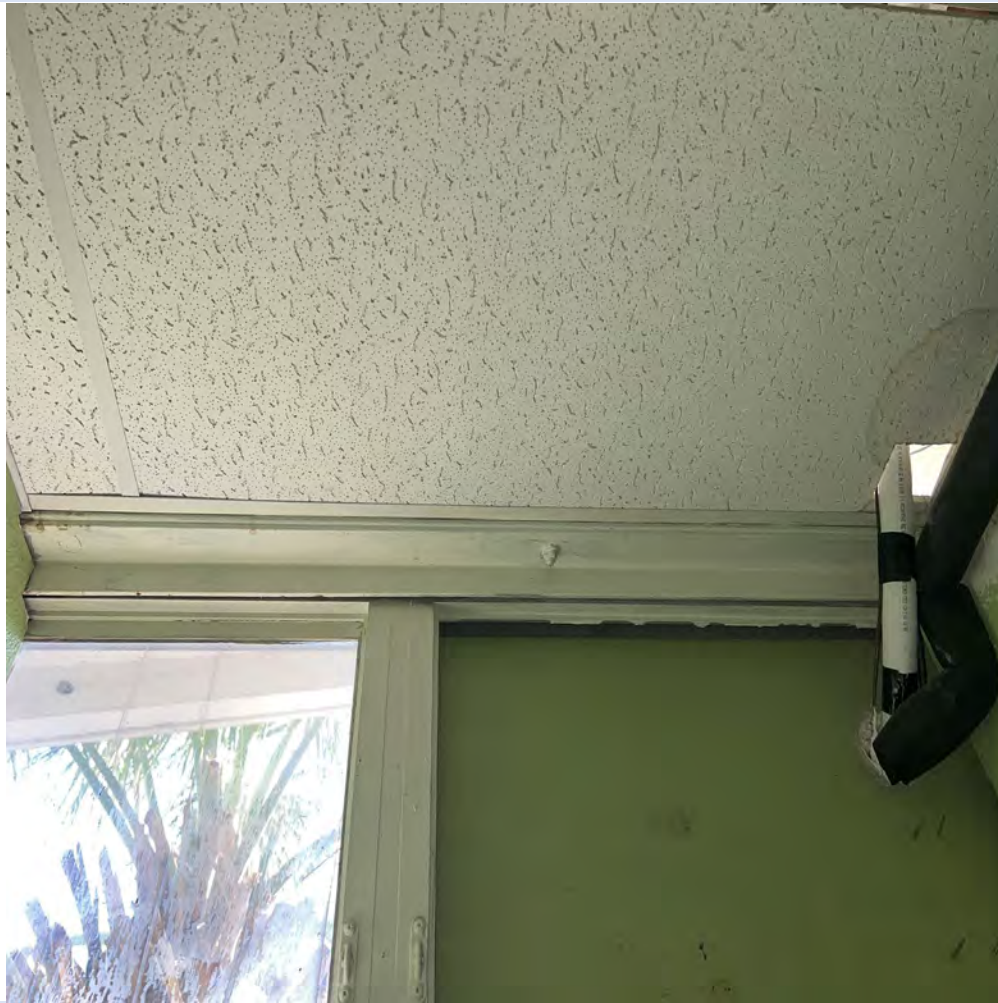
Room #: Laundry Bathroom

Ceiling, Wall

24 SF drywall 5/8" (8' x 3')

24 SF batt insulation 4" (8' x 3')

20 LF vinyl cove baseboard 4"

1 EA ACT 2' x 4'

8 SF batt insulation 4" (4' x 2')

1 EA interior hollow core door 28" x 80"

17 LF wood door casing 2"

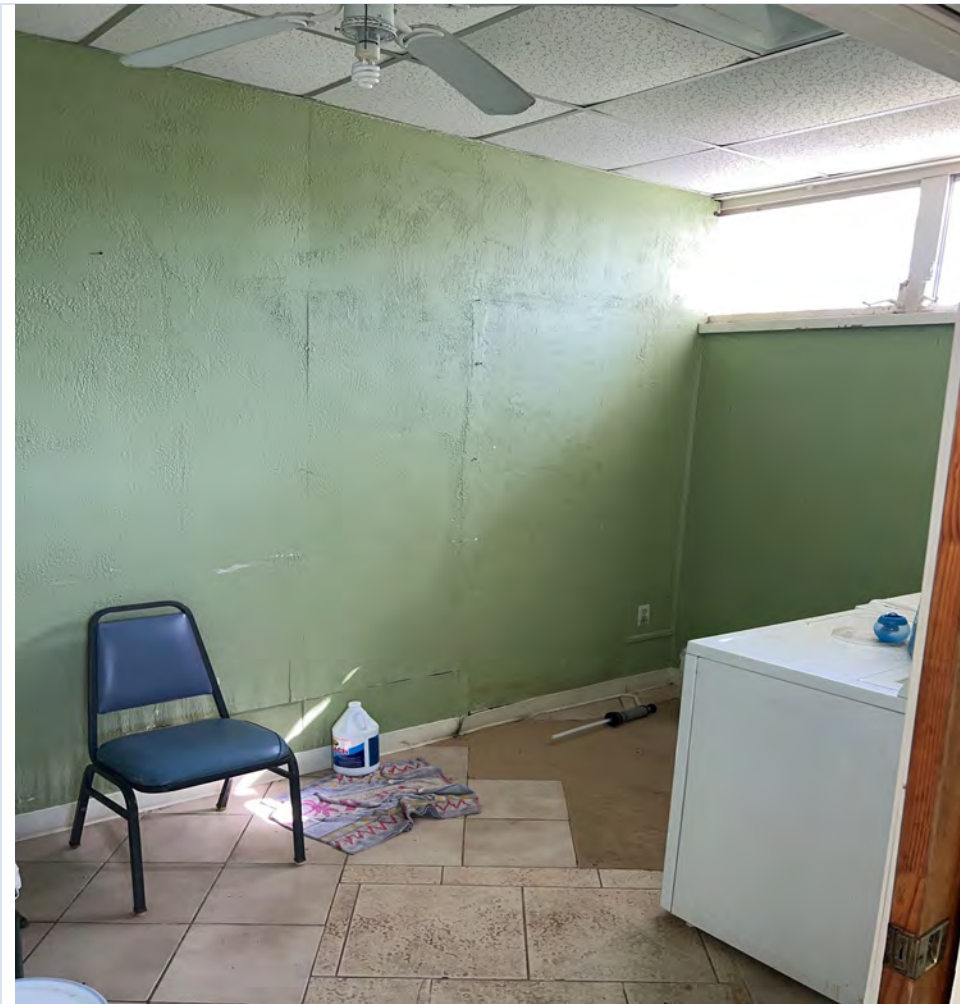
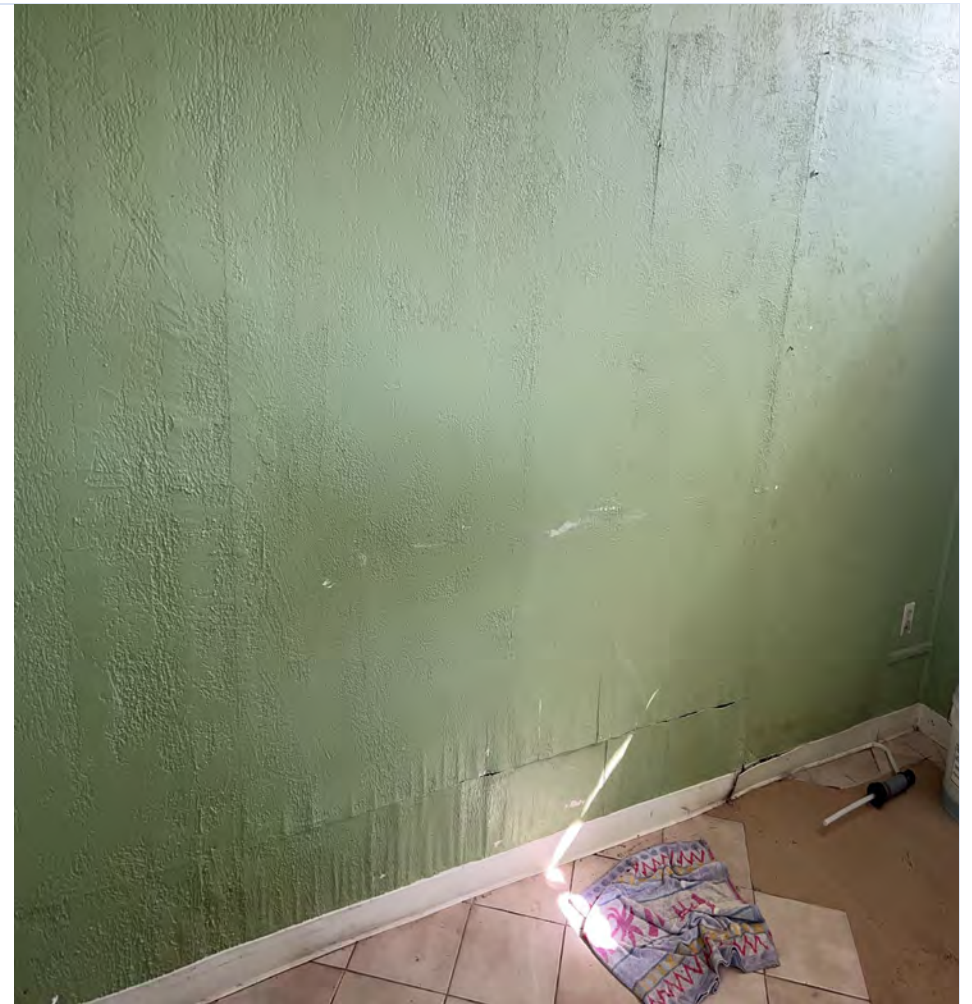
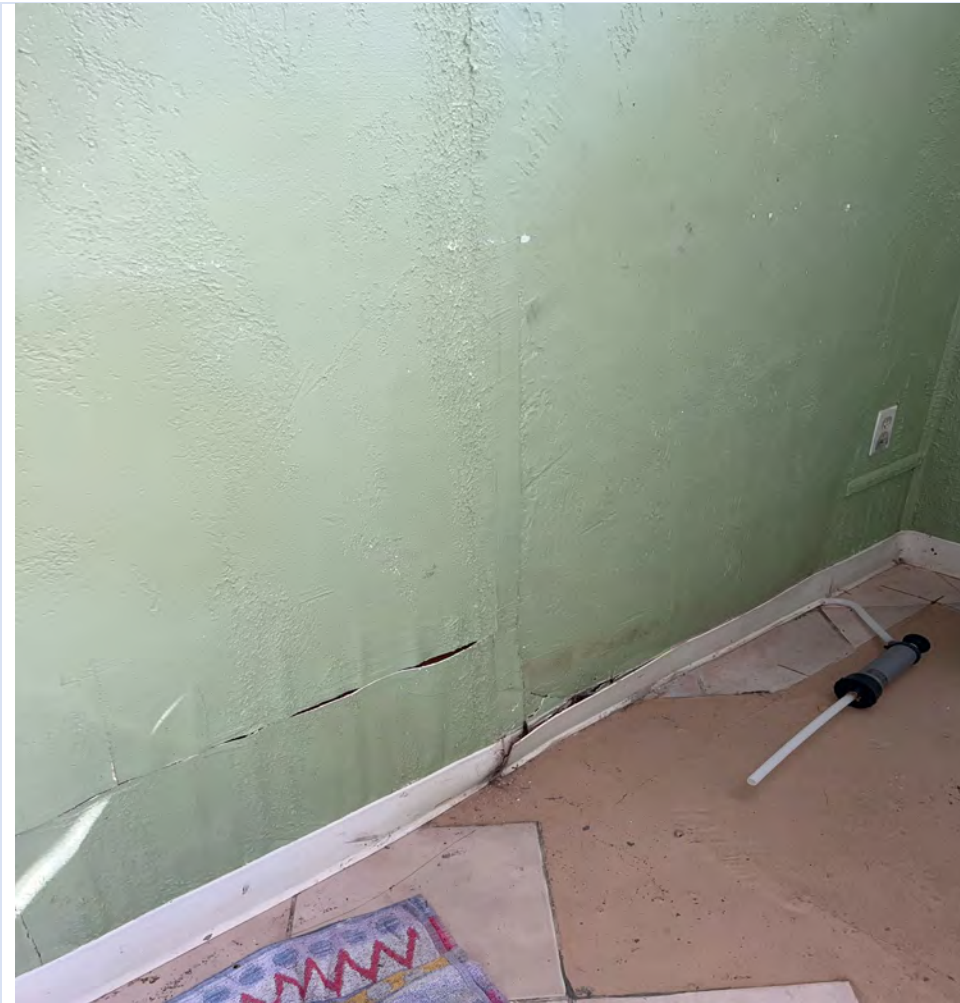
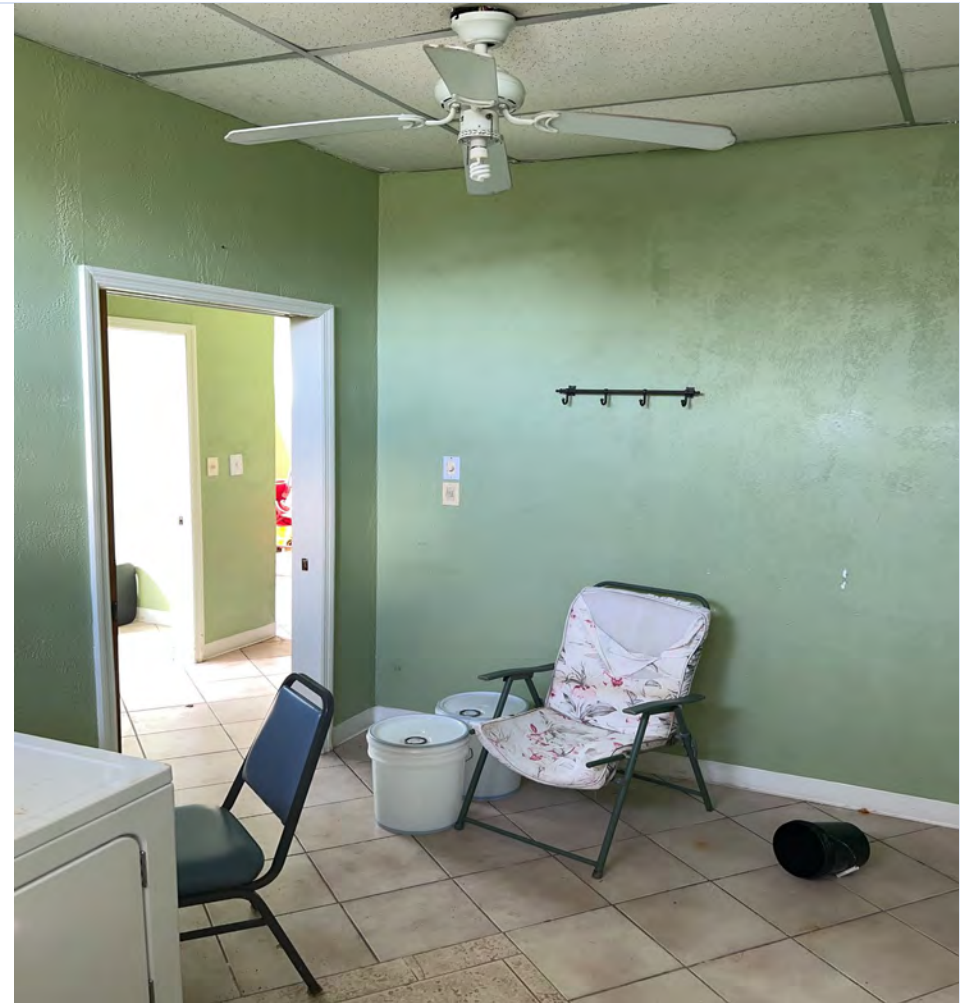
Room #: Laundry Room
Room Dimensions: 12' x 8' x 9'

Ceiling, Wall, Electrical (receptacle photos for reference)

180 SF drywall 5/8" (20' x 9')
180 SF batt insulation 4" (20' x 9')
5 LF vinyl cove baseboard 4"
6 EA dual receptacles

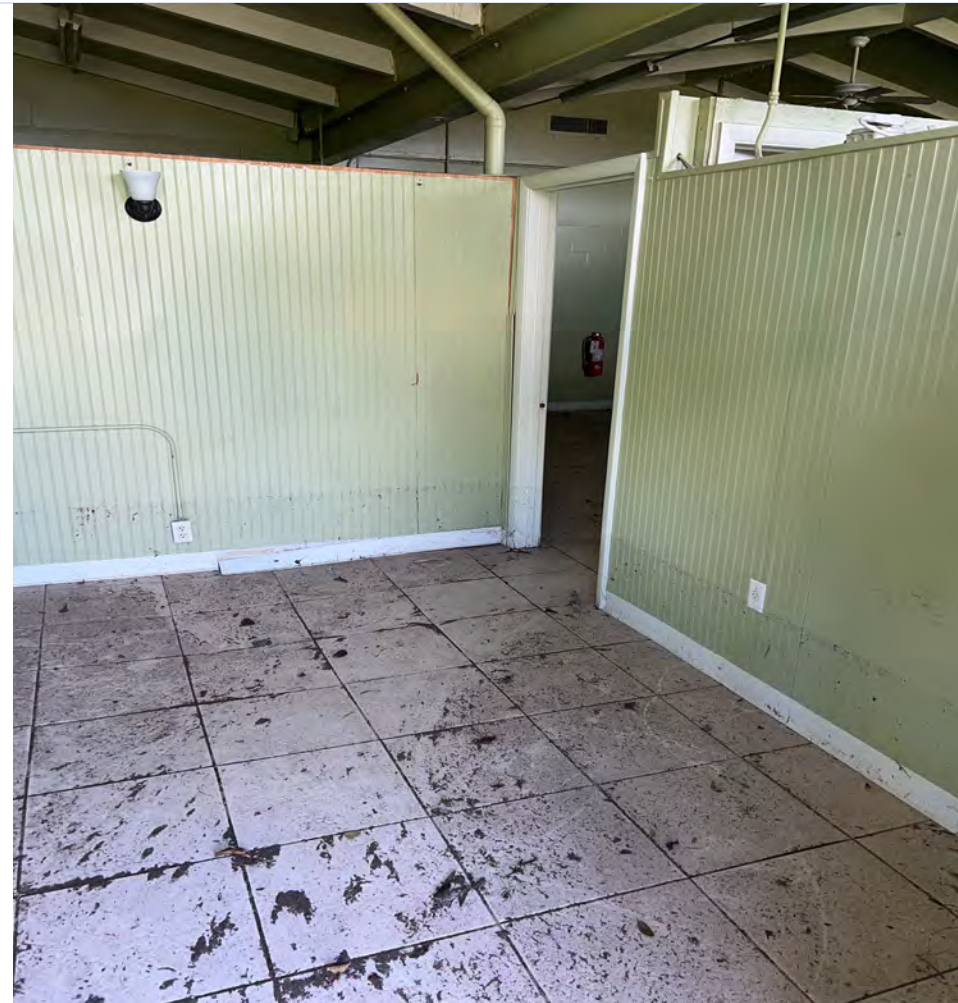
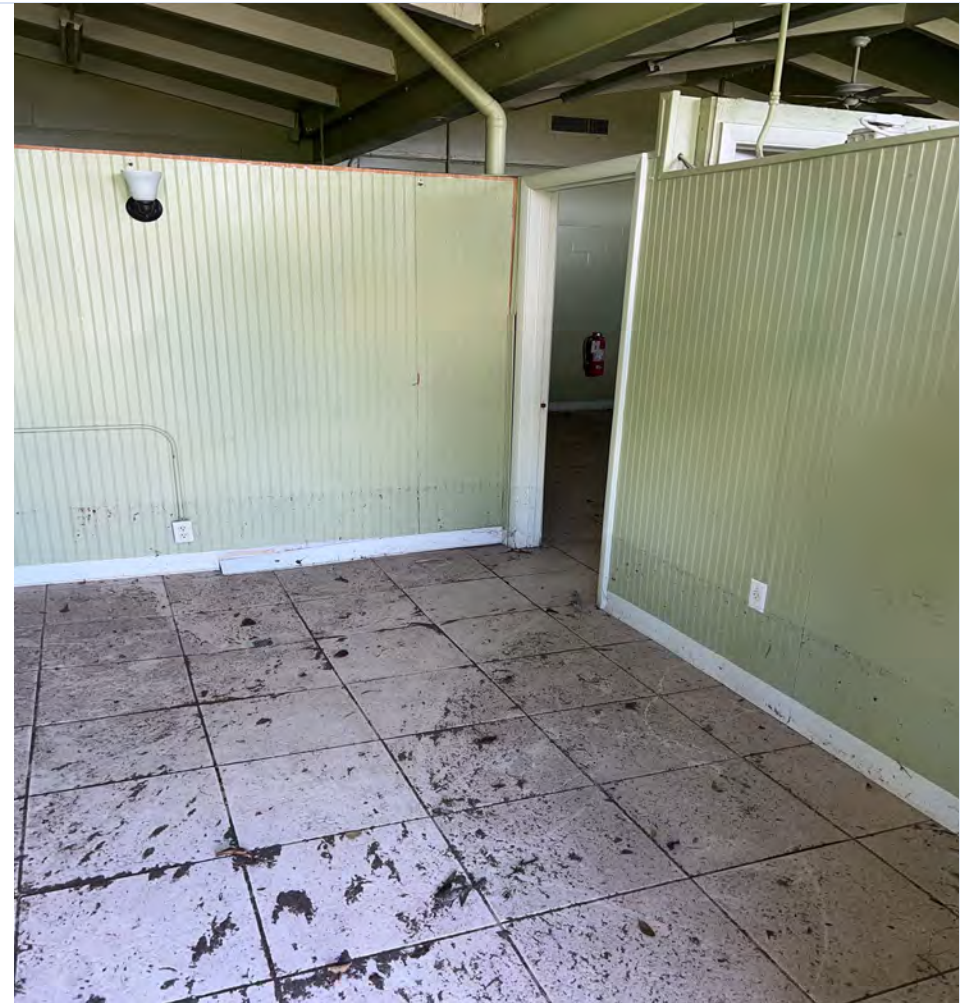
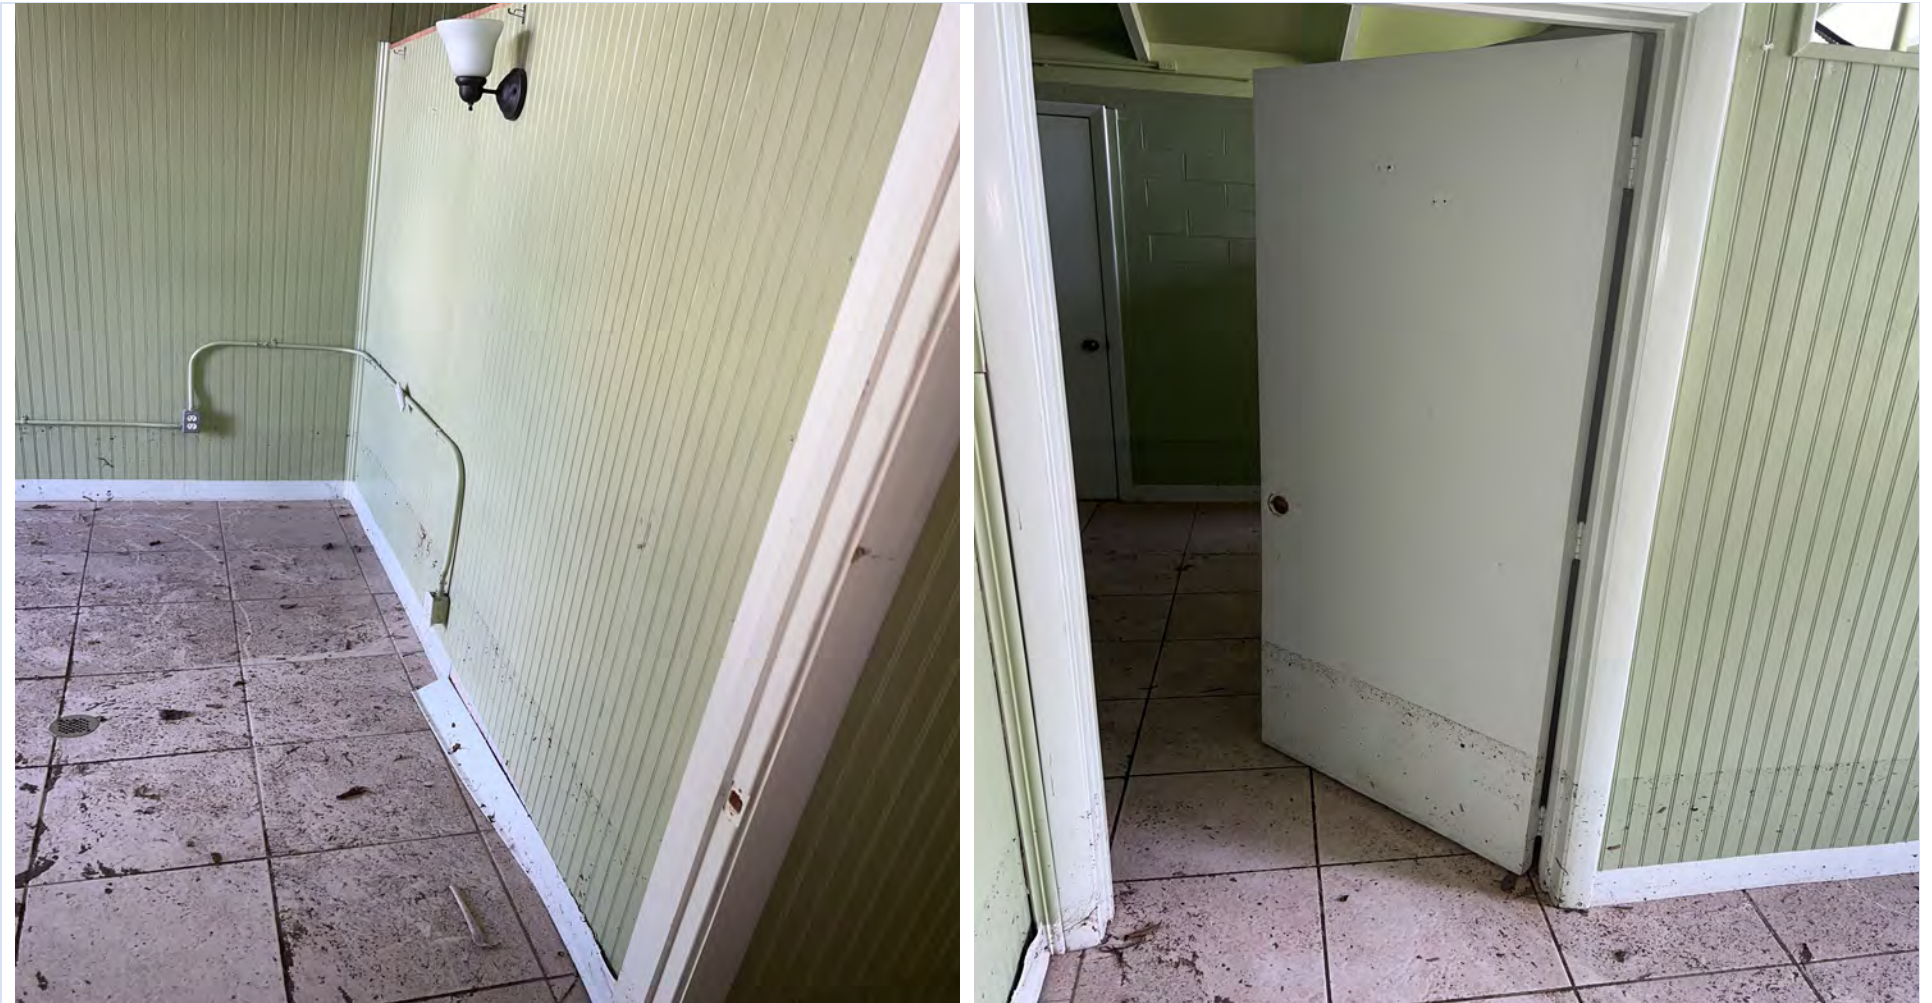
Room #: Skin Care Building Room 1

Wall, Electrical (receptacle photos for reference)

210 SF painted beadboard paneling (35' x 6')

46 LF vinyl cove baseboard 4"

1 EA interior hollow core door 32" x 76"

16 LF wood door casing 2"

8 EA dual receptacles

64 LF metal conduit 1/2" and wiring

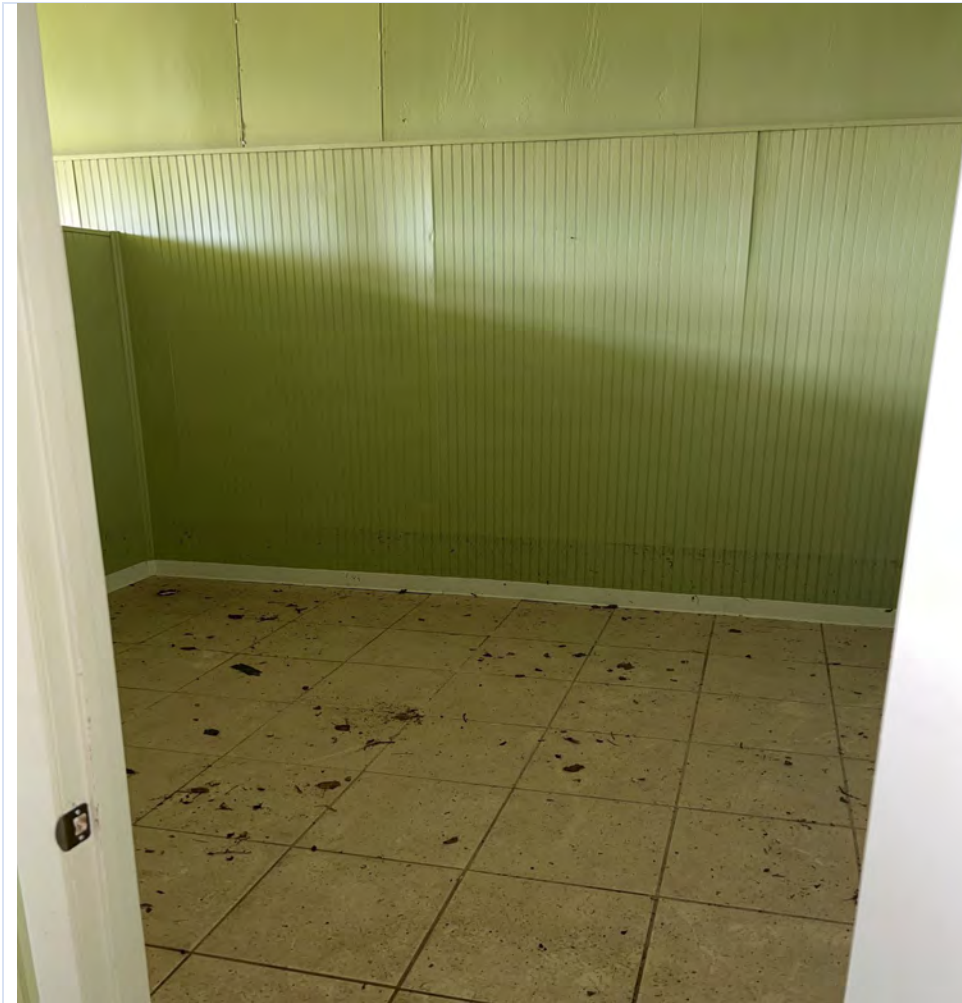
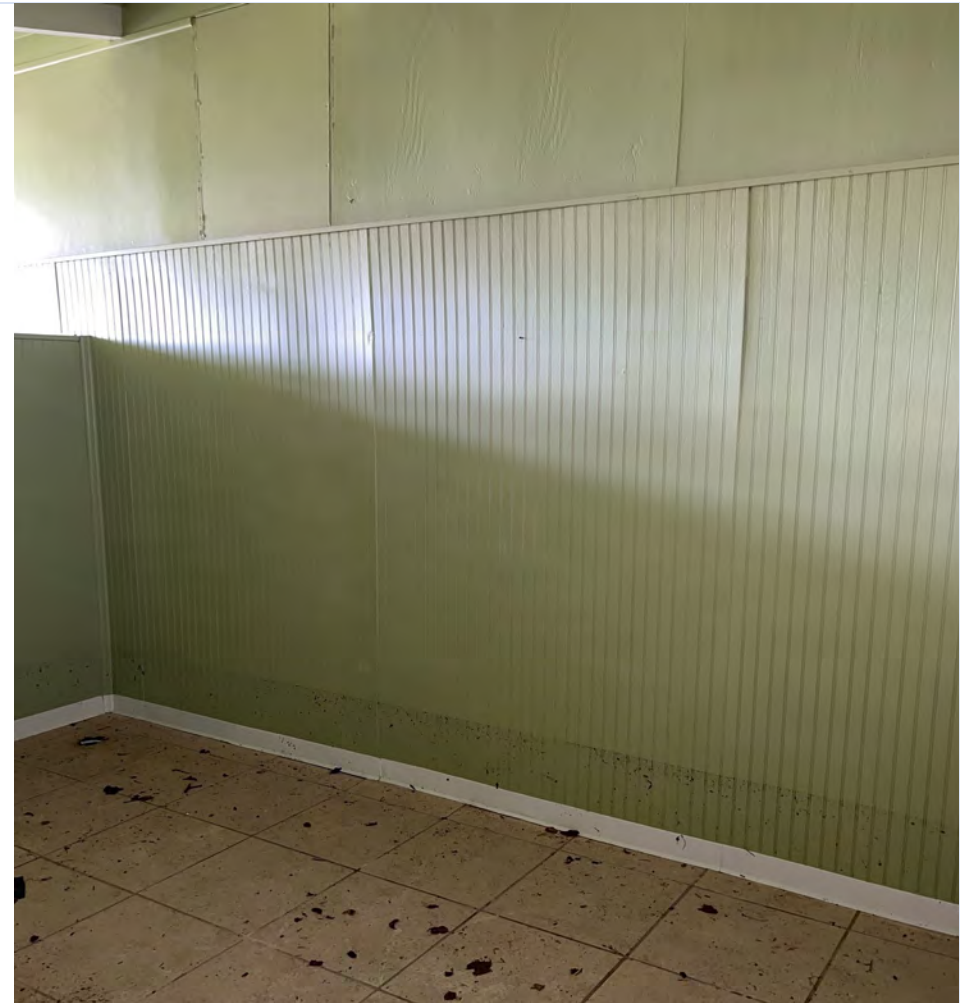
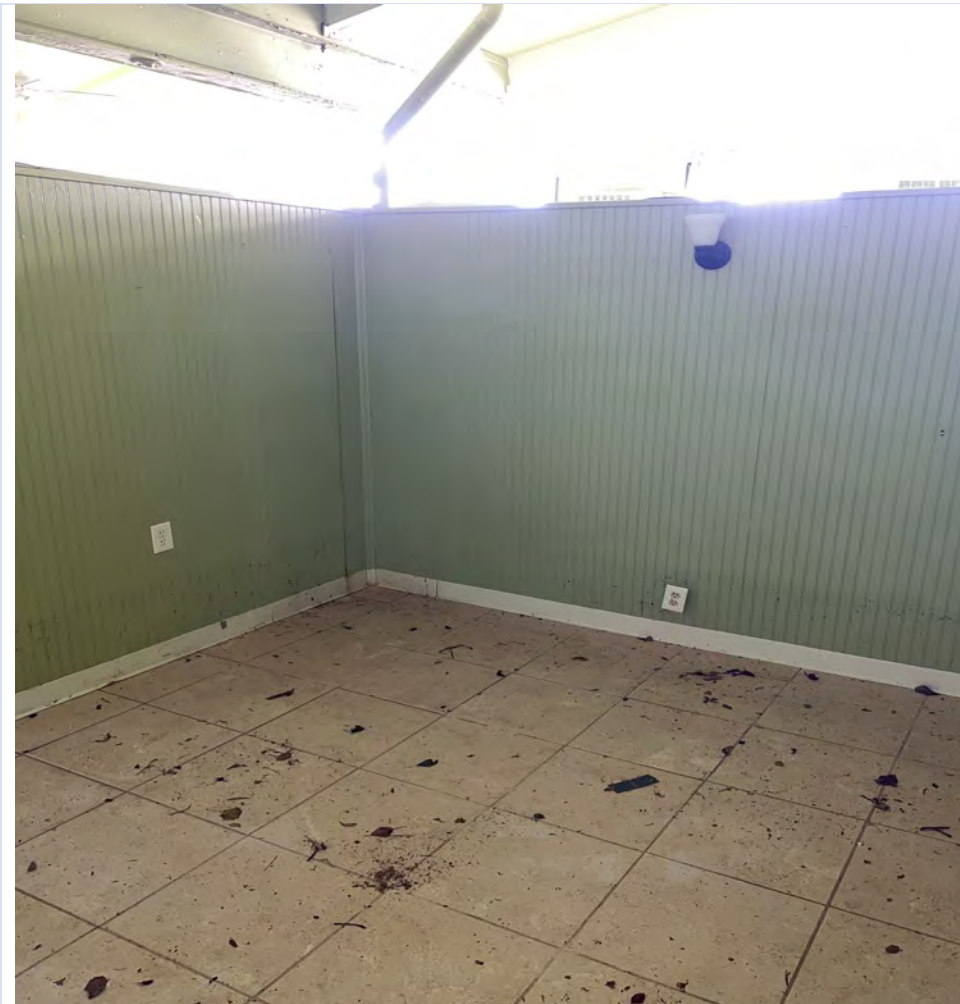
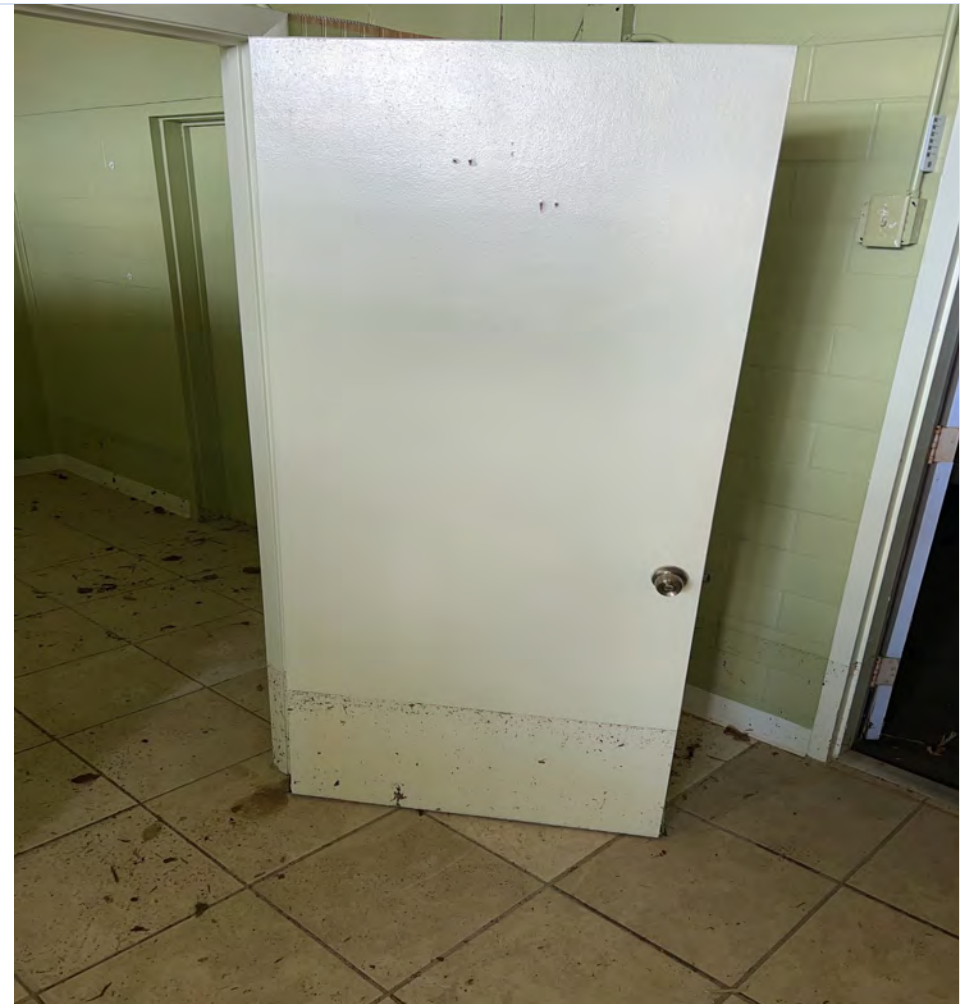
Room #: Skin Care Building Room 2

Wall, Electrical (receptacle photos for reference)

216 SF painted beadboard paneling (27' x 8')

1 EA interior hollow core door 32" x 76"

16 LF wood door casing 2"

5 EA dual receptacles

40 LF metal conduit 1/2" and wiring
