Damage Assessment Report

Warm Mineral Springs Clubhouse 2

Address: 12200 San Servando Ave,
North Port, FL 34287

SITE INSPECTION REPORT

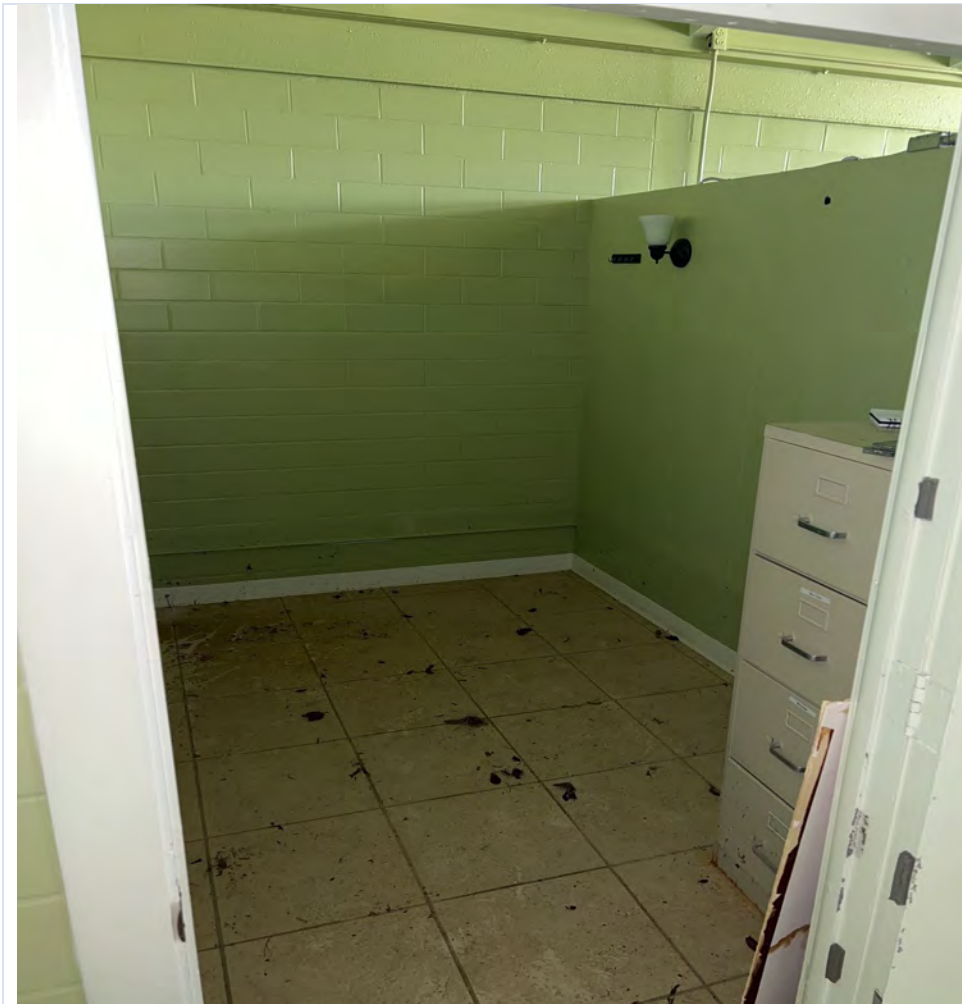
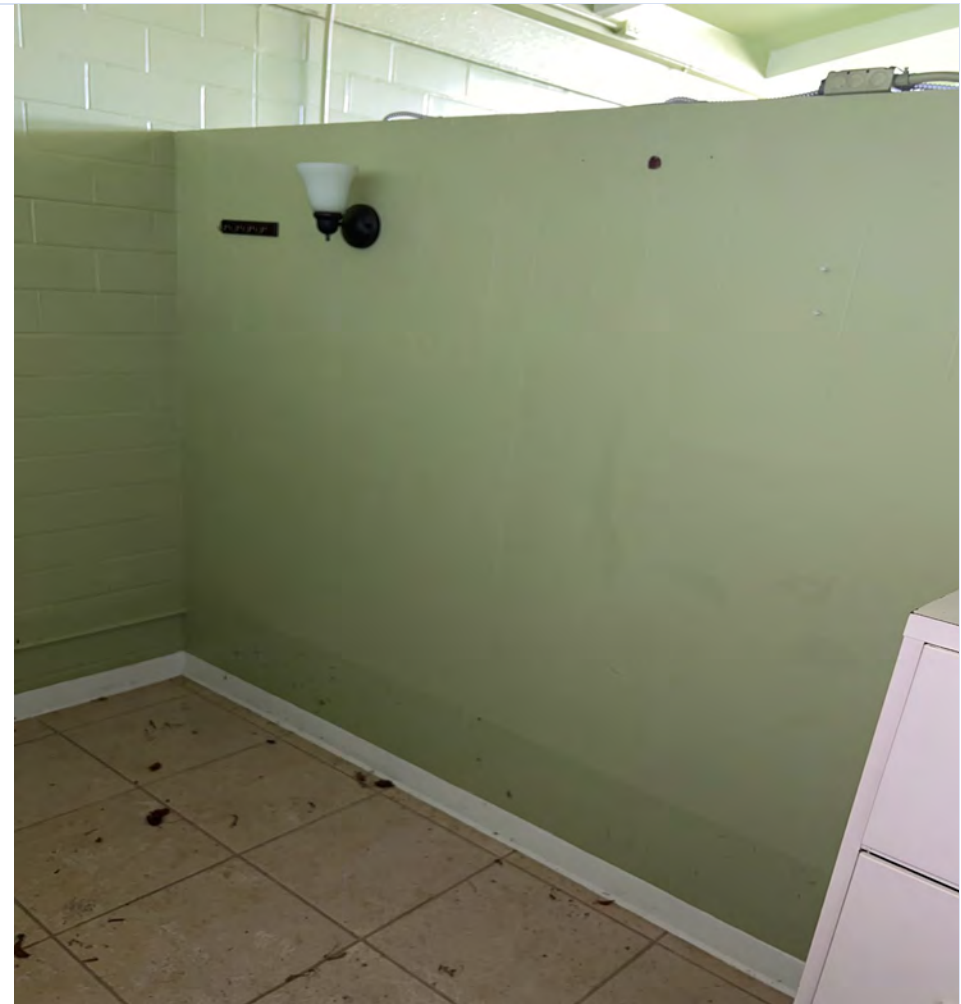
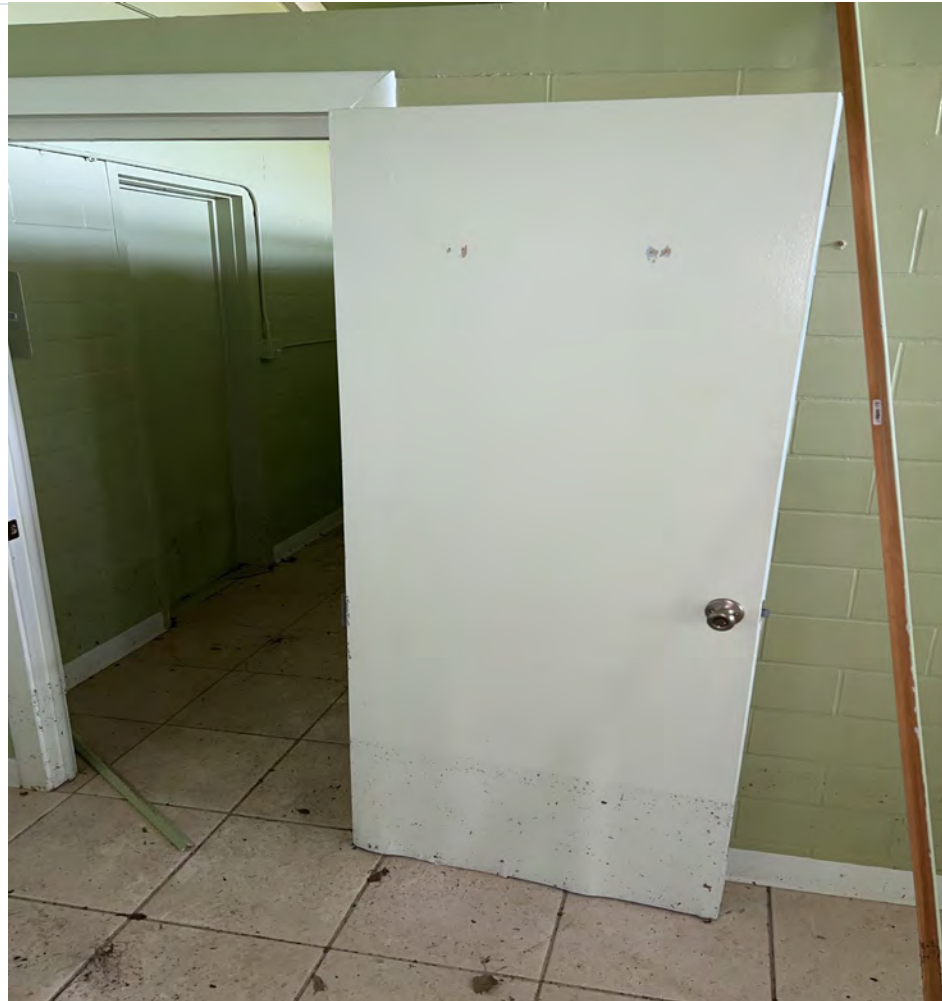
Room #: Skin Care Building Room 3
Room Dimensions: 10' x 7' x 12'

Wall, Electrical (receptacle photos for reference)

72 SF painted beadboard paneling (12' x 6')
1 EA interior hollow core door 32" x 76"
16 LF wood door casing 2"
6 EA dual receptacles
48 LF metal conduit 1/2" and wiring

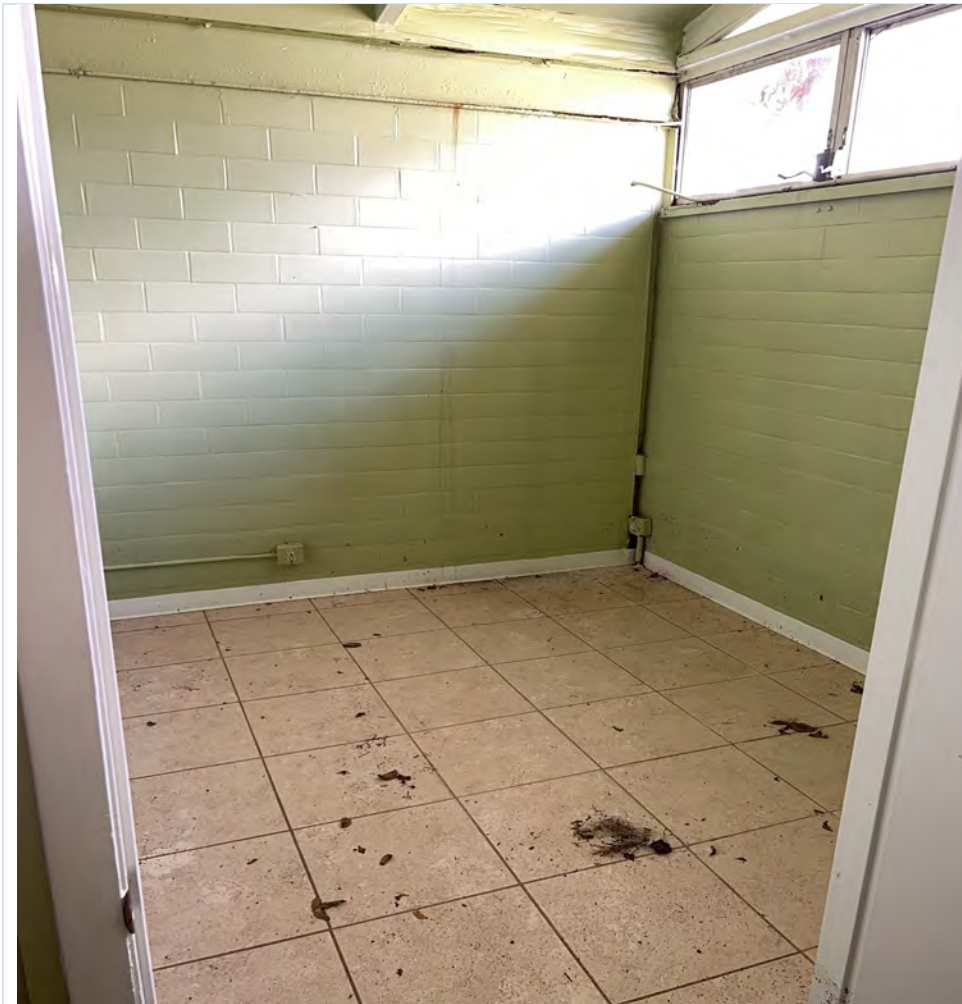
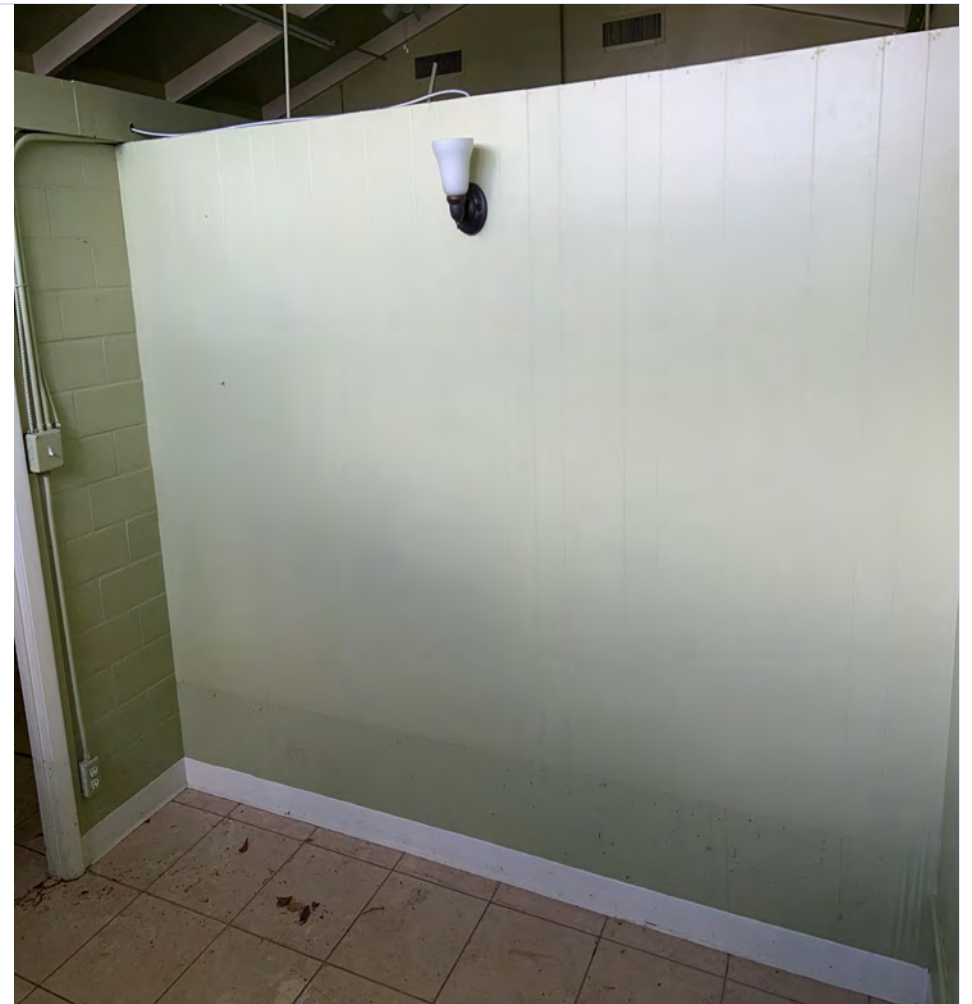
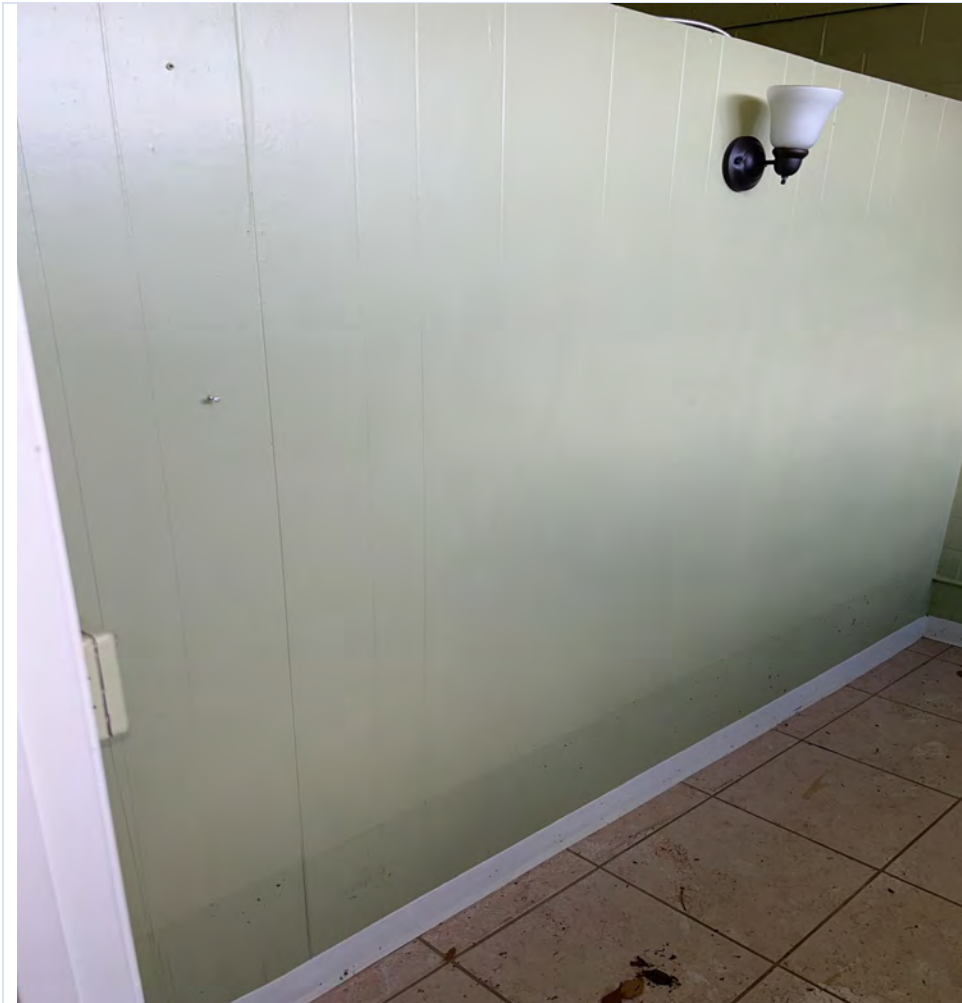
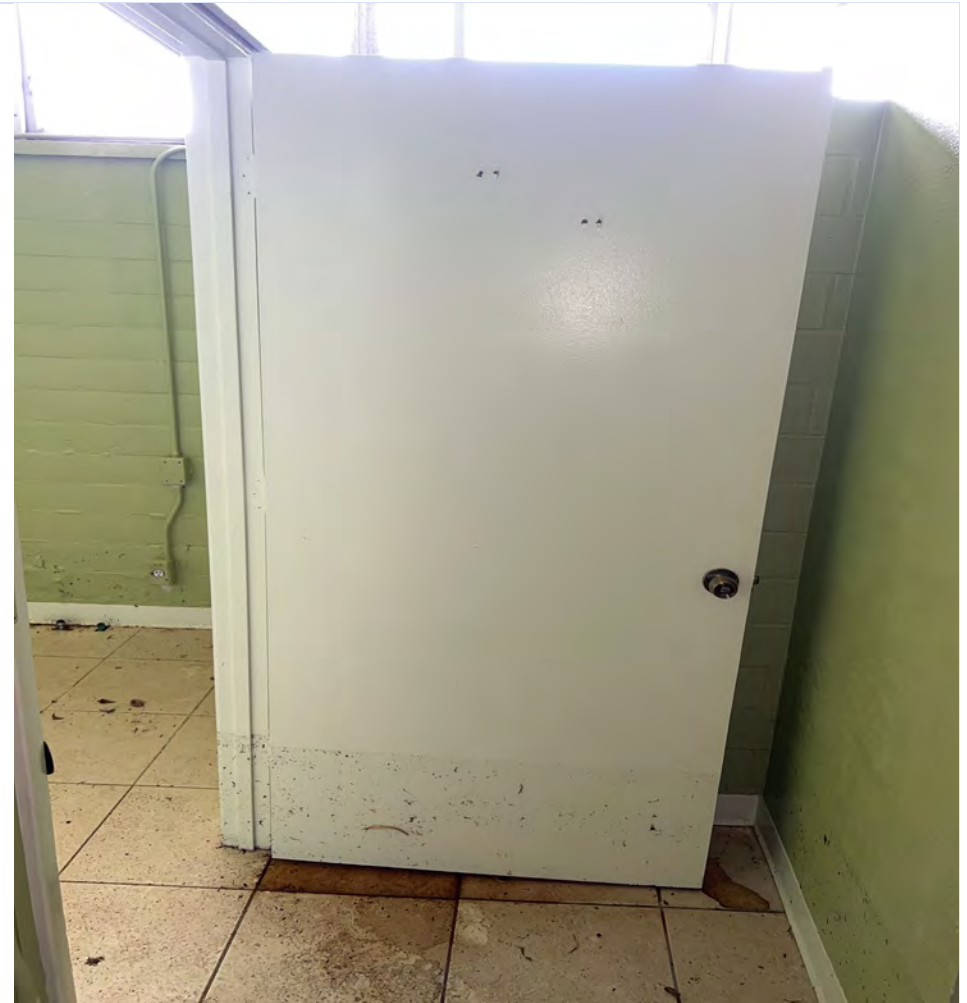
Room #: Skin Care Room 4

Wall, Electrical (receptacle photos for reference)

42 SF painted beadboard paneling (7' x 6')

1 EA interior hollow core door 32" x 76"

16 LF wood door casing 2"

6 EA dual receptacles

48 LF metal conduit 1/2" and wiring

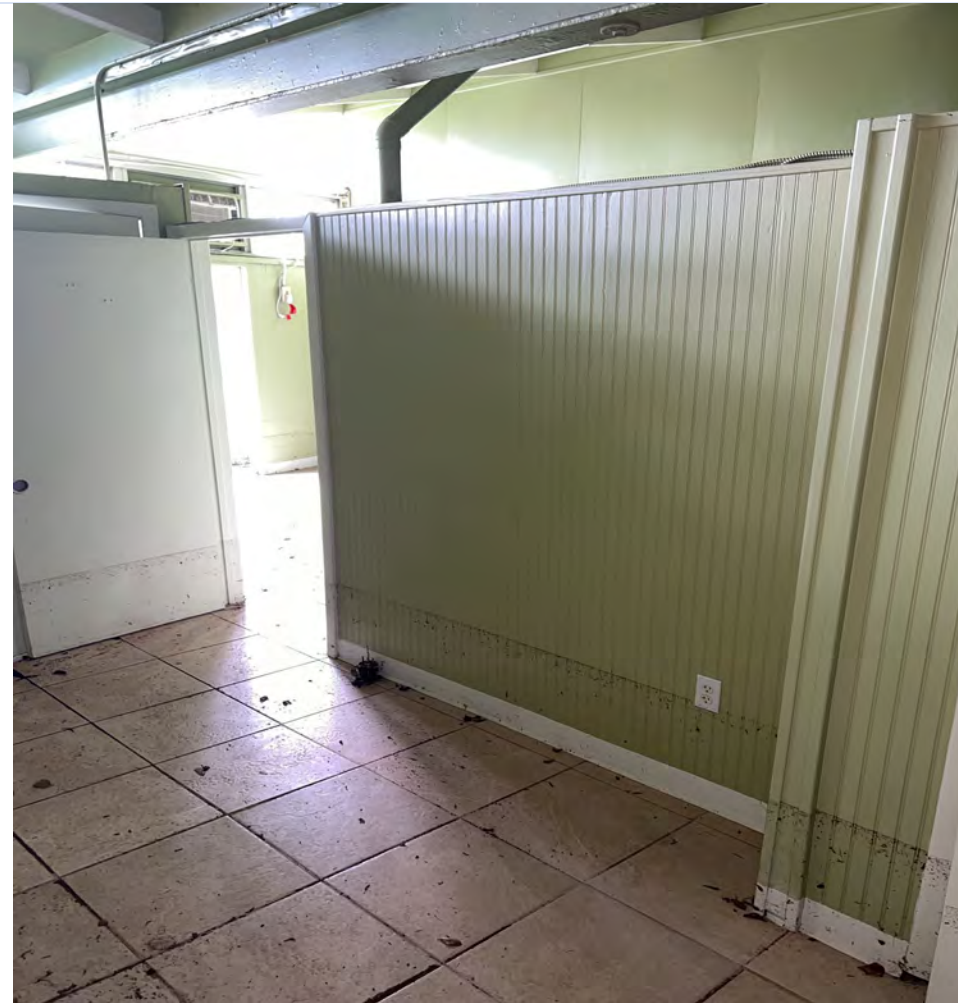
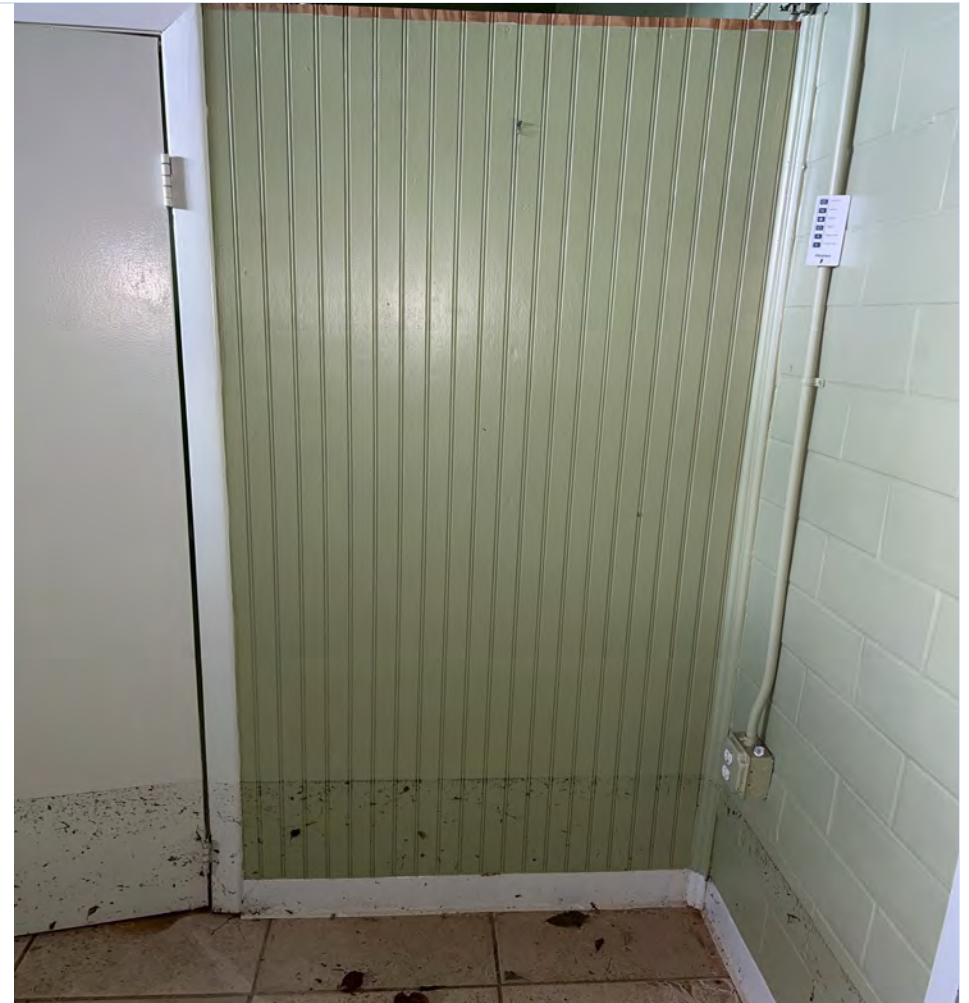
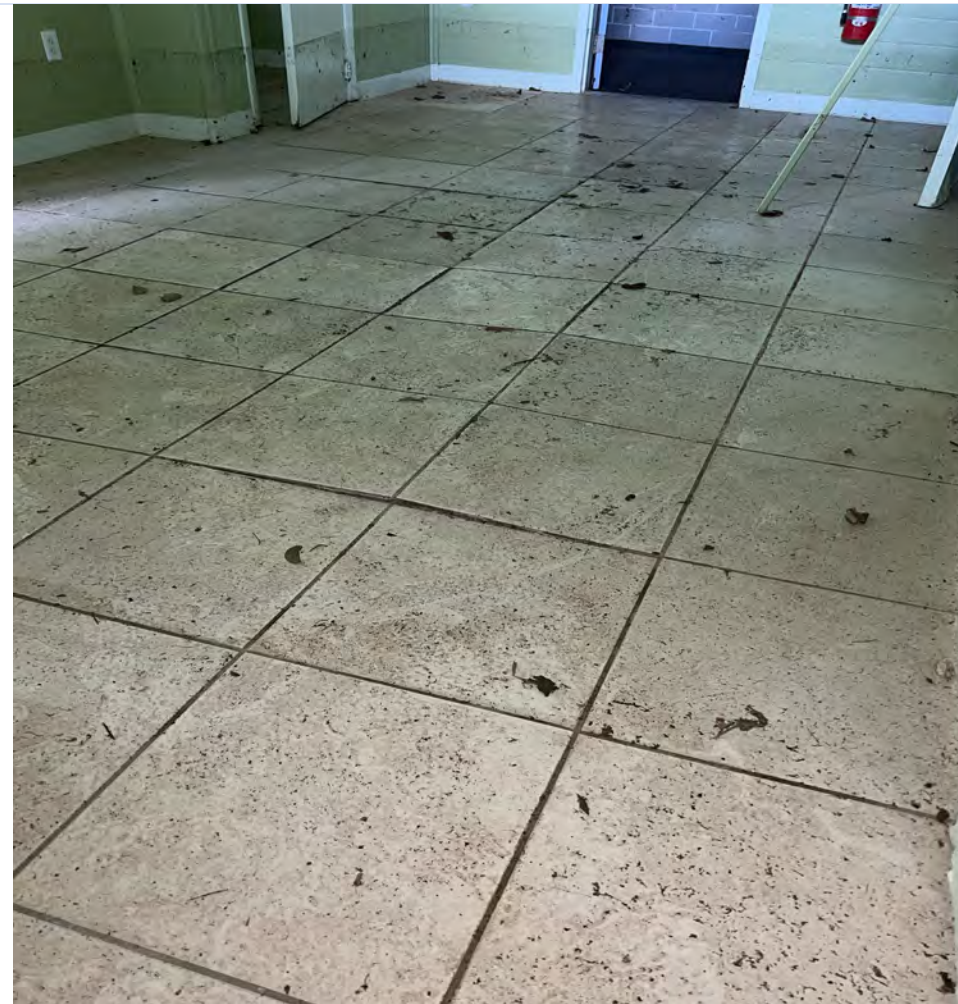
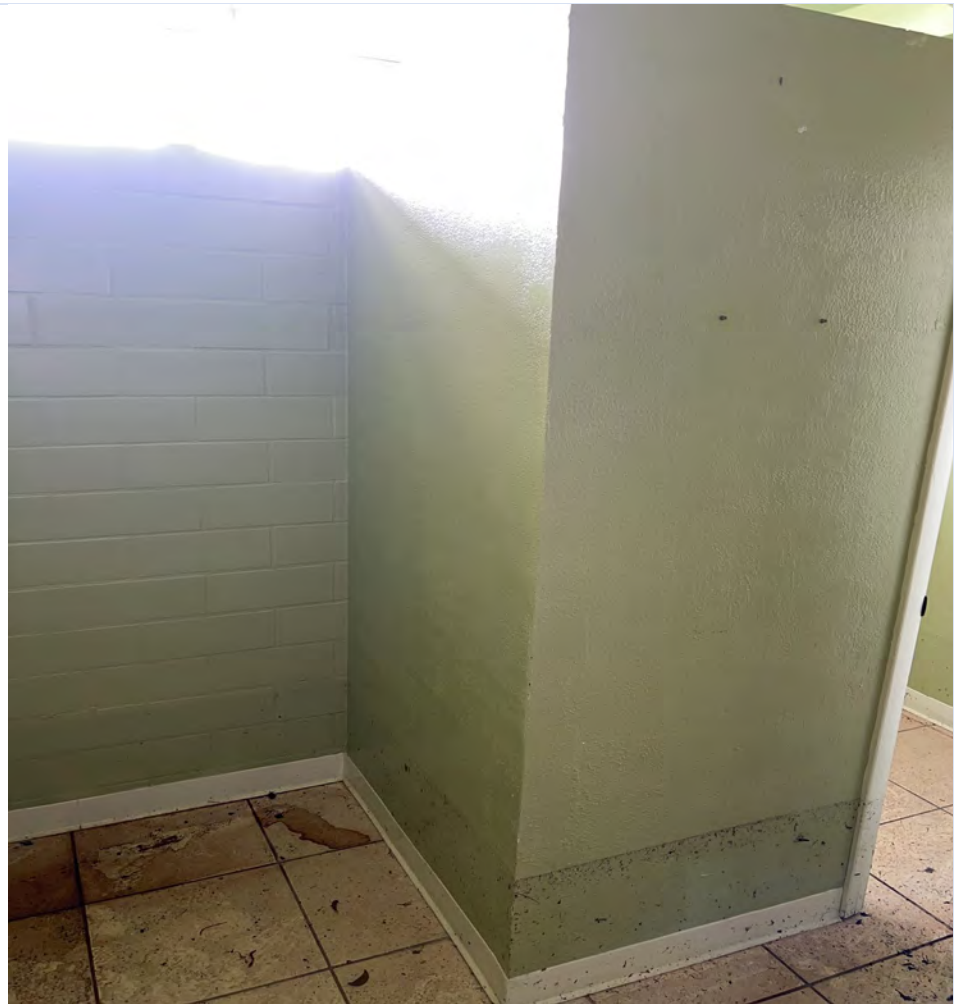
Room #: Skin Care Main Room

Wall, Flooring, Electrical (receptacle photos for reference)

66 SF painted beadboard paneling (11' x 6')

56 SF drywall 5/8" (8' x 7')

56 SF batt insulation 4" (8' x 7')

200 SF ceramic floor tile 16" x 16" (20' x 10')

5 EA dual receptacles

60 LF metal conduit 1/2" and wiring

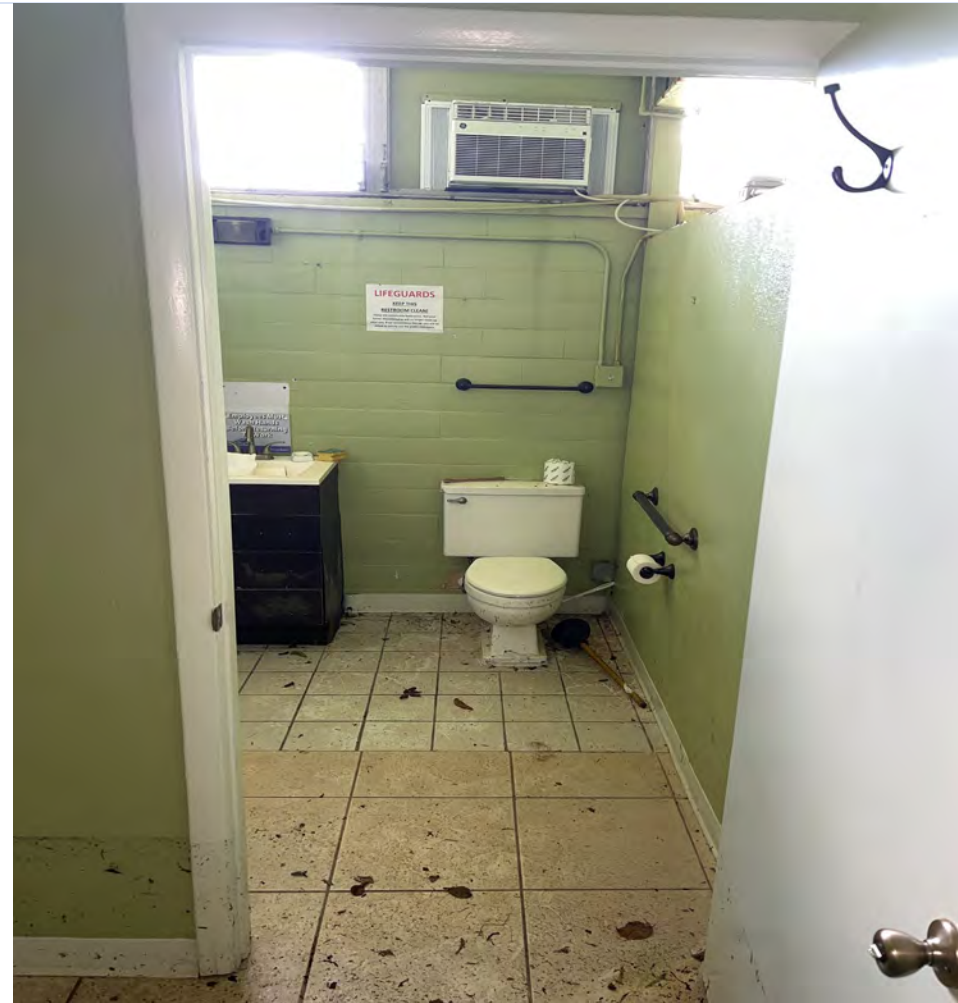
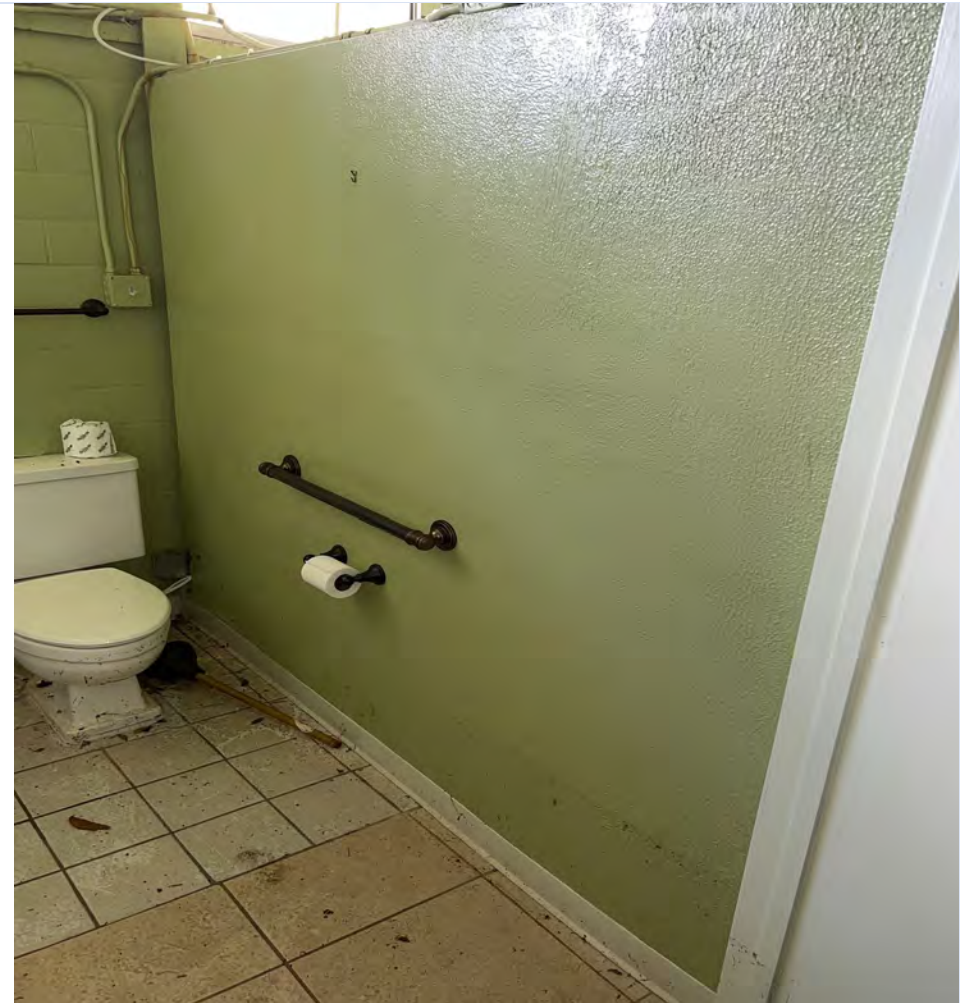
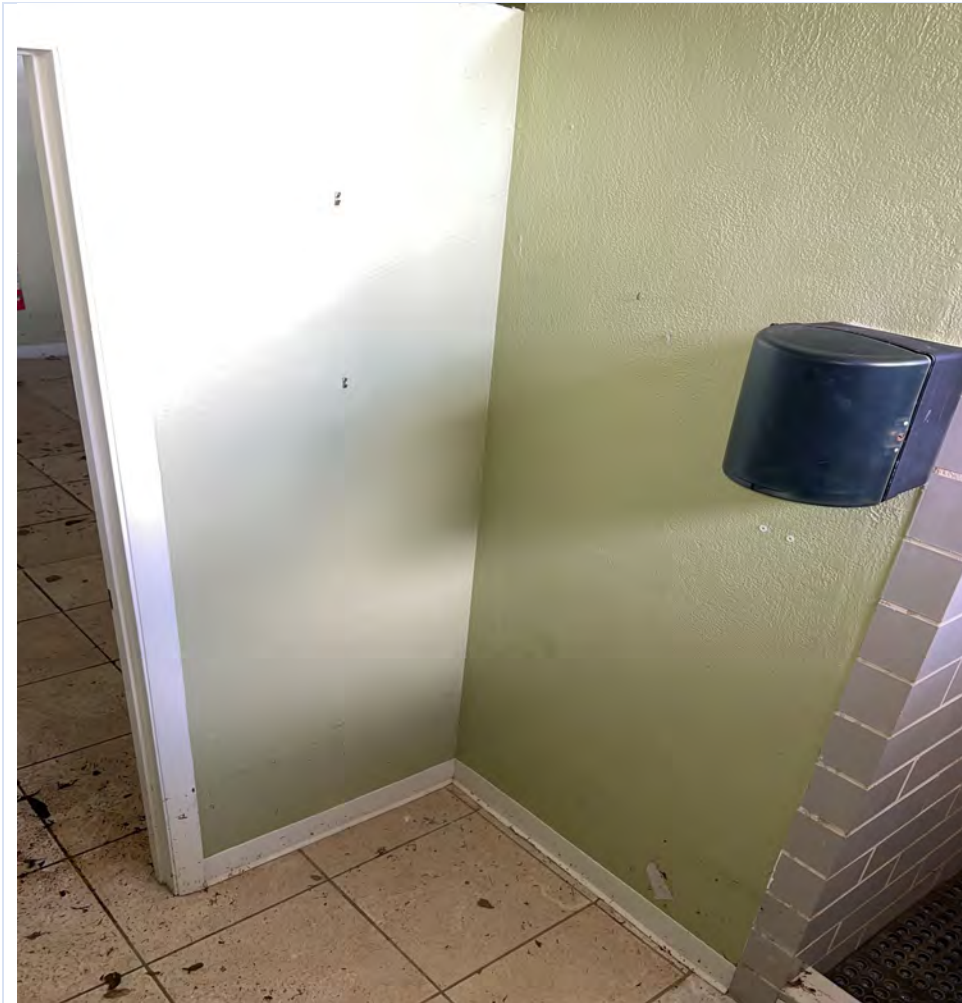
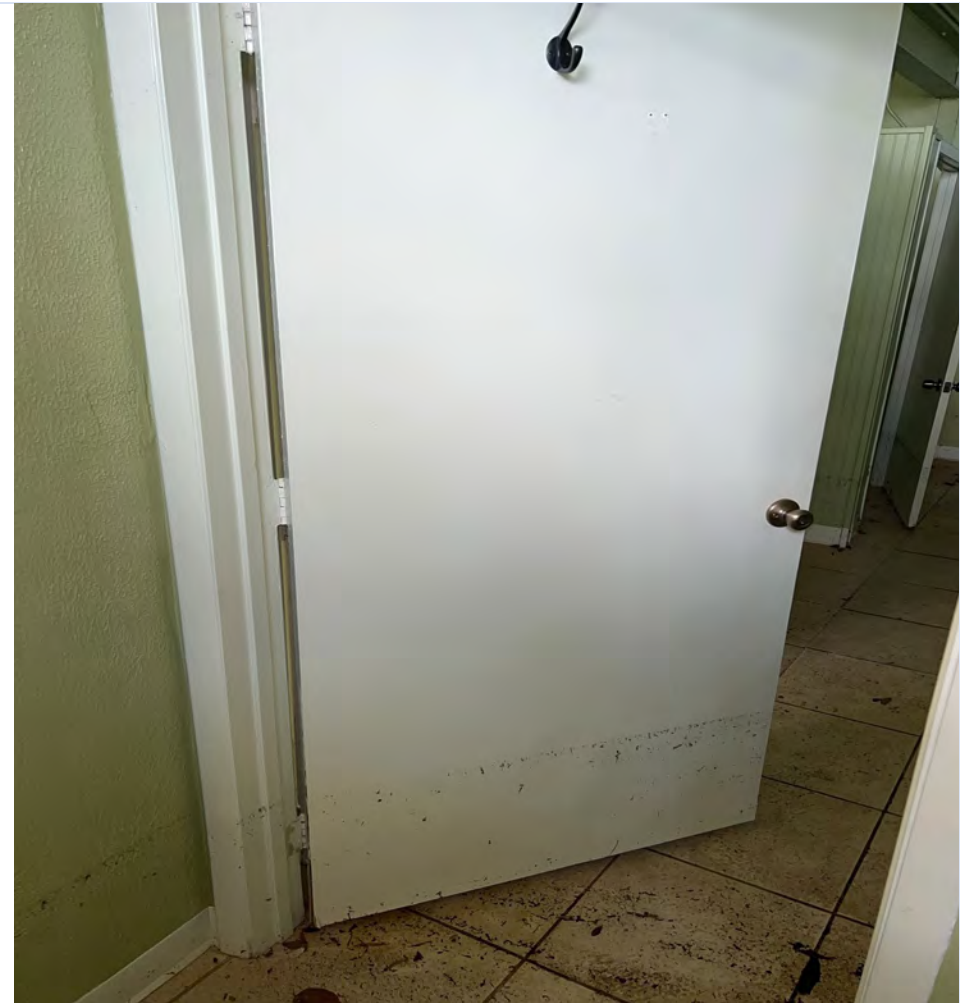
Room #: Skin Care Building Bathroom

Wall

72 SF drywall 5/8" (12' x 6')

72 SF batt insulation 4" (12' x 6')

1 EA interior hollow core door 32" x 76"

16 LF wood door casing 2"

1 EA bathroom vanity 32" x 13" x 16"

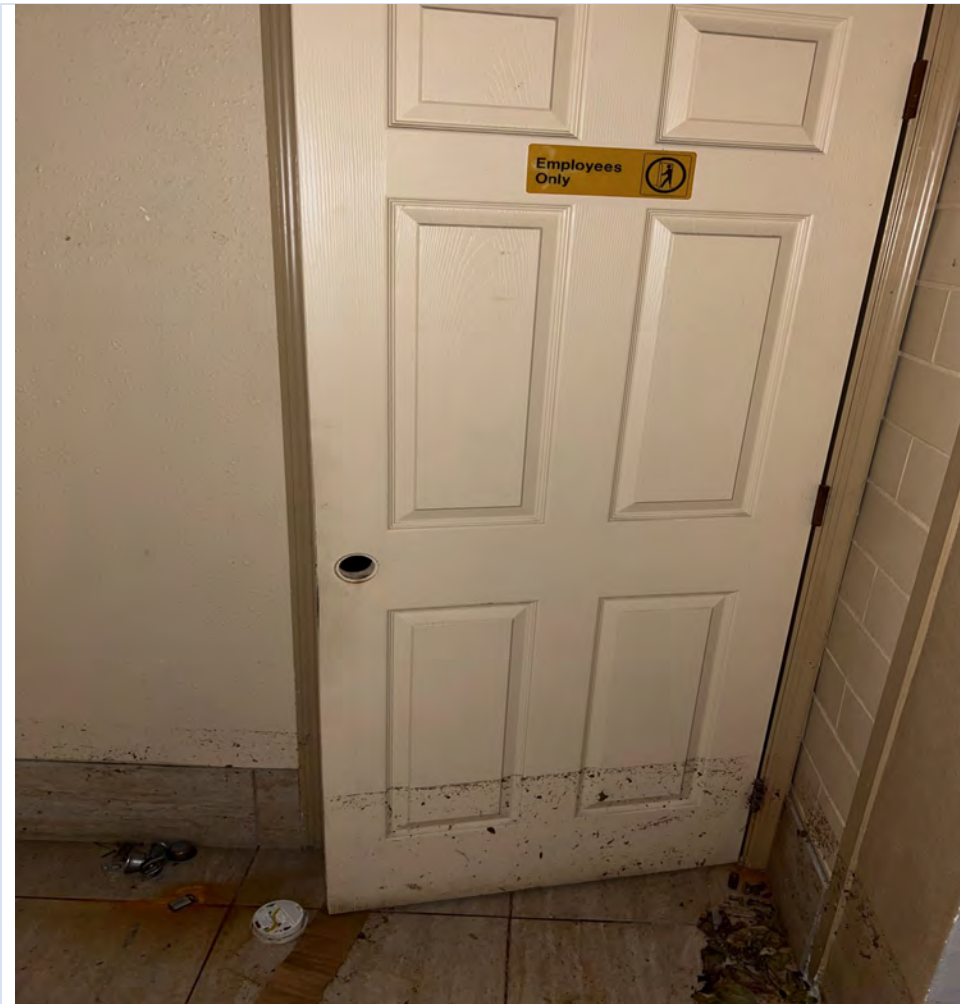
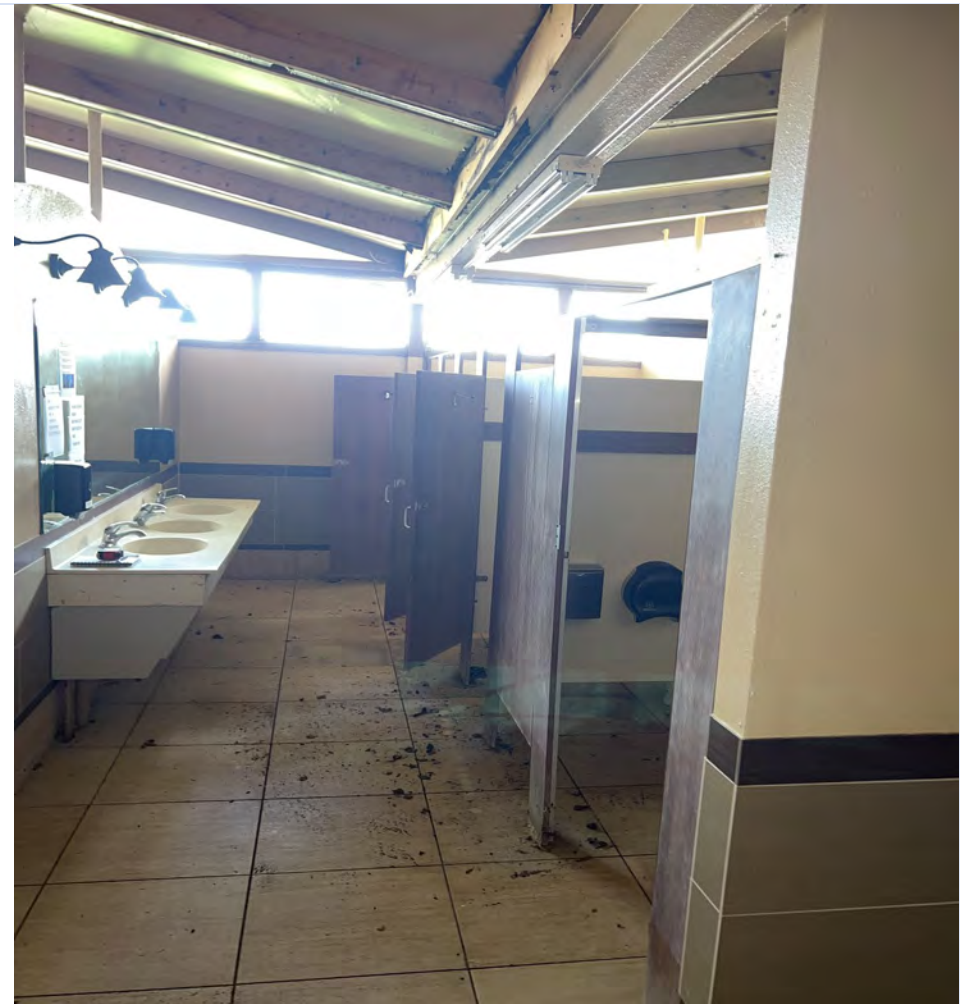
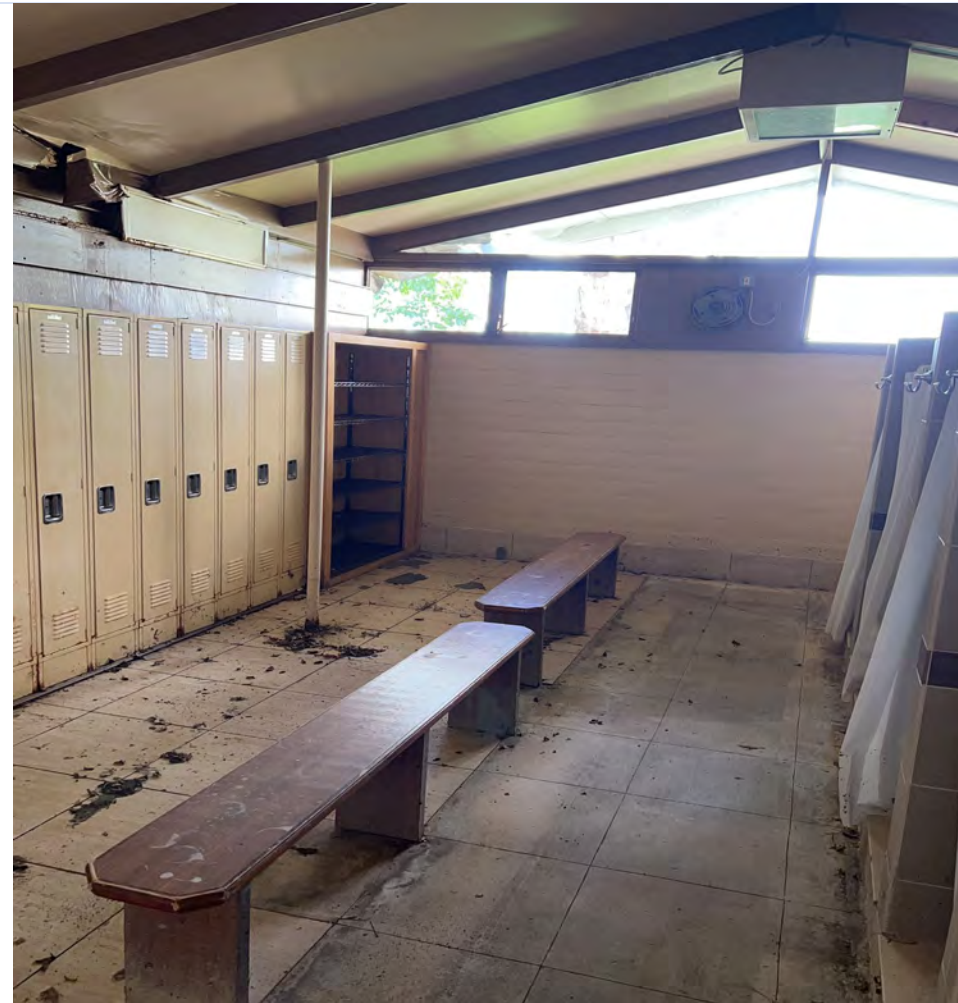
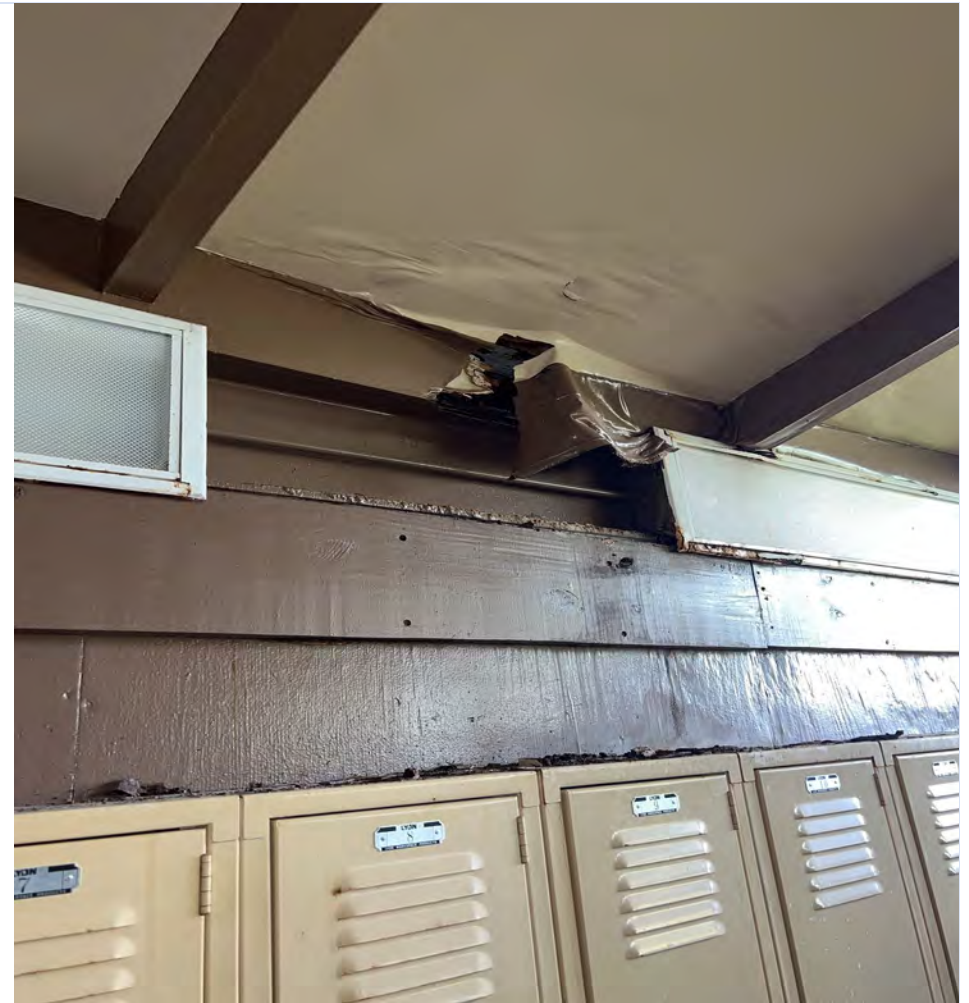
Room #: Womens Lockerroom

Ceiling, Wall

1 EA interior hollow core door 32" x 76"

16 LF wood door casing 2"

720 SF ceramic tile 16" x 16" (30' x 24')

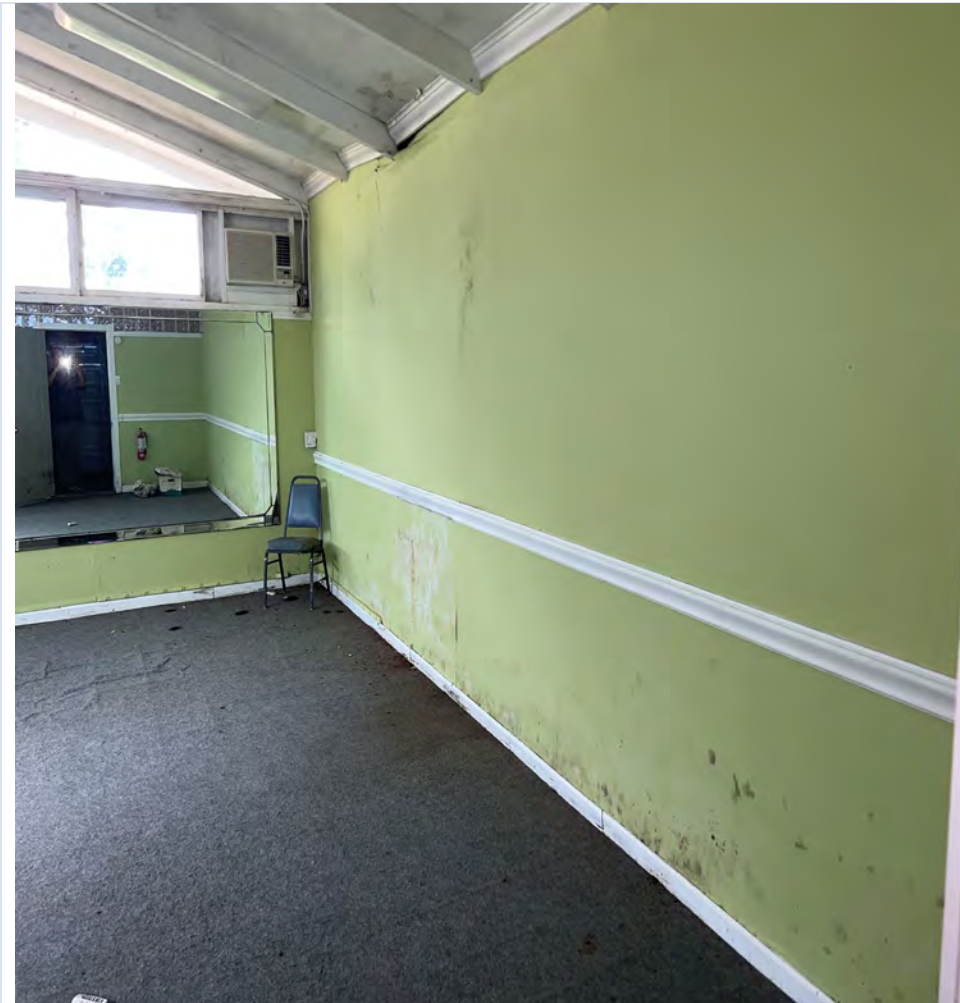
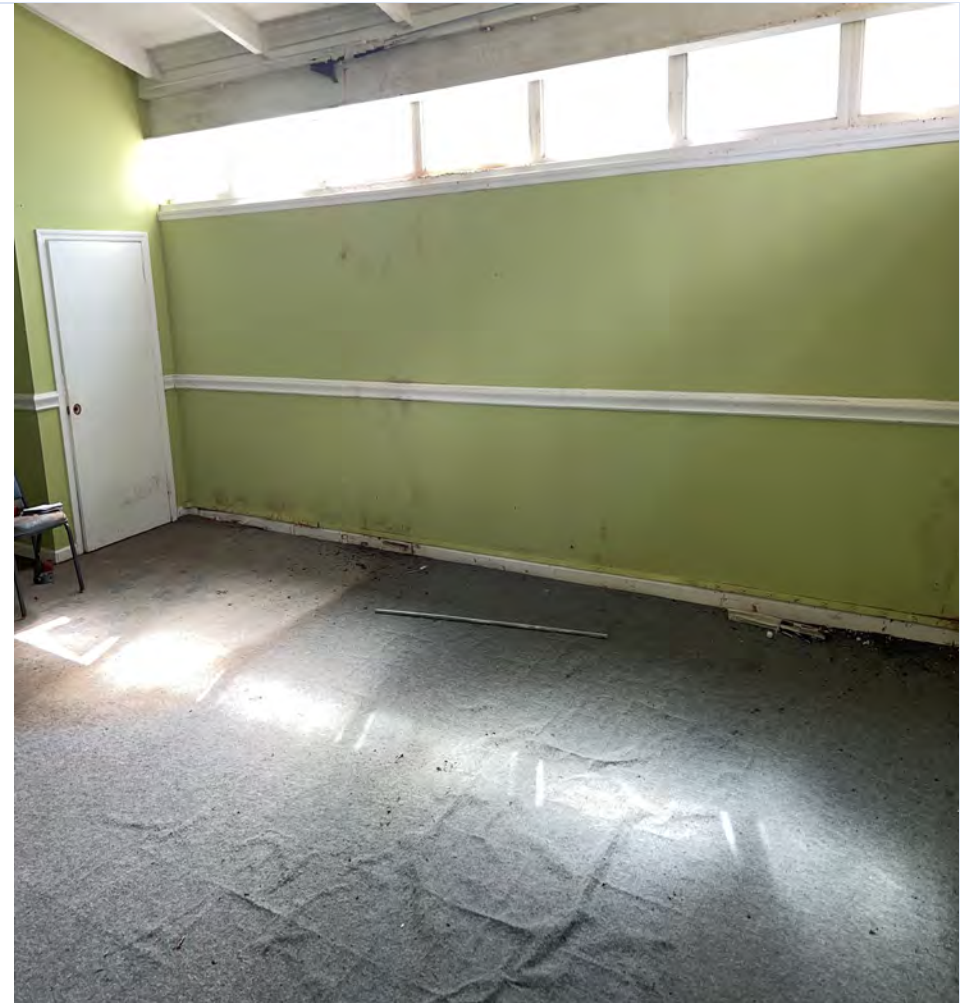
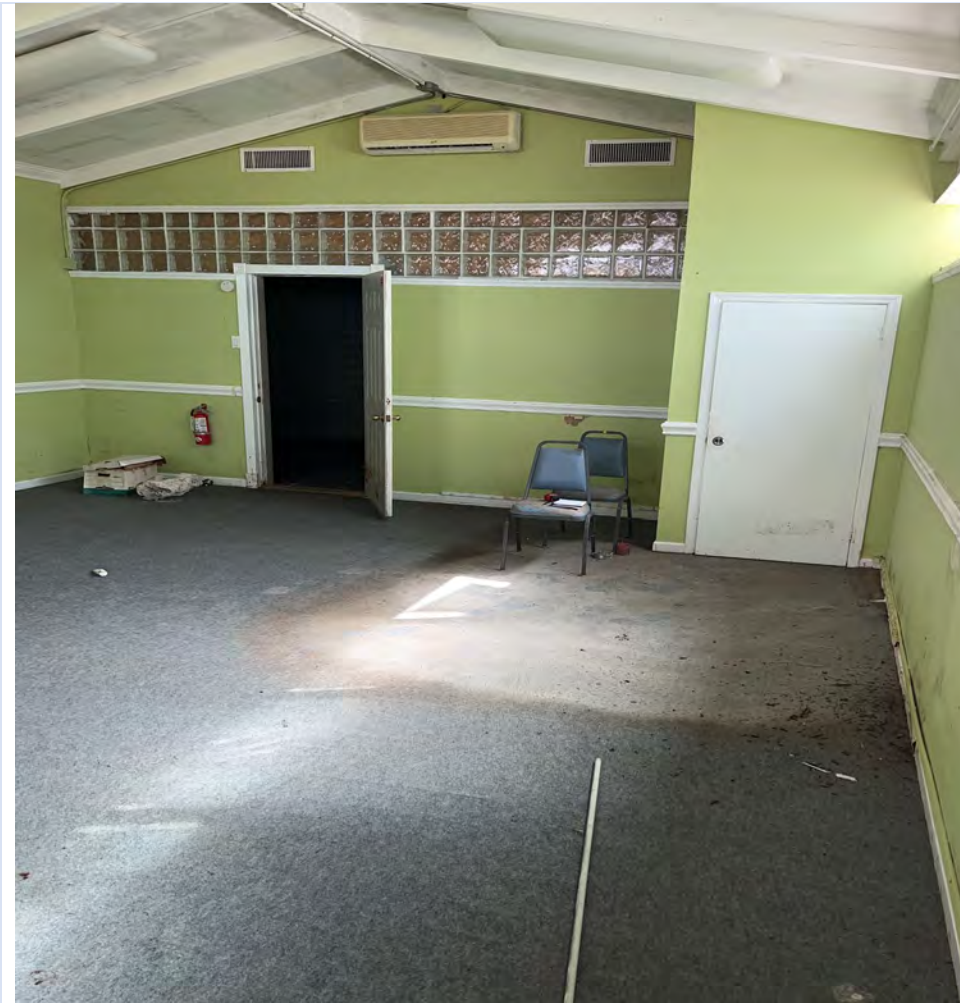
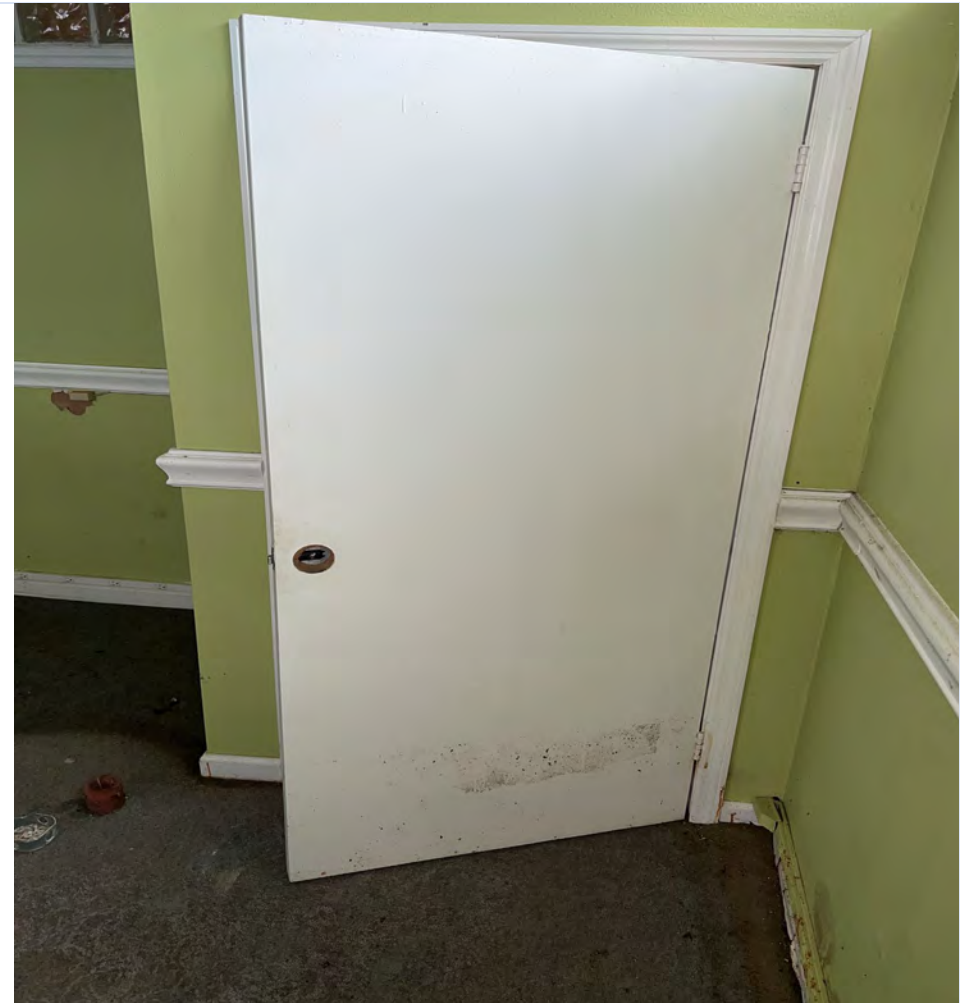
Room #: Meeting Training Room
Room Dimensions: 24' x 20' x 12'

Wall, Electrical (receptacle photos for reference)

590 SF drywall 5/8" (59' x 10')
590 SF batt insulation 4" (59' x 10')
1 EA interior hollow core door 32" x 76"
16 LF wood door casing 2"
480 SF commercial carpet (24' x 20')
5 EA dual receptacles
45 LF metal conduit 1/2" and wiring
