Damage Assessment Report

Warm Mineral Springs Clubhouse 2

Address: 12200 San Servando Ave,
North Port, FL 34287

SITE INSPECTION REPORT

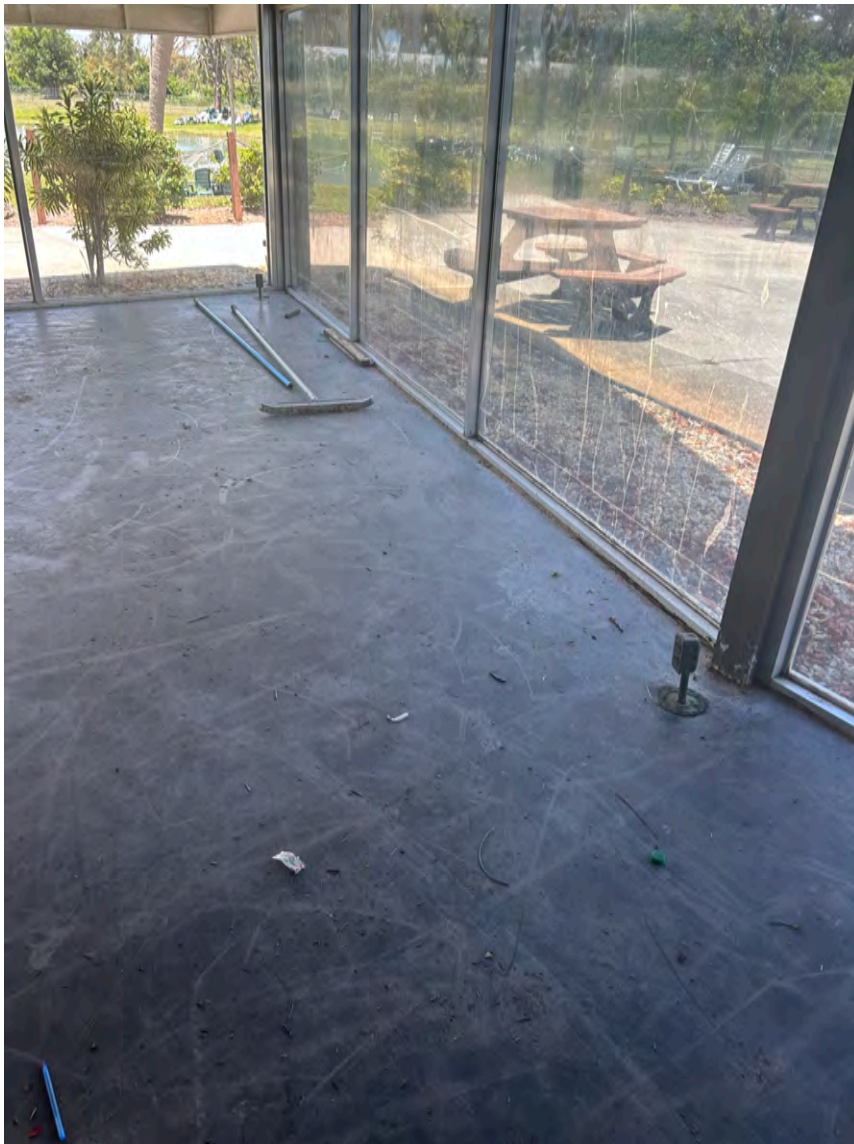
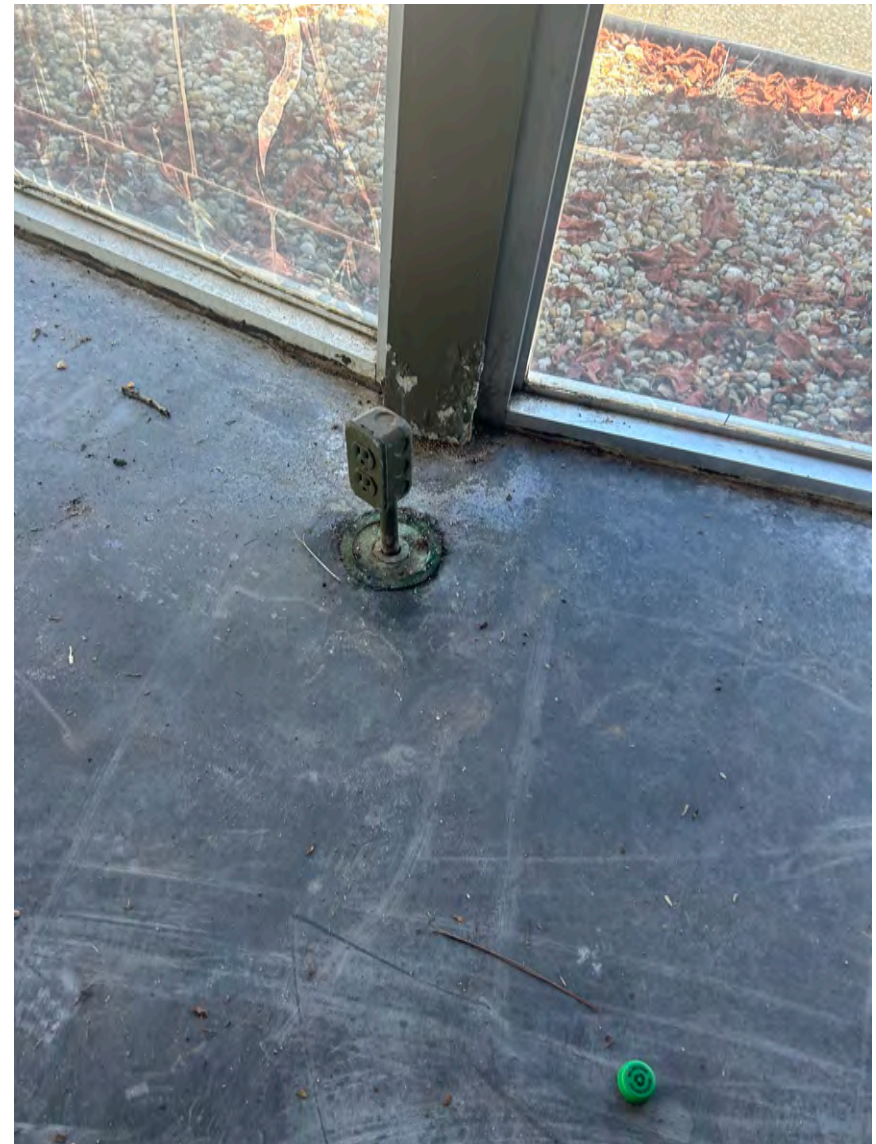
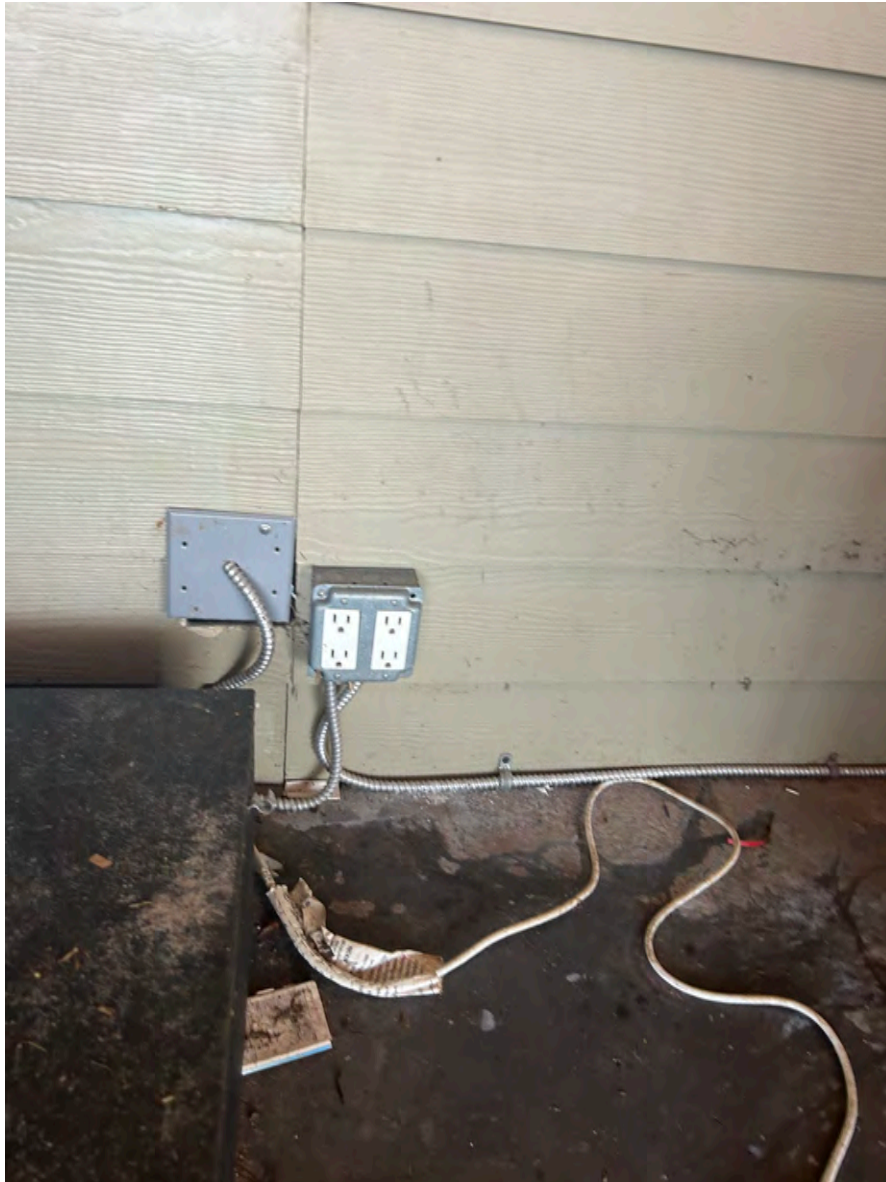
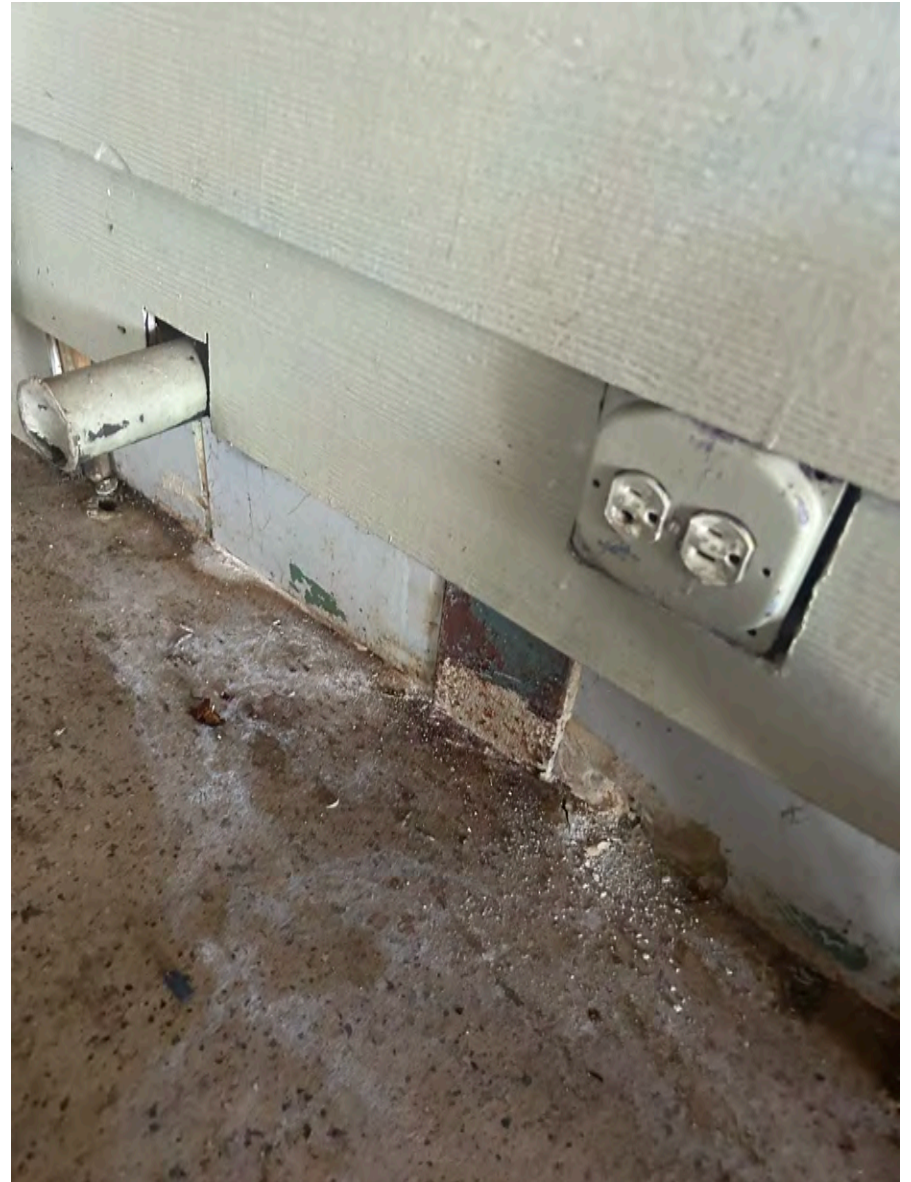
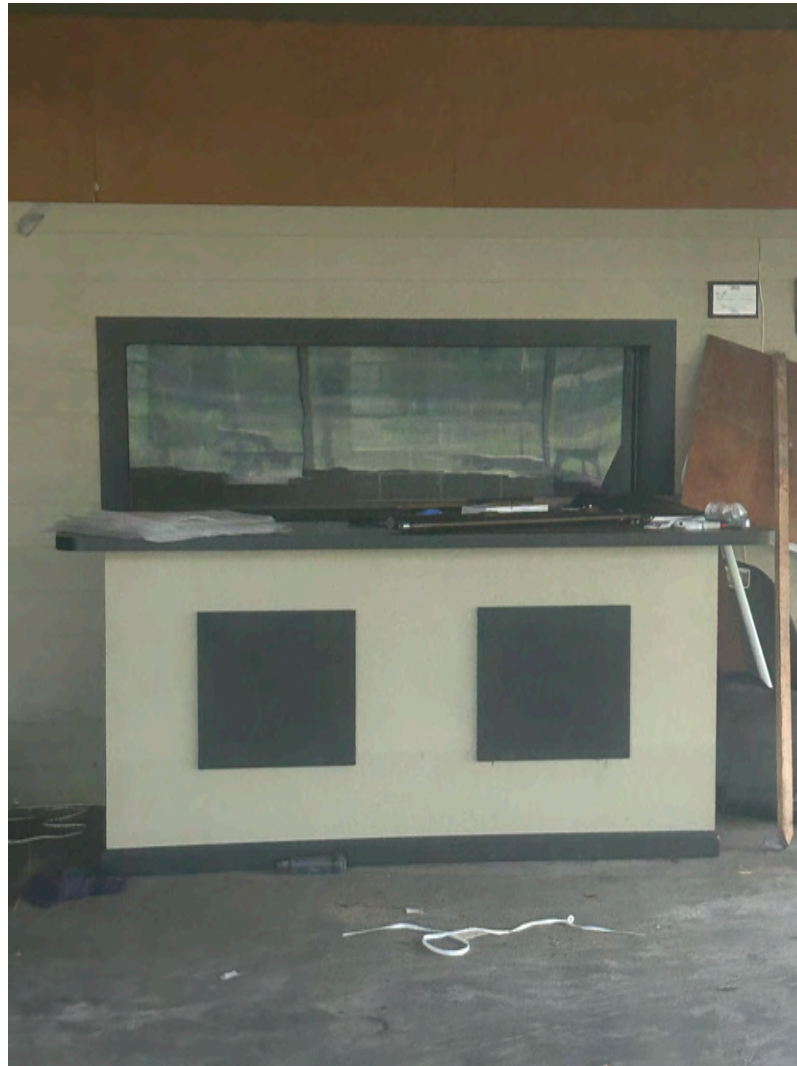
Room #: Old Cafe

Electrical (receptacle photos for reference)

6 EA dual receptacles

46 LF metal conduit 1/2" and wiring

27 SF plywood countertop 3/4"

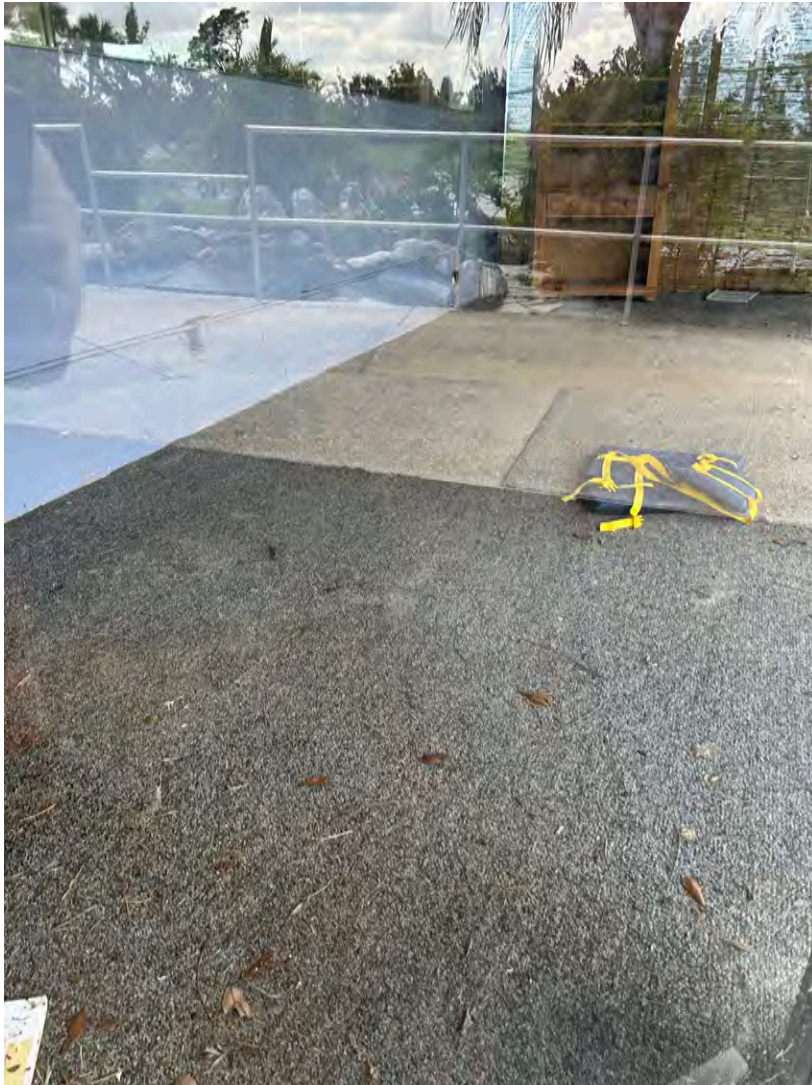
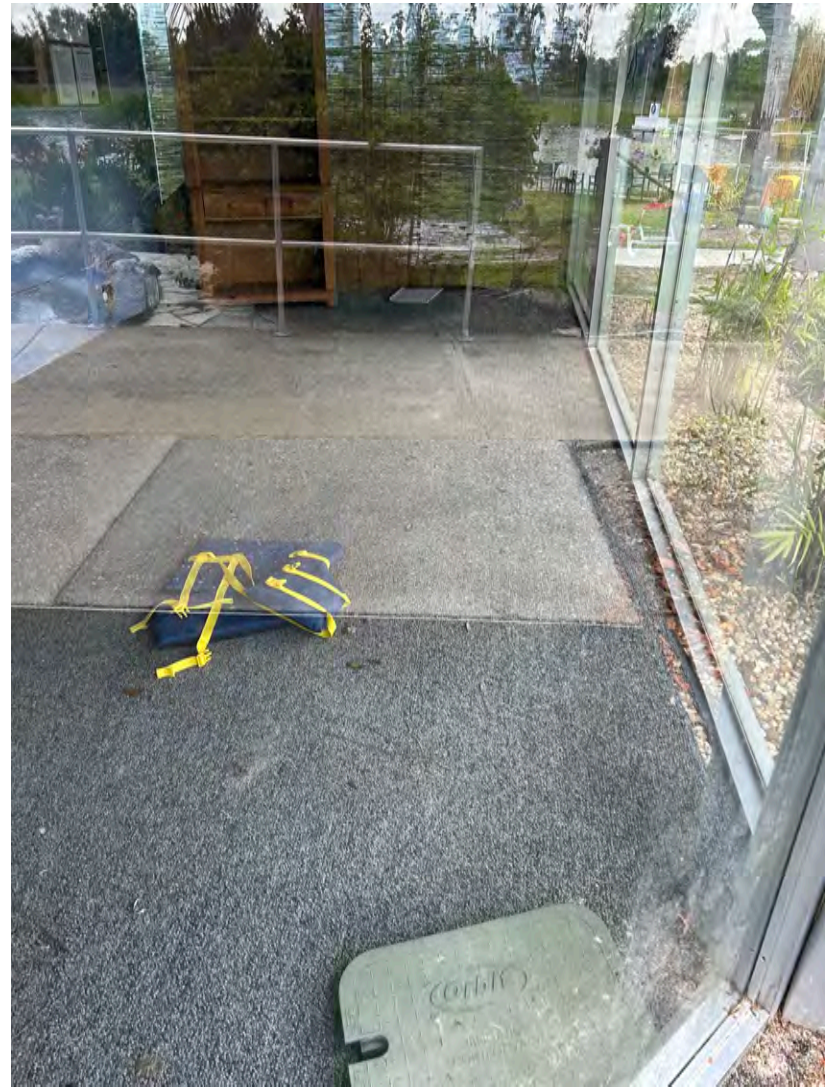
Room #: Spa Waiting Room

Flooring

220 SF commercial grade carpet (22' x 10')
