**District One
Priority Project Information Packet**

Project Name: Price Boulevard Myakkahatchee Creek Bridge Replacement

City of North Port Price Boulevard Bridge #175014 crossing Myakkahatchee Creek – Reference Attachment A.

FLORIDA DEPARTMENT OF TRANSPORTATION
BRIDGE MANAGEMENT SYSTEM
Inspection/CIDR/Bridge Profile Report
Inspection

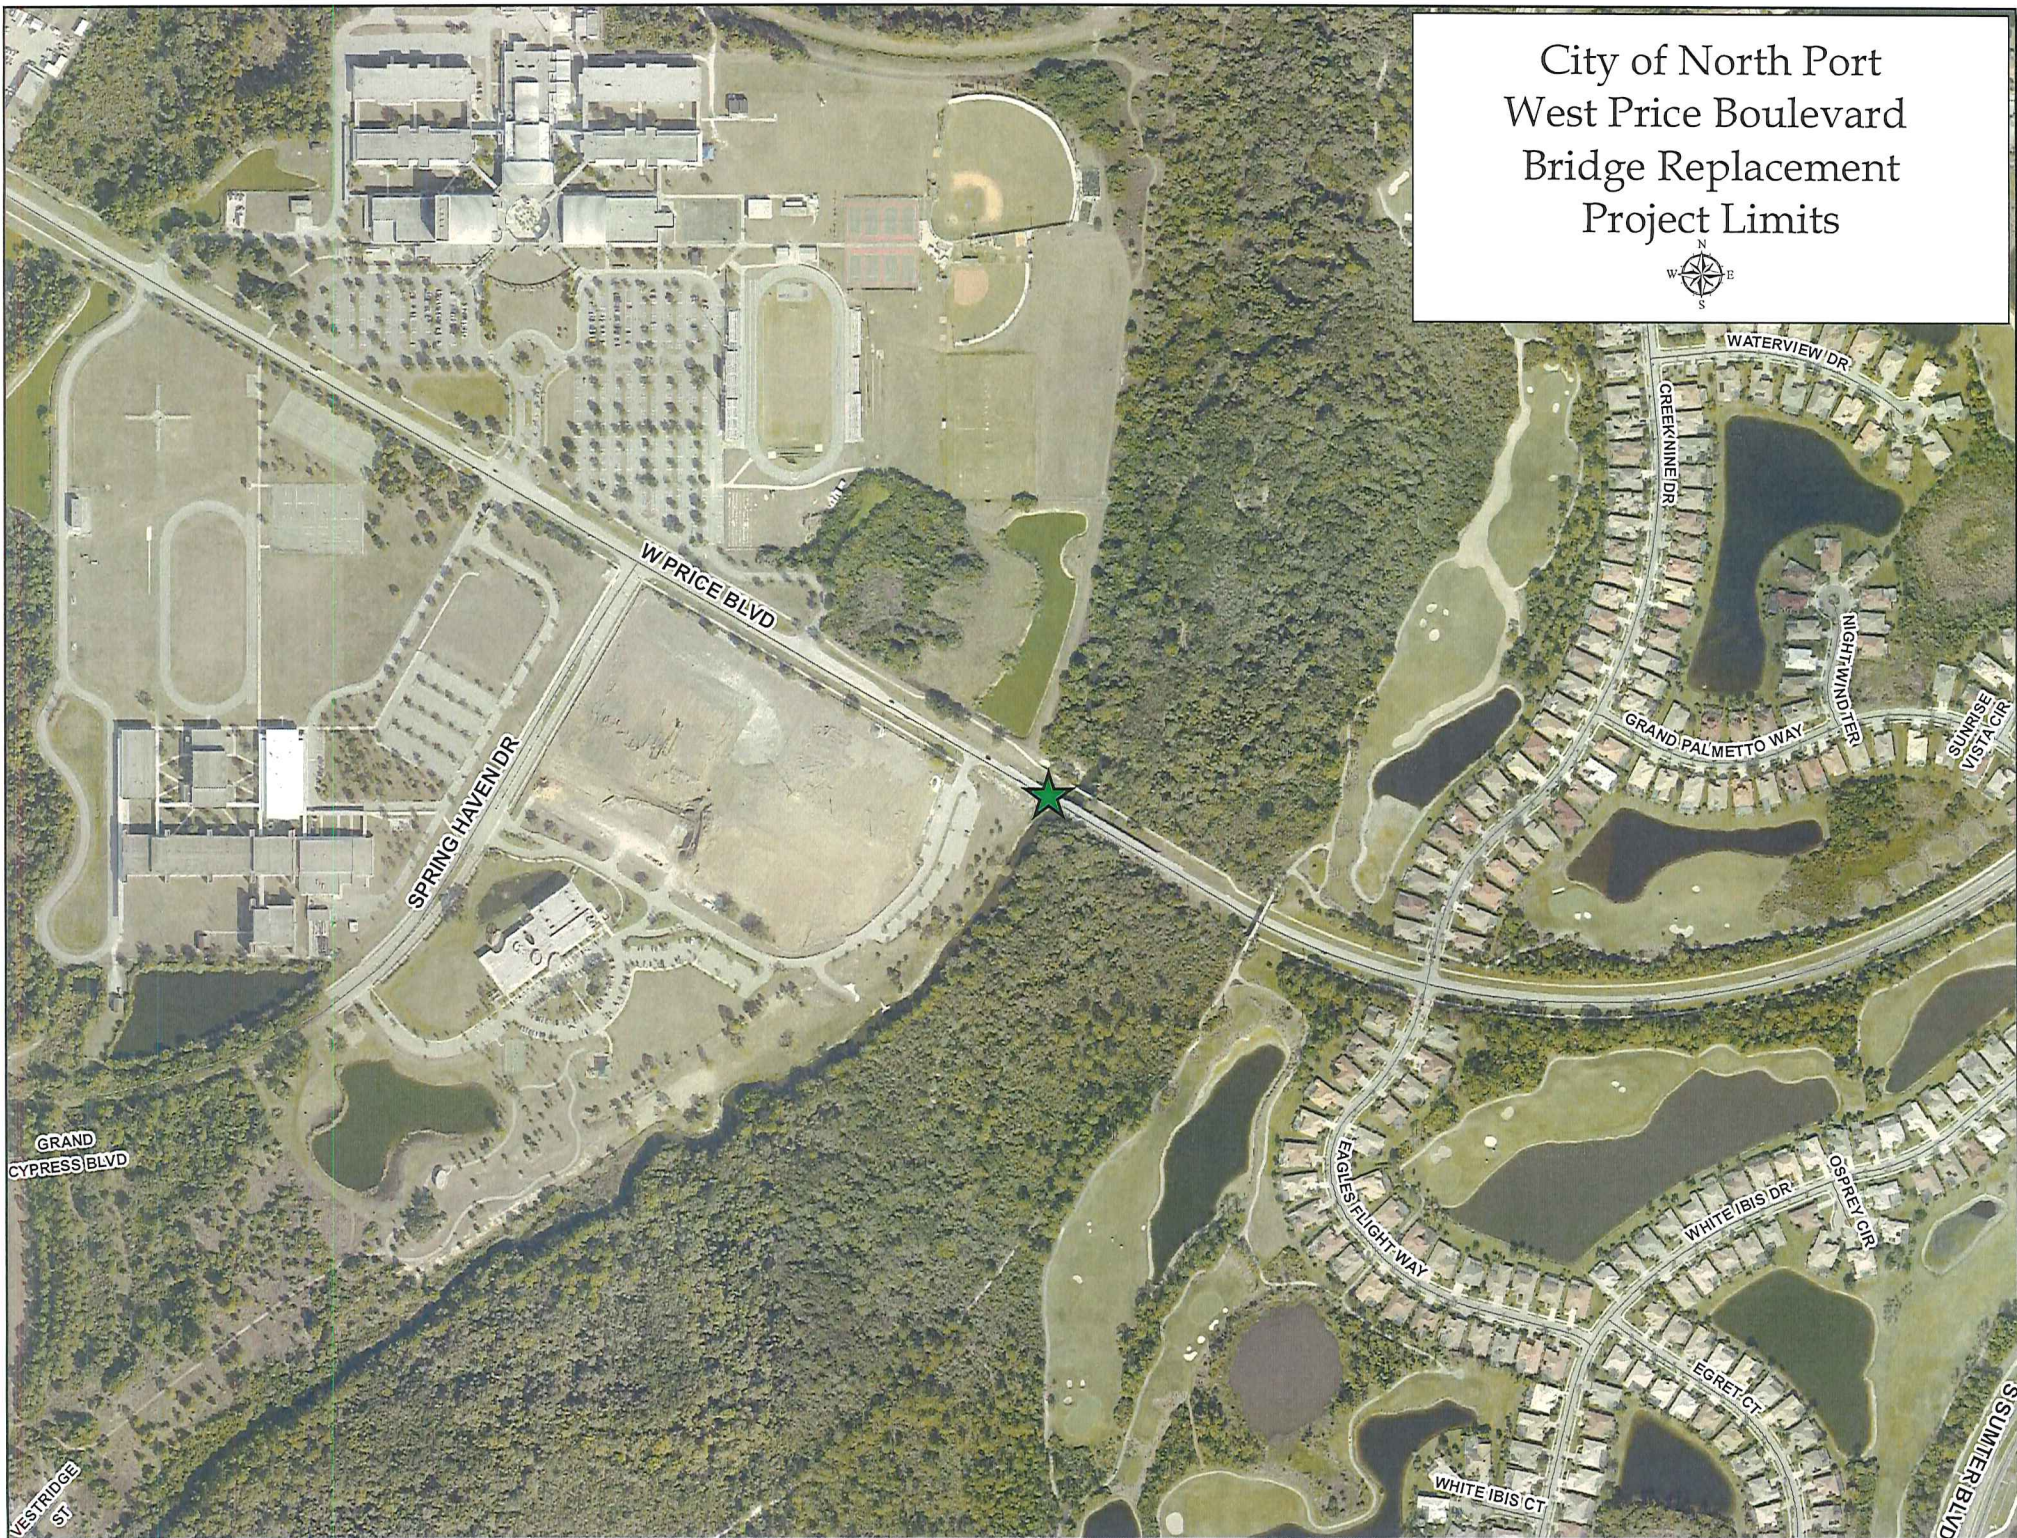
City of North Port
West Price Boulevard
Bridge Replacement
Project Limits

*MEASUREMENT IS APPROXIMATE, TEMPORARY CONSTRUCTION EASEMENT WILL BE REQUIRED TO COMPLETE THE SLOPE CONSTRUCTION.

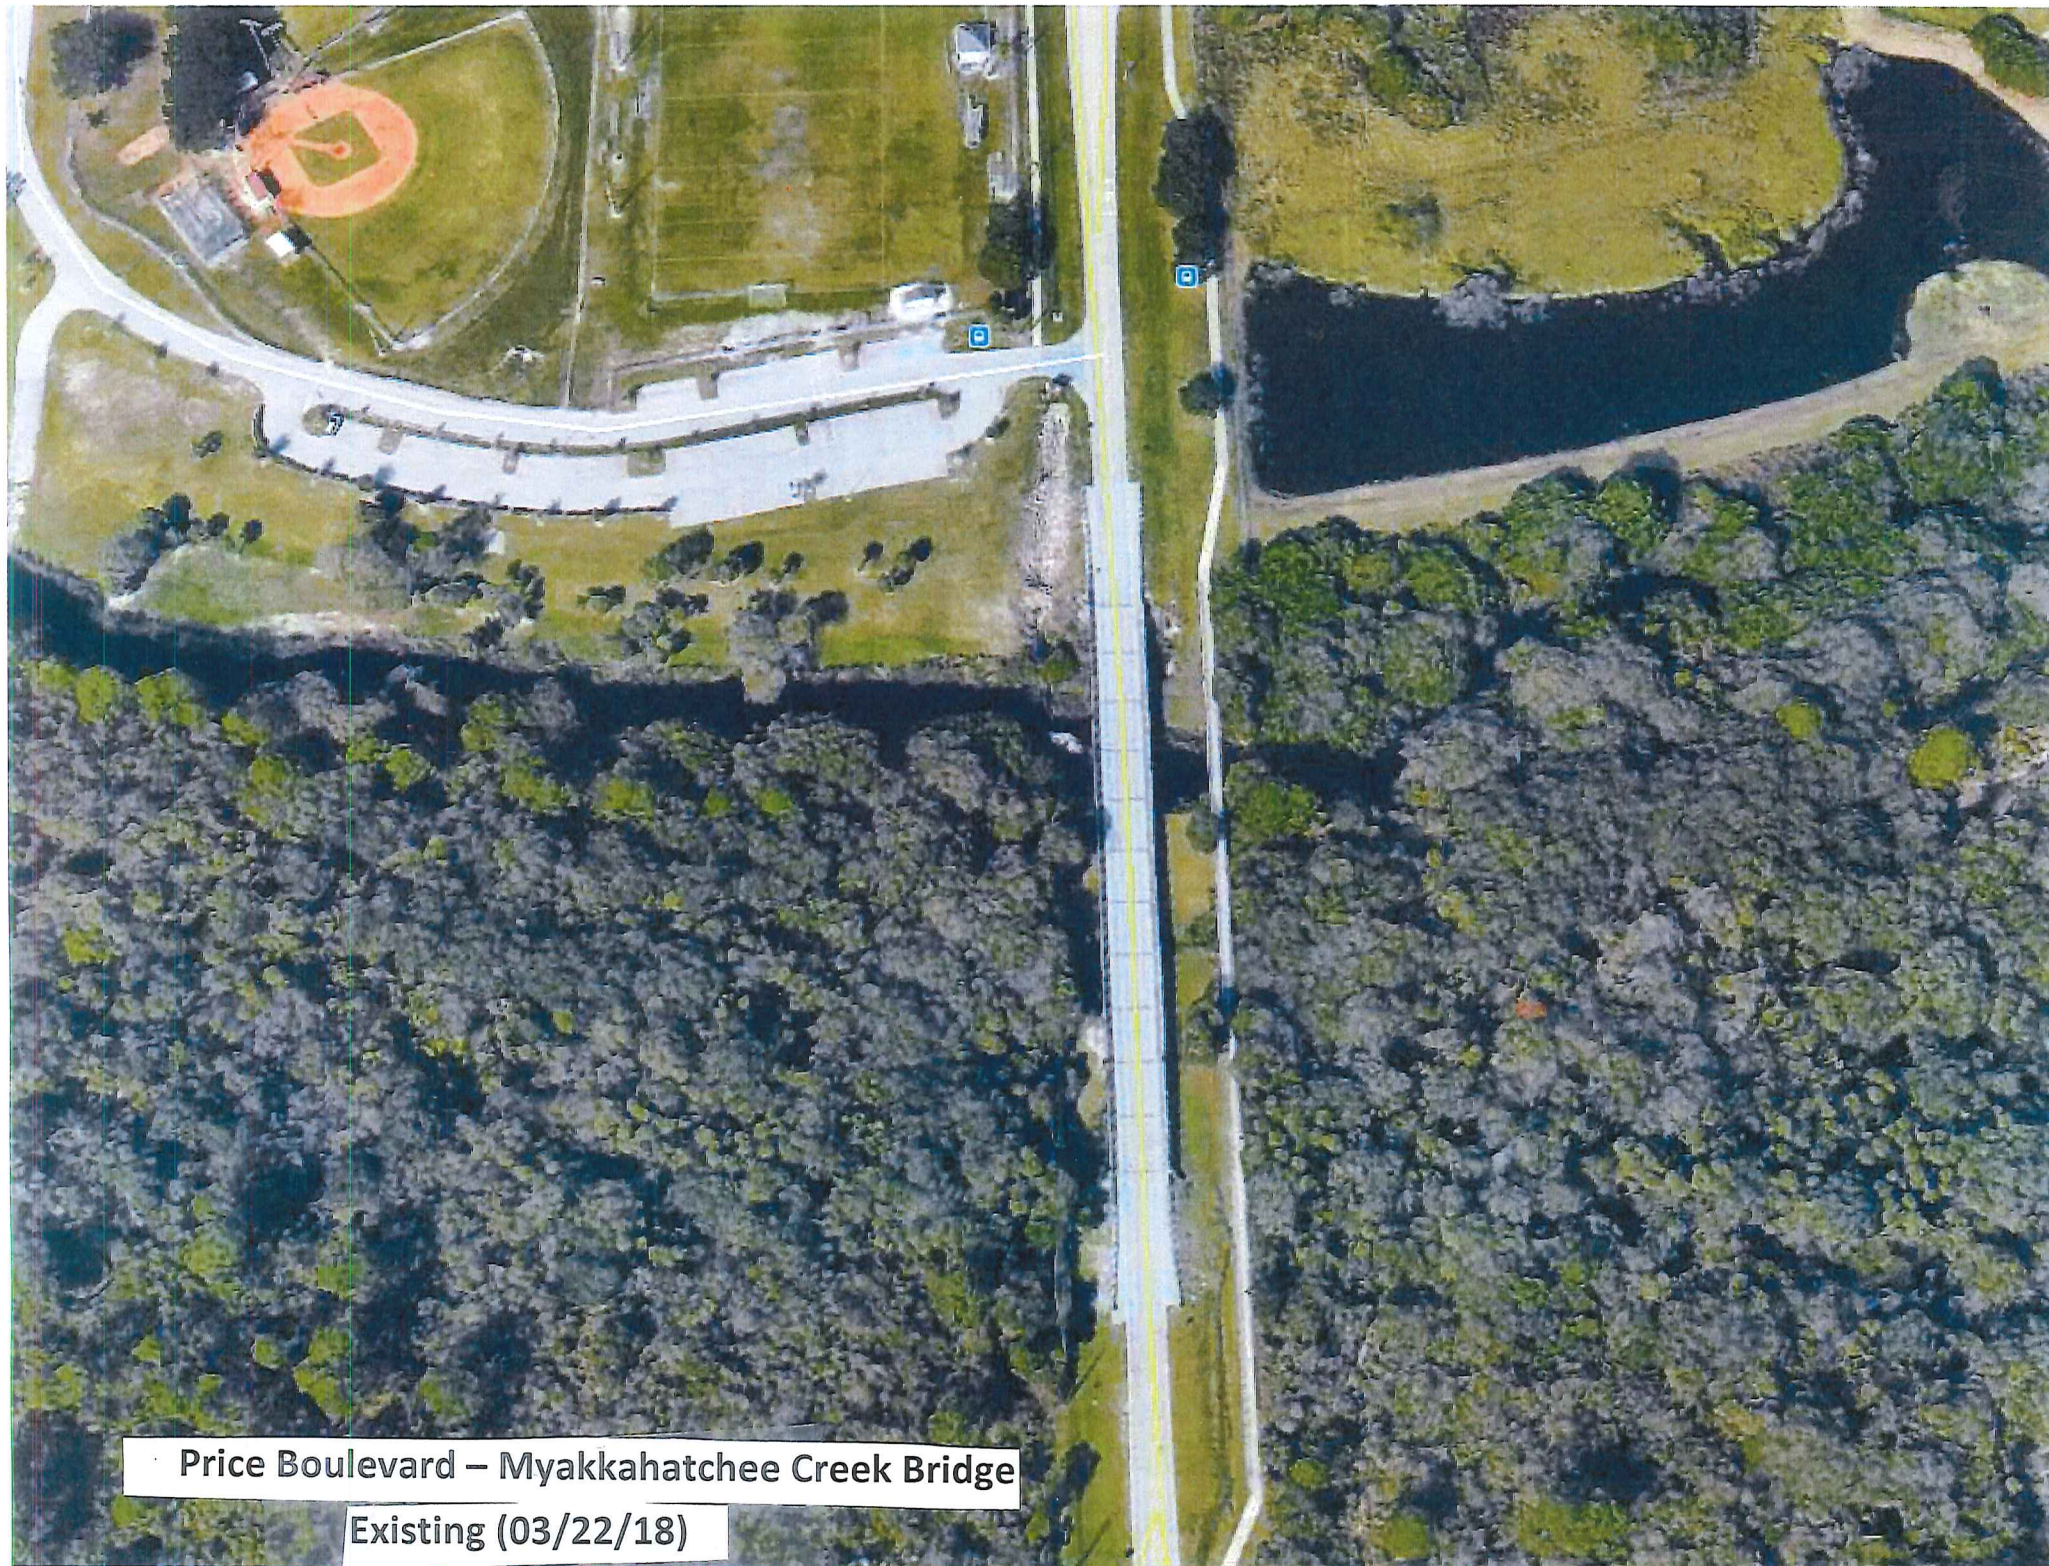
Price Boulevard – Myakkahatchee Creek Bridge

Existing (03/22/18)

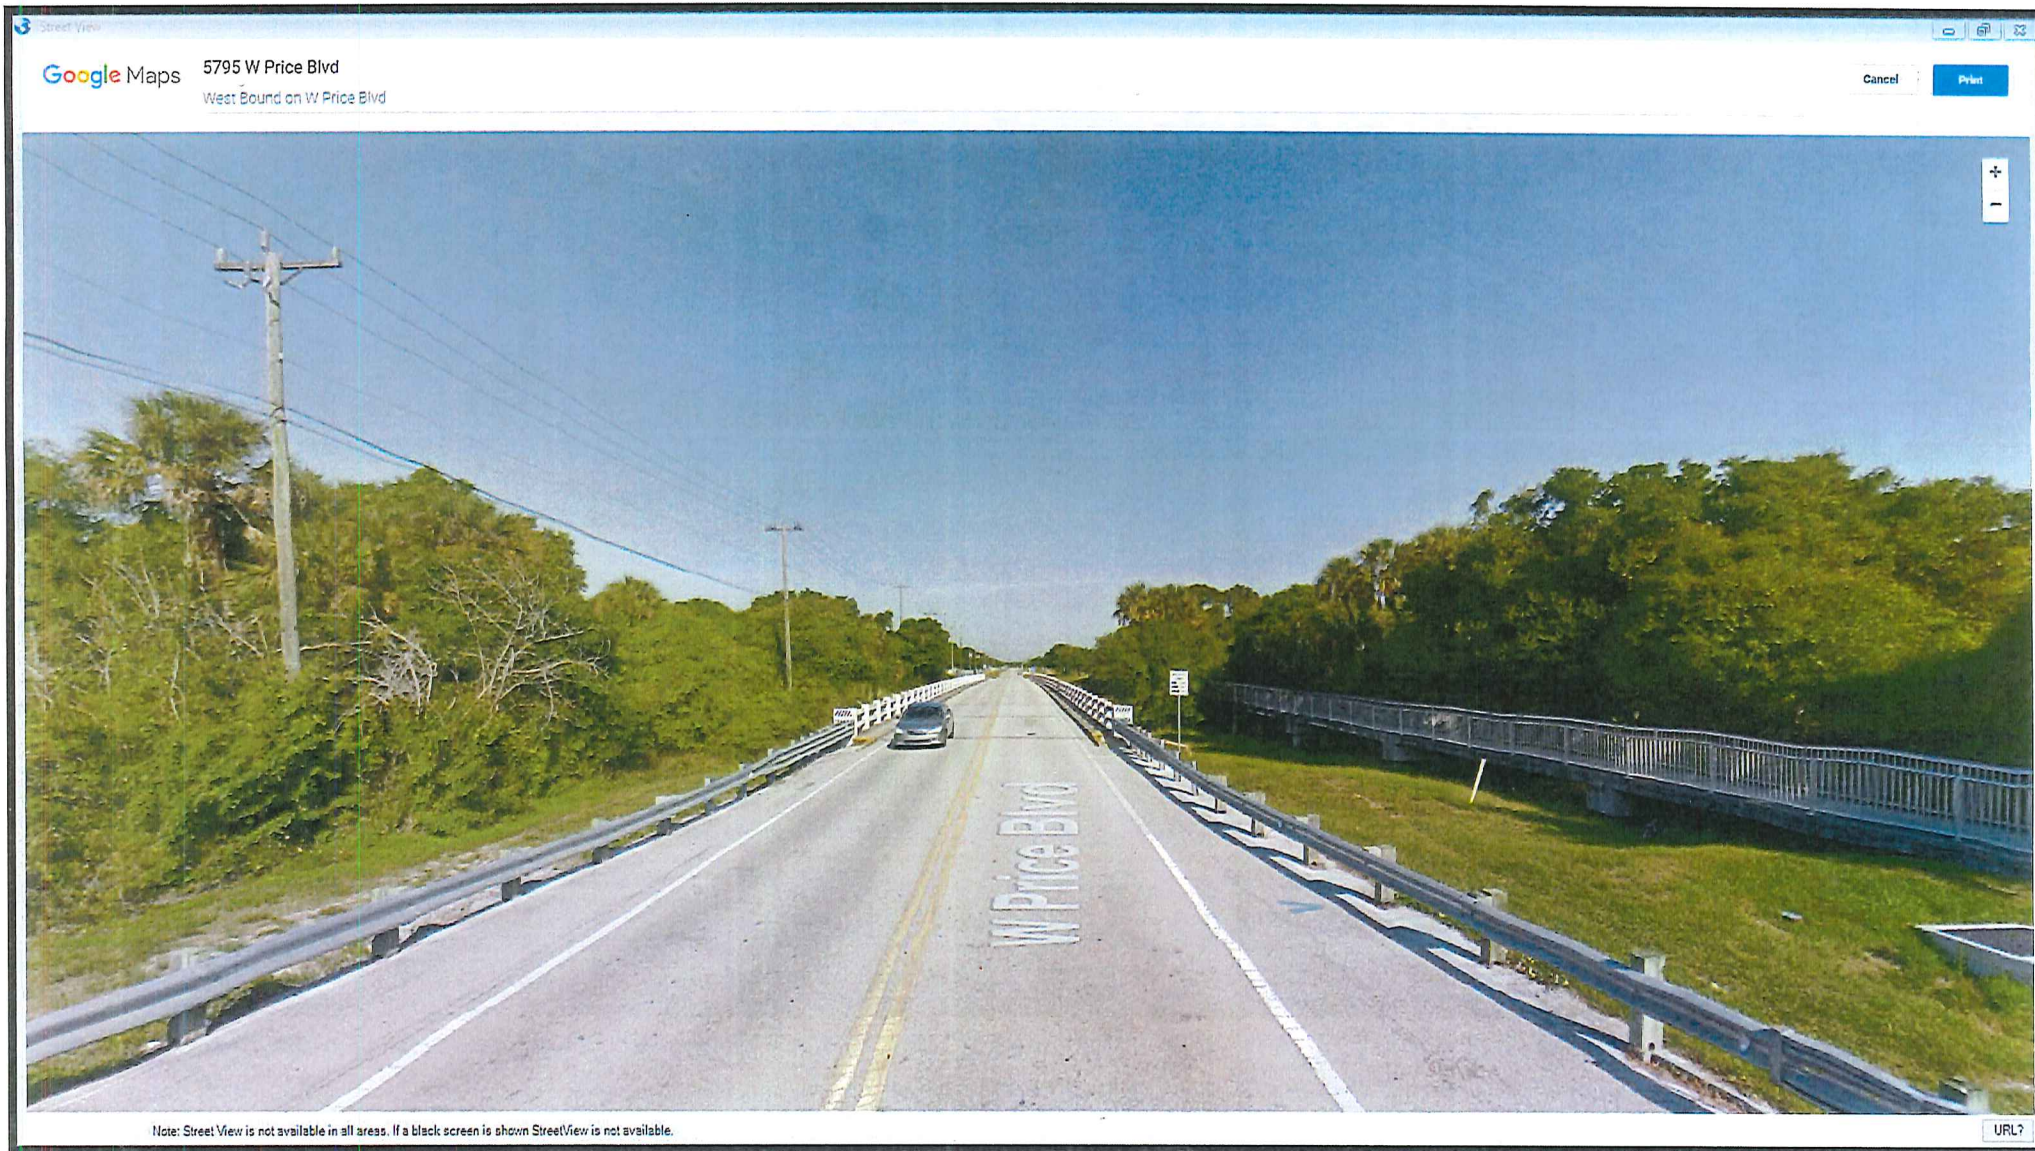
Price Boulevard – Myakkahatchee Creek Bridge – Existing (03/22/18)

Facing West

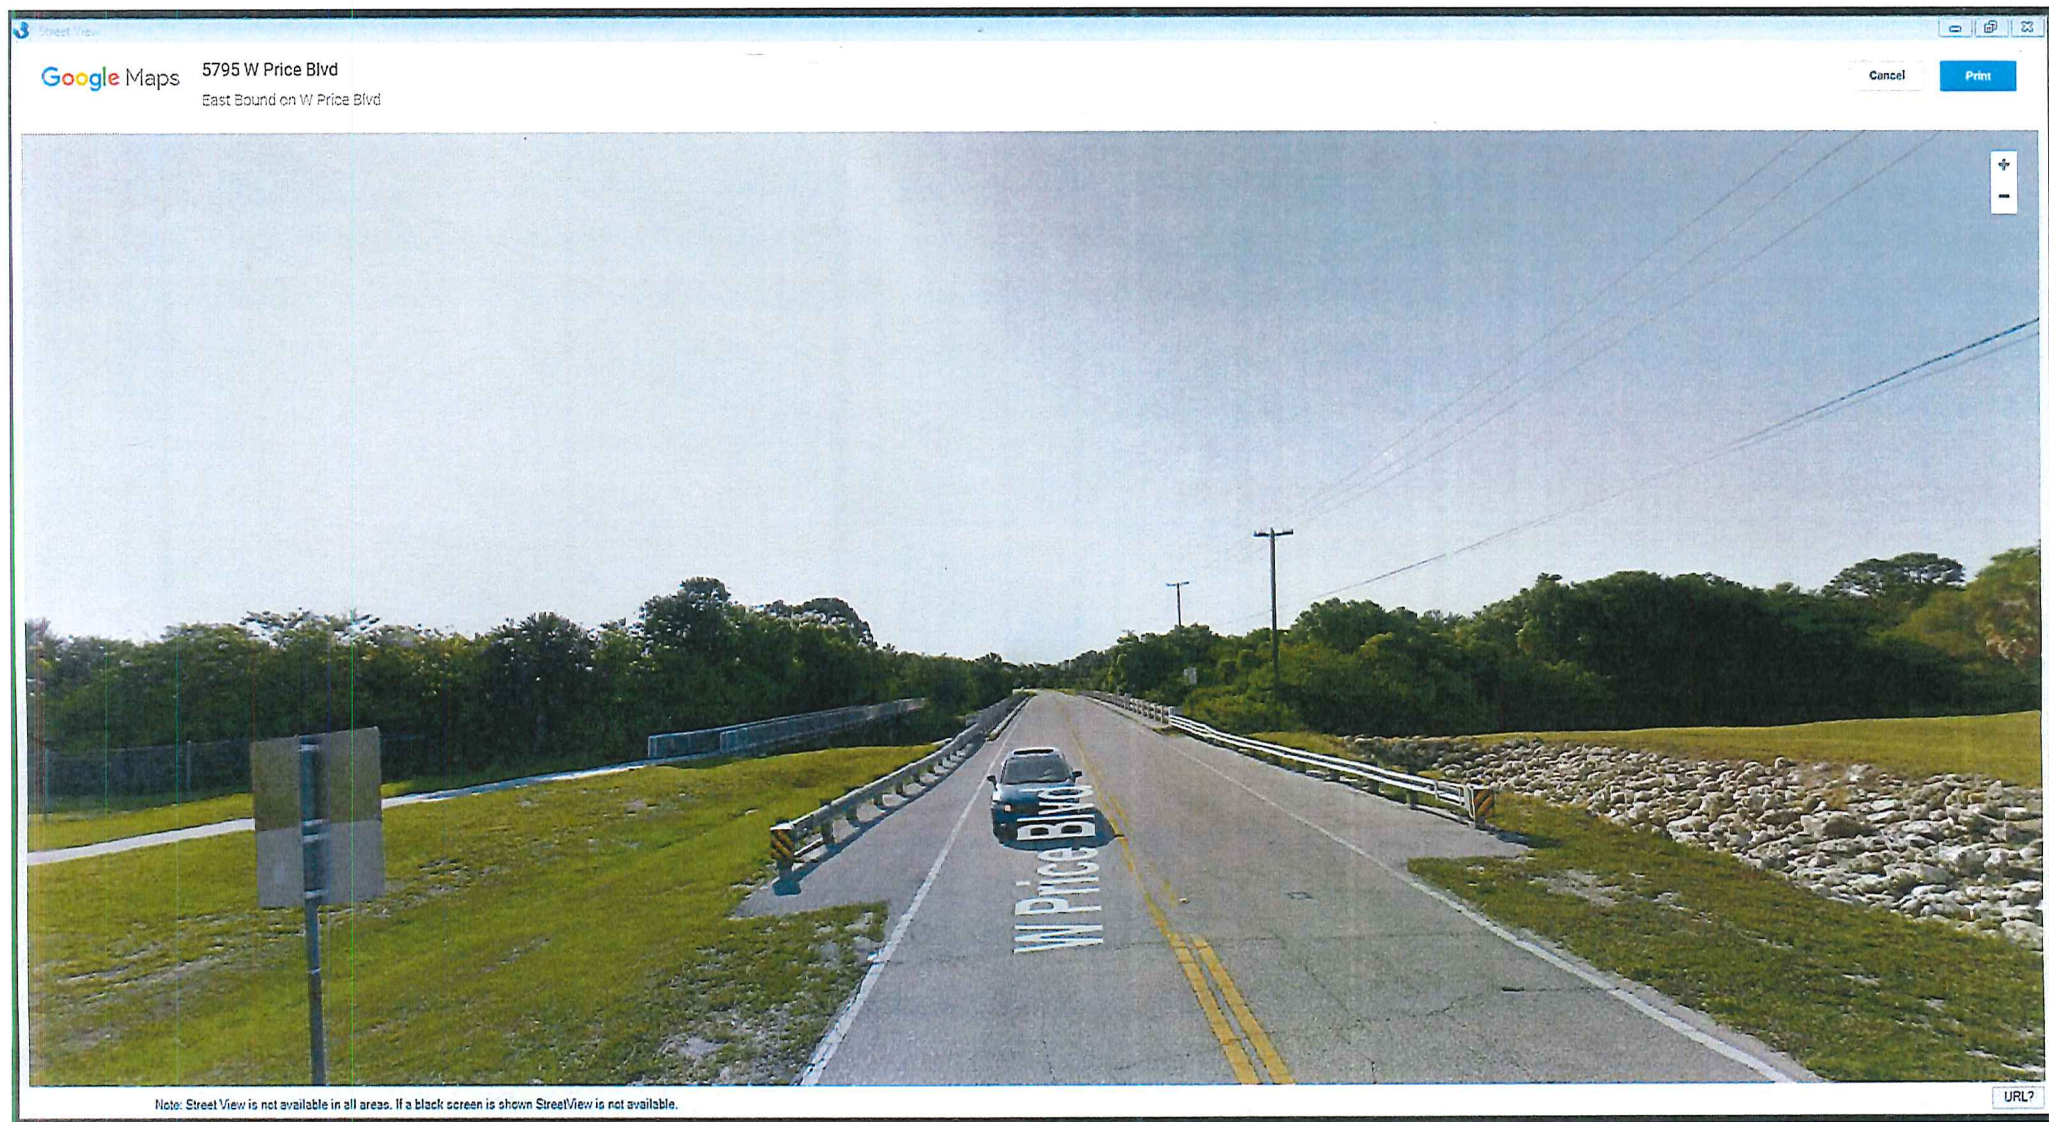
Price Boulevard – Myakkahatchee Creek Bridge – Existing (03/22/18)

Facing East

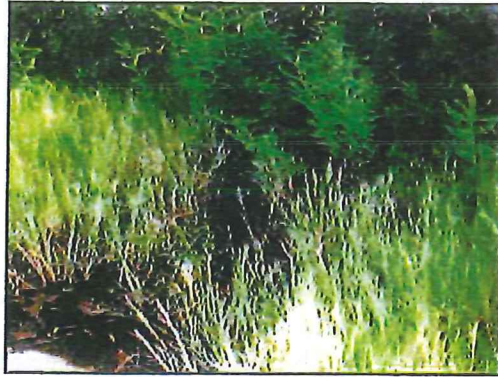
**Emergent Wetland
North Right-of-Way at Little Salt Spring Facility**

Two PEM1 wetlands encroach into the Price Boulevard right-of-way. The western-most wetland is located at the Little Salt Spring Research Facility, and extends along the north and south side of Price Boulevard. The system is slightly brackish, and is a remnant feature of a historically contiguous slough. The natural drainage of this system is to the spring to the south, which drains through a natural spring run to a series of excavated ditches. These ditches discharge to Big Slough and ultimately, the Myakka River. Vegetation within this system is periodically maintained. Vegetation to the south is moderate quality and includes soft rush (*Juncus effuses*), wax myrtle, sawgrass (*Cladium jamaicense*), and Brazilian pepper. The area is bordered by mesic hammock. Vegetation along the edge of the system to the north of the Price

Boulevard right-of-way is dominated by Brazilian pepper. Though maintained regularly, this area also contains herbaceous wetland vegetation consisting of saw grass, soft rush, and torpedo grass.

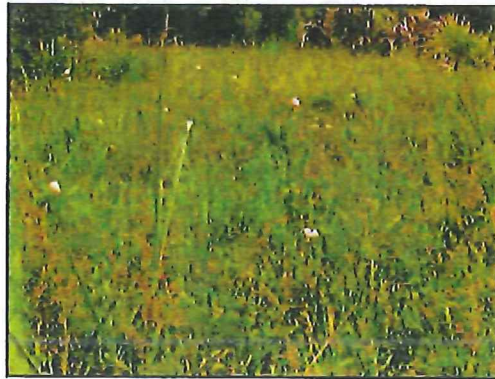
Prairie Meadow Wetland NE of Sumter Boulevard

The second PEM1 wetland system is located along the north side of the corridor east of Sumter Boulevard. This isolated, herbaceous wetland/prairie marsh system encroaches into the right-of-way north of the existing sidewalk. This wetland is of moderate to high quality. The vegetation consists of swamp lily (*Crinum* sp.), pickerelweed (*Pontederia cordata*), tickseed (*Coreopsis* sp.), milkweed (*Asclepias lanceolata*), morning-glory (*Ipomoea* sp.), buttonweed (*Diodia virginiana*), peppervine (*Ampelopsis arborea*), cattails, and prairie grasses and sedges such as foxtail (*Setaria* sp.), bluestem (*Andropogon* spp.), and torpedograss. Chinese tallow sprouts (*Sapium sebiferum*) and Carolina willow are present along the edges. Impacts to this system are anticipated to be minimal.

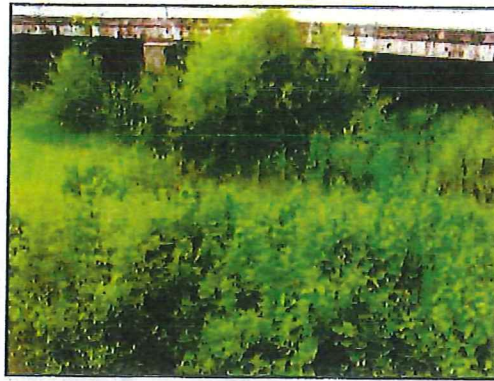
Big Slough within Price Boulevard Right-of-Way

Price Boulevard roadside swales drain into Big Slough at its bridge crossing. Just to the north of Price Blvd. is a recently constructed pedestrian bridge. Soil disturbance associated with the construction

of this bridge is evident. Vegetation within the Price Blvd. right-of-way consists of predominantly nuisance disturbance herbaceous species and shrubs. Vegetation includes Brazilian pepper, alligatorweed (*Alternanthera philoxeroides*), bermudagrass (*Cynodon dactylon*), caesarweed, primrosewillow, and hairy indigo (*Indigofera hirsuta*). The area shows signs of sedimentation and water quality degradation.

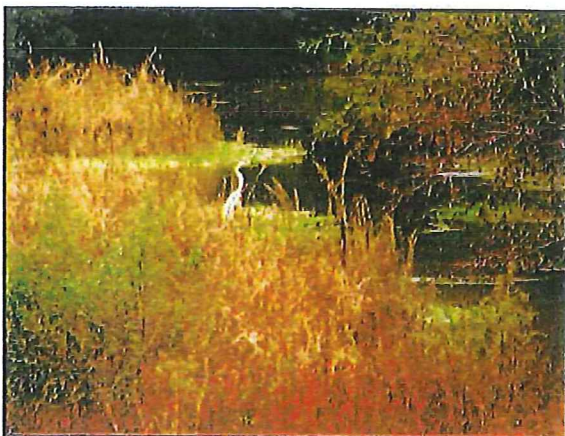
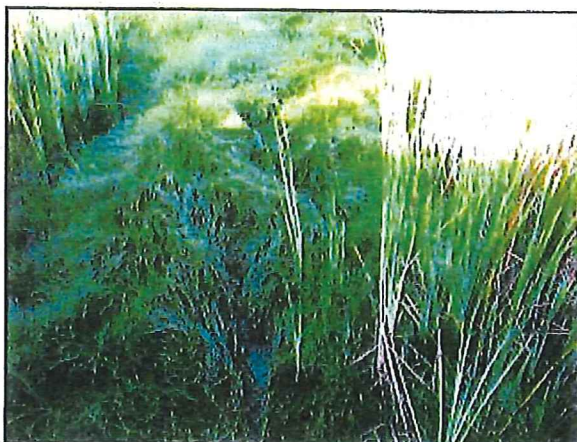
Hydric-Cut Aquatic Features along Price Boulevard

Eleven (11) hydric-cut aquatic features intercept the Price Boulevard right-of-way. In general, these excavated features flow southwest and appear to be part of historic sloughs or wetlands. Many of these water features exhibit poor water quality near the roadway structures including rust from culverts, oil sheen from vehicles, and prolific invasive species such as cattails and primrose willow. The majority of these features contain large areas of open water. Many contain vegetated slopes and littoral zones. The littoral zone community varies with depth of excavation within these systems. Typical vegetation includes torpedo grass, pickerelweed (*Pontederia cordata*), cattails, arrowhead (*Sagittaria latifolia*), primrose willow, Brazilian pepper, smartweed (*Polygonum* sp.), maidencane (*Panicum hemitomon*) and water lettuce (*Pistia Stratiotes*). Perimeter (buffer) vegetation include cabbage palm hammocks, mesic hammock and pine flatwoods.

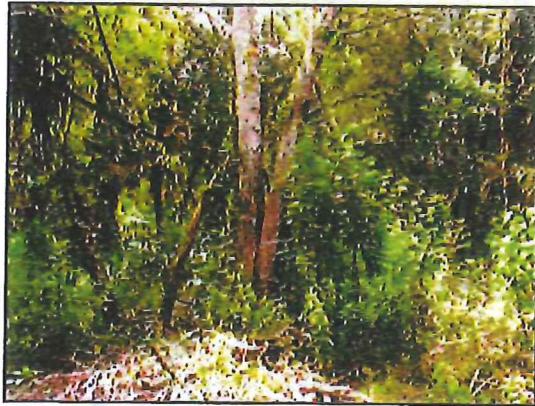
Forested Wetland Southeast of Sumter Boulevard

One forested wetland system was identified just east of Sumter Boulevard on the south side of Price Boulevard. This wetland appears to be part of an isolated system within a predominantly flatwoods landscape. Its NWI classification is Palustrine Forested Broad-Leaved Deciduous and Evergreen, Seasonally Flooded (PFO1/2C). The dominant vegetation includes a canopy of laurel oak and cabbage palm with a significant understory of Brazilian pepper and other disturbance species. The minimal groundcover includes caesarweed, arrow-head, and peppervine. The portion of this wetland encroaching into the Price Boulevard right-of-way has been maintained and contains a dominance of wetland forbs and sedges. Impacts to this system are anticipated to be minimal.

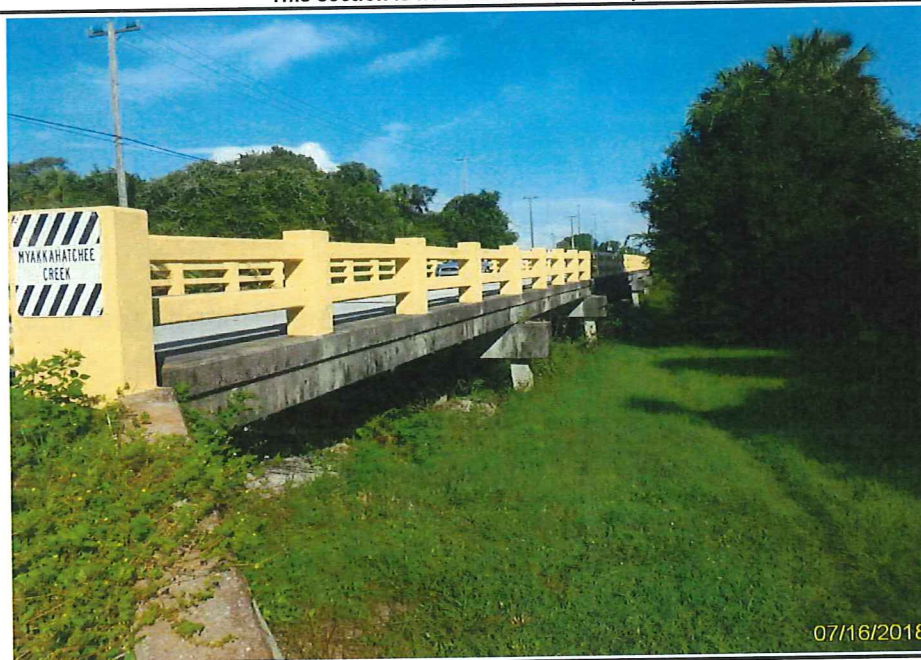
Price Blvd. over Myakkahatchee Creek

0.8 Mile West of Sumter Blvd.

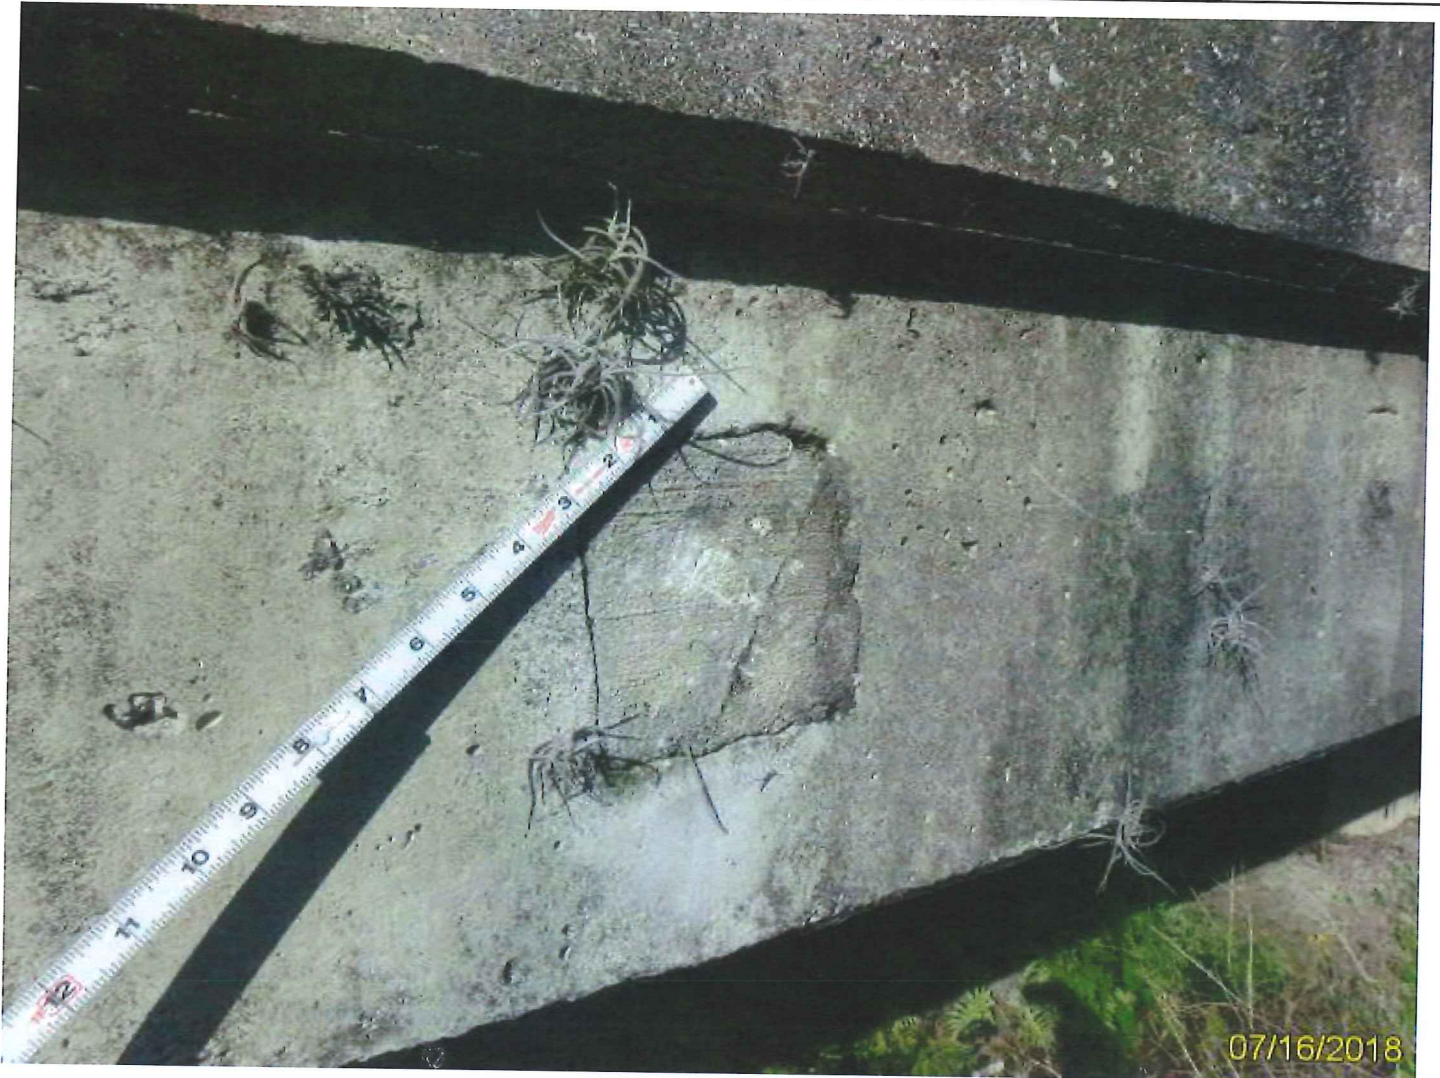
Photo 1 - Element 8099 PS Conc Slab (Sonovoid)

CS3 1080 = The left and right fascias have patches covering the transverse post-tension rod ends. These patches are unsound intermittently throughout up to 5in. x 5in. with Slab Unit 1-5 north face being spalled - INCREASE. Refer to photo 1. (20SF)

The north face of Slab Unit 5-1 has a exposed post tension rod bolt with light corrosion - NEW. Refer to photo 3.

Spalled post tension rod patch with light corrosion on the post tension bolt

REPAIR RECOMMENDATION:
None

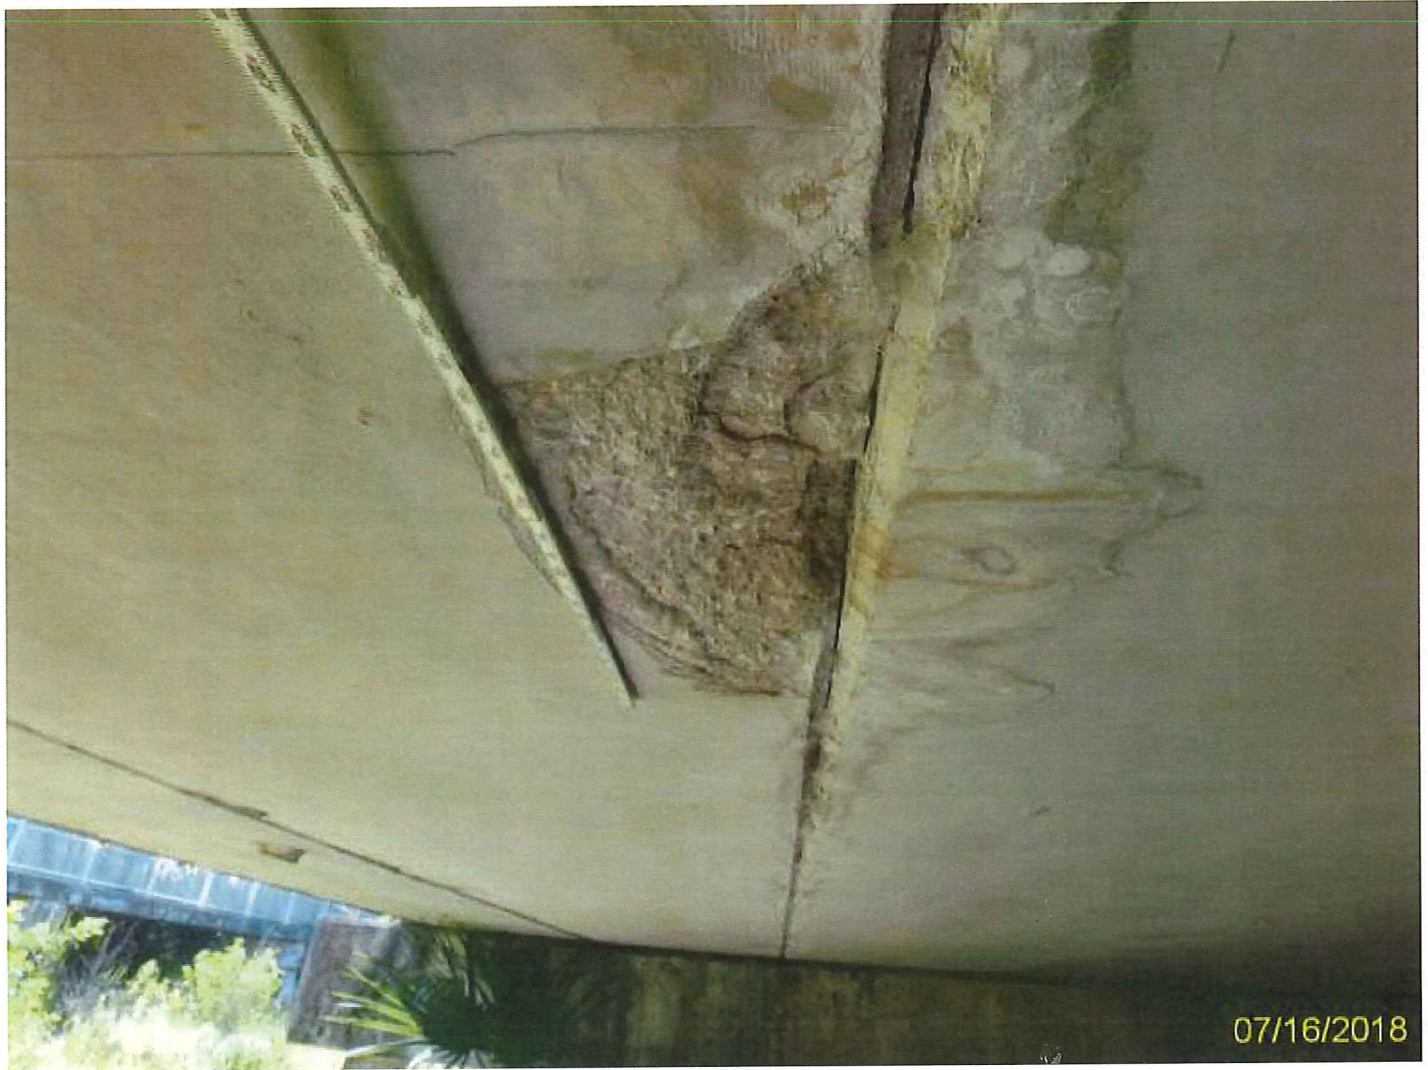
Photo 2 - Element 8099 PS Conc Slab (Sonovoid)

CS3 1080 = Slab Unit 6-2, right edge, has a 22in. x 9in. x 2in. spall near mid-span. Refer to photo 2. REPAIR (2SF)

Spall in the right edge of Slab Unit 6-2 near mid-span

REPAIR RECOMMENDATION:

Repair spalls in Slab Units 1-4 1-8 6-2 and 11-7.

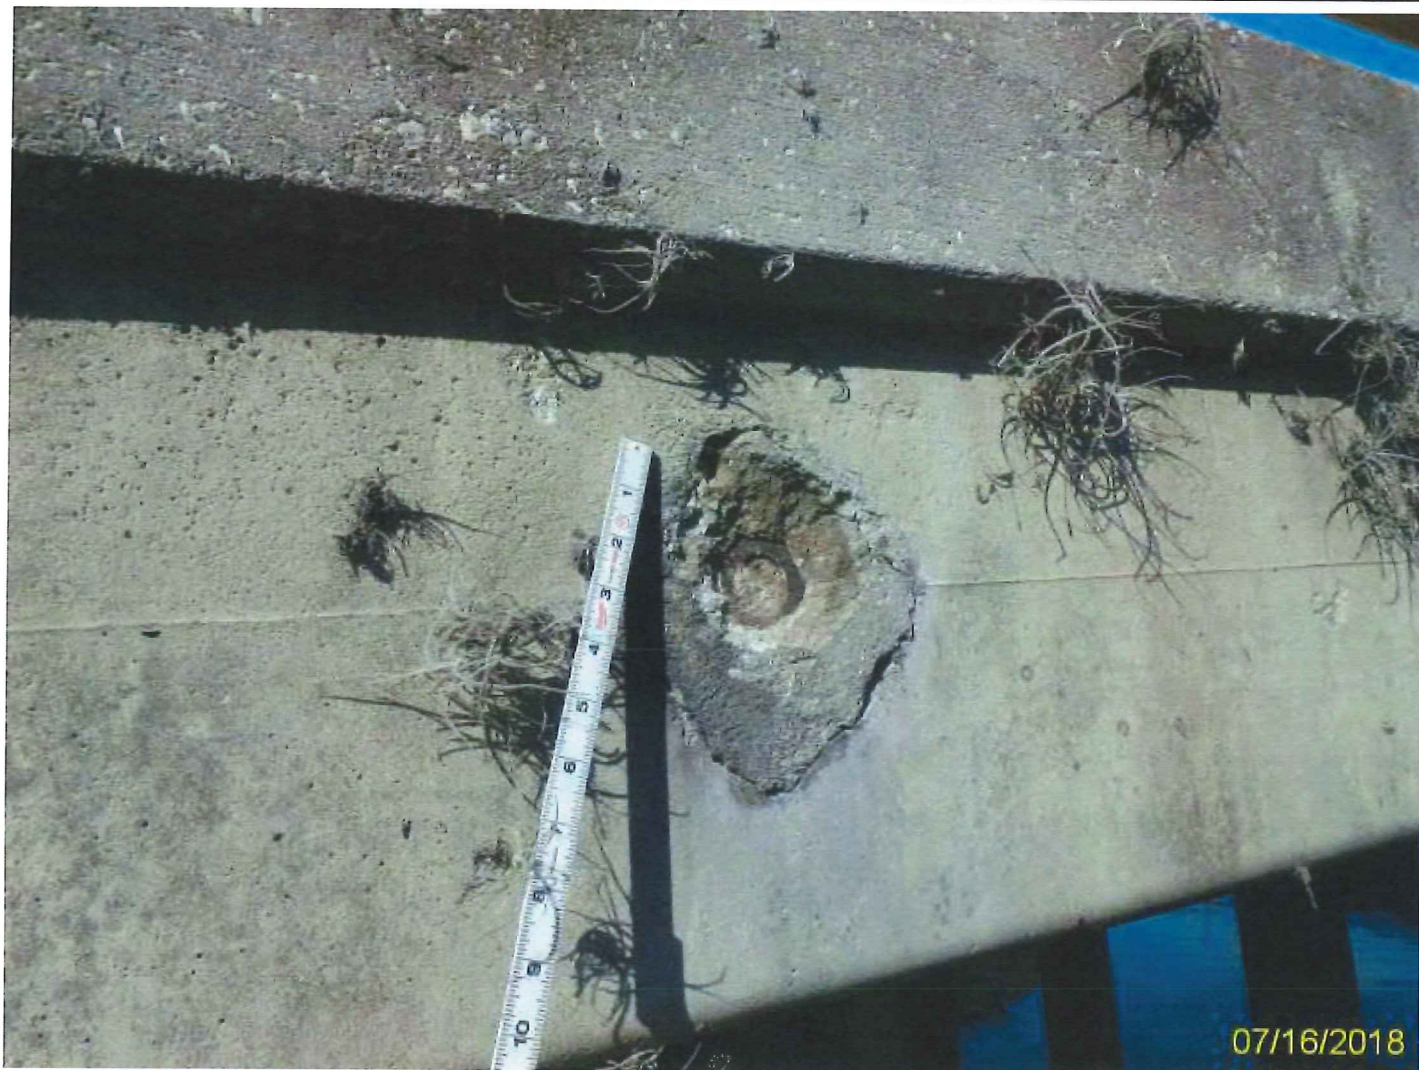
Photo 3 - Element 8099 PS Conc Slab (Sonovoid)

Exposed post tension rod bolt Slab Unit 1-5

REPAIR RECOMMENDATION:
None

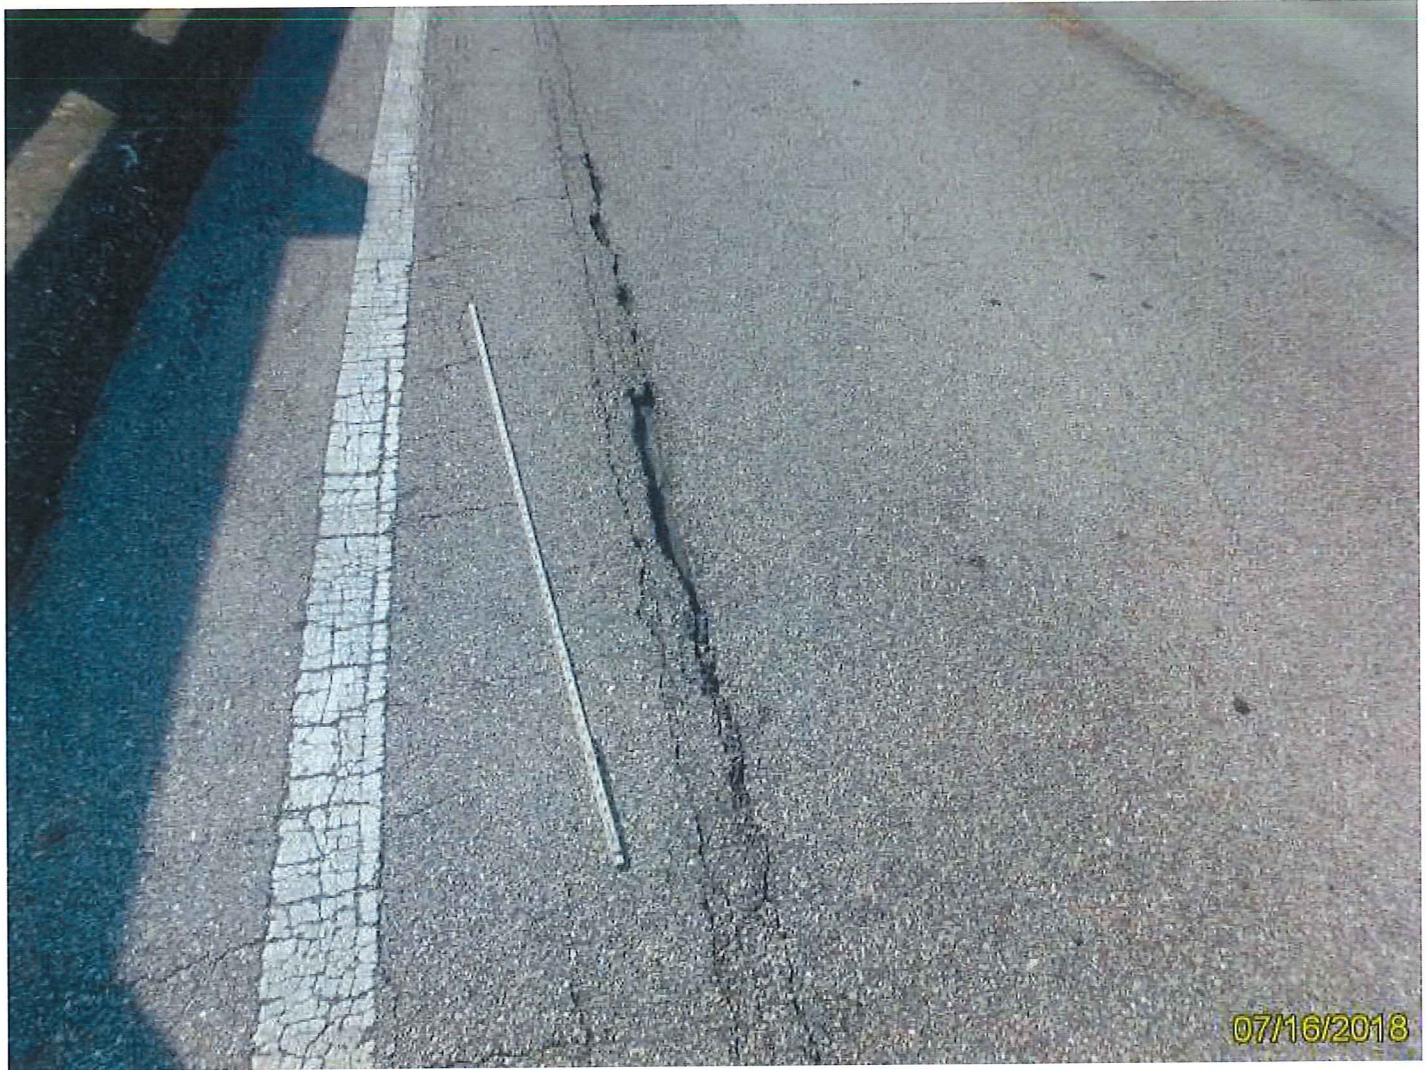
Photo 4 - Element 8099 PS Conc Slab (Sonovoid) (510 Wearing Surfaces)

CS3 3220 = Span 3, Lane 1 has an 8ft. long x 5in. wide x 2in. deep pothole in the left wheel path - NEW. Refer to photo 4. REPAIR (40SF)

Pothole in Span 3 left wheel path

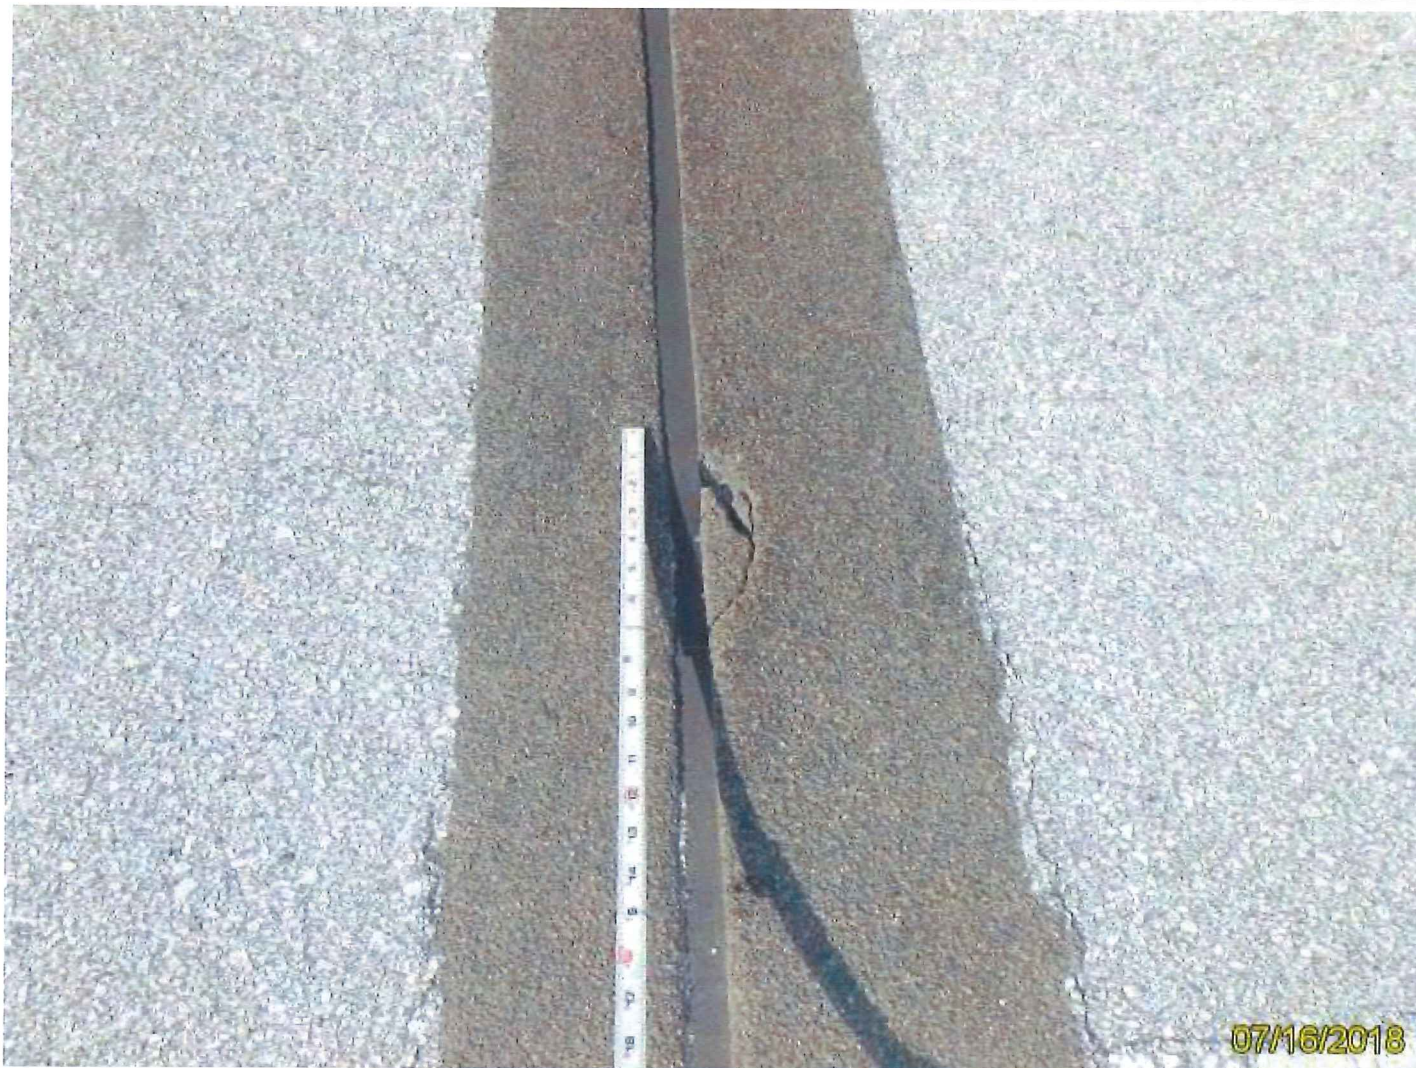
Photo 5 - Element 301 Pourable Joint Seal

CS3 2360 = Bent 8 joint, Lane 1, right wheel path has a delamination in the header 6in. long x 1-1/2in. wide. Refer to photo 5. REPAIR (1FT)

Bent 8 joint, Lane 1, right wheel path delamination in the header

REPAIR RECOMMENDATION:
