**District One
Priority Project Information Packet**

Project Name: Price Boulevard Myakkahatchee Creek Bridge Replacement

City of North Port Price Boulevard Bridge #175014 crossing Myakkahatchee Creek – Reference Attachment A.

FLORIDA DEPARTMENT OF TRANSPORTATION
BRIDGE MANAGEMENT SYSTEM
Inspection/CIDR/Bridge Profile Report
Inspection

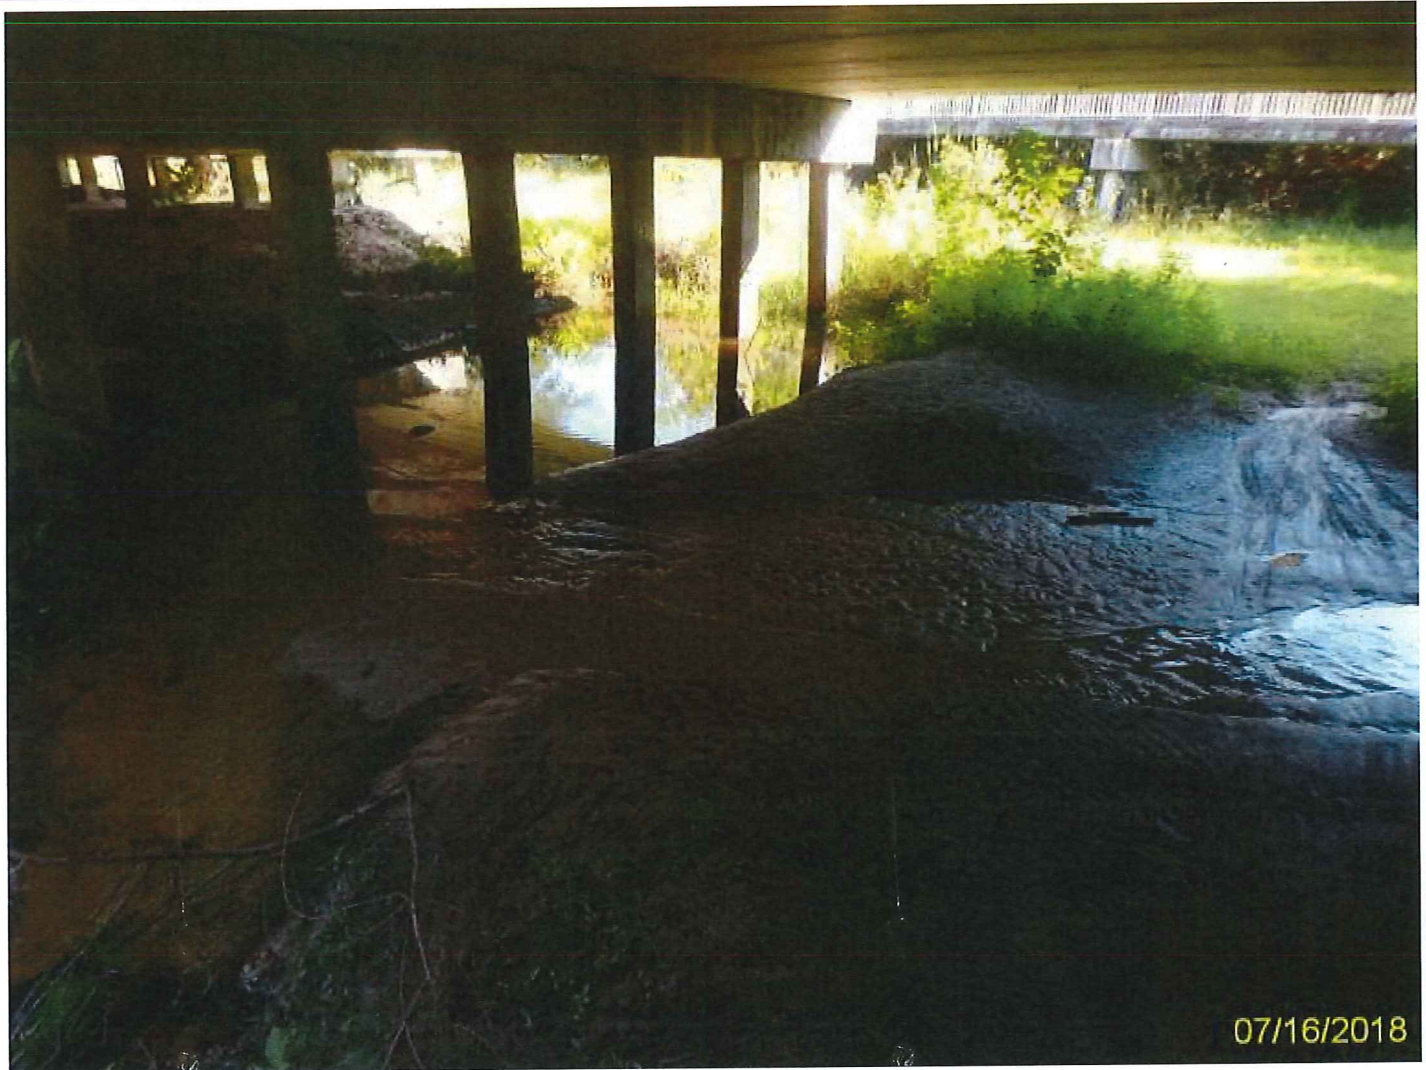
Photo 6 - Element 8290 Channel

Erosion trenches under Bent 8

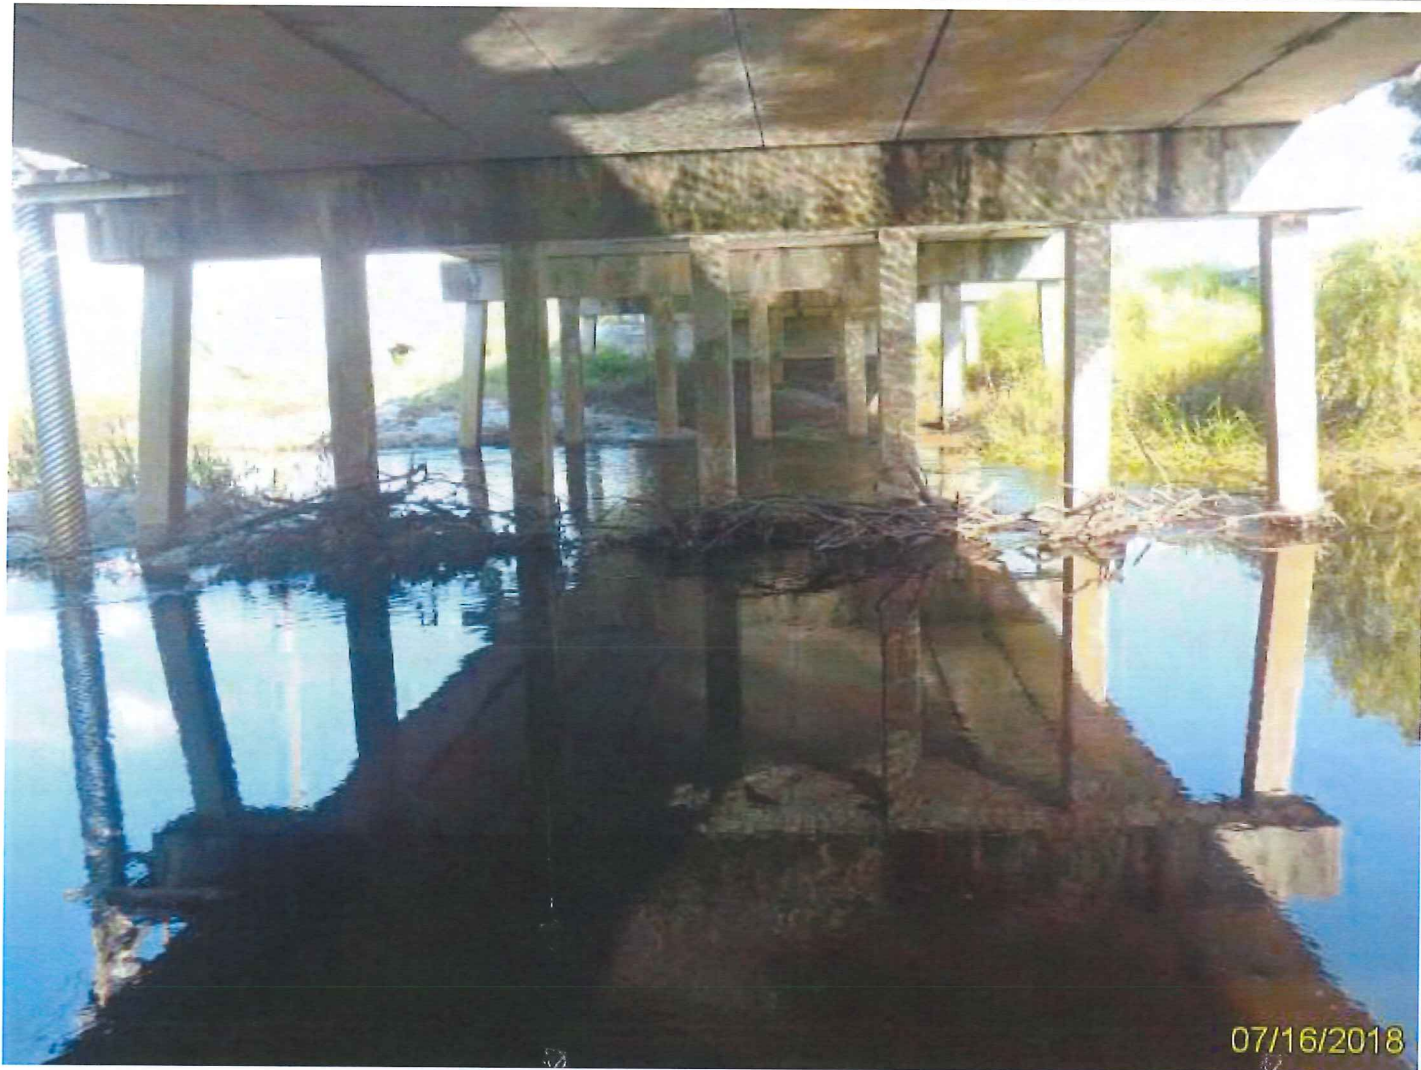
Photo 7 - Element 8290 Channel

Debris around Bent 4

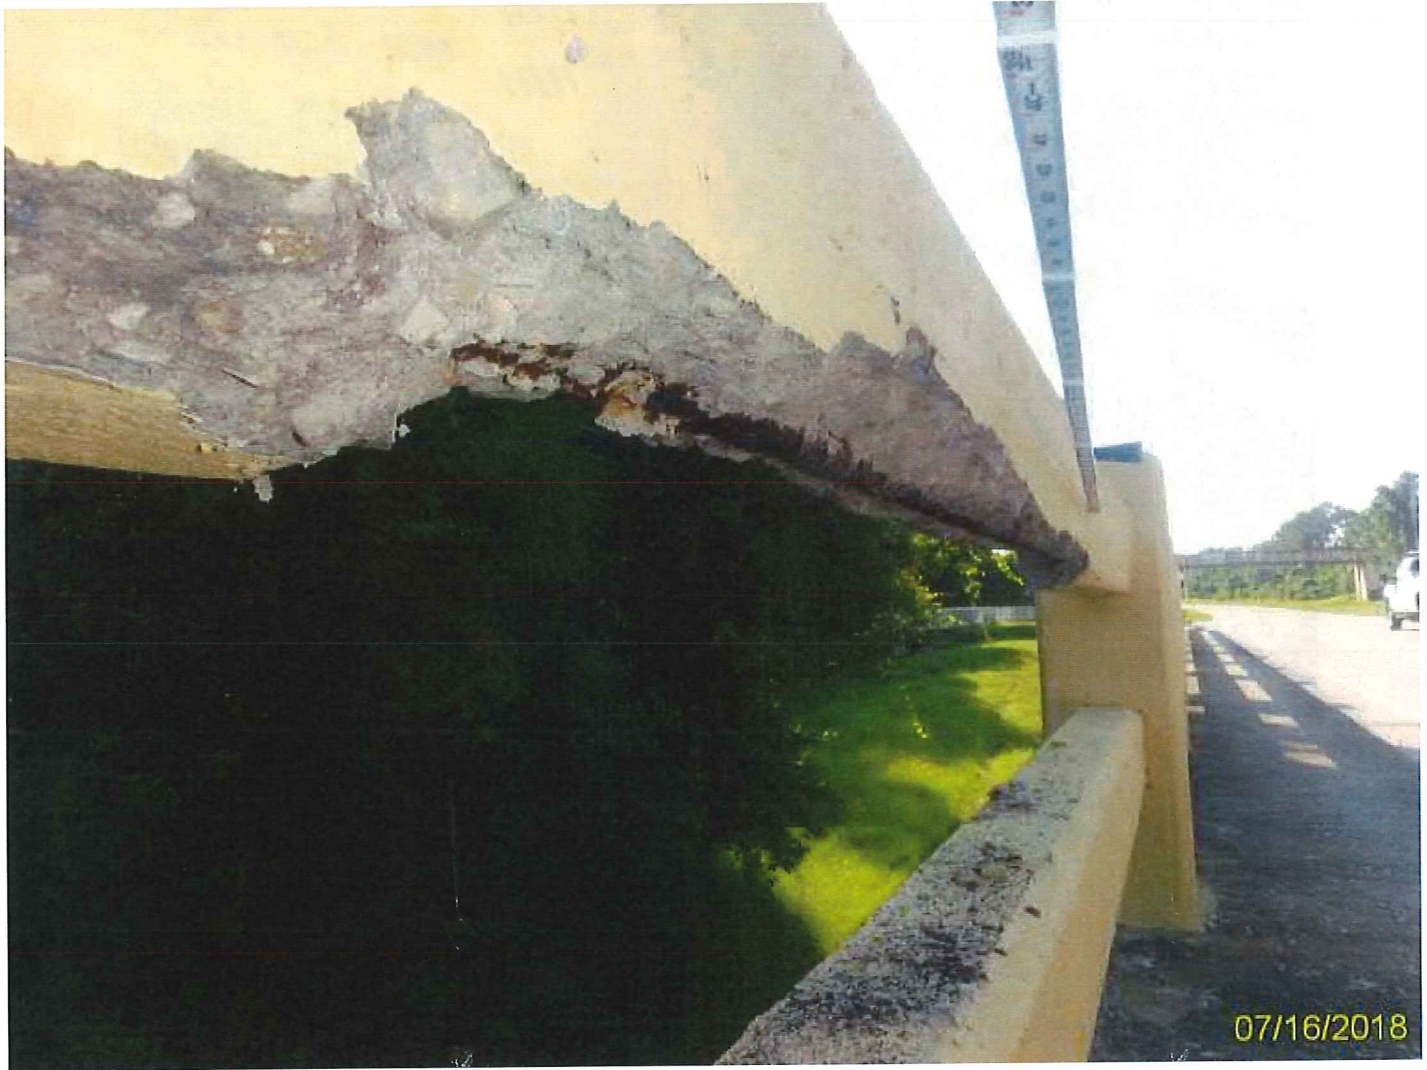
Photo 8 - Element 331 Re Conc Bridge Railing

Spall with exposed and painted rebar in top rail between Posts 9-2 and 9-3 left

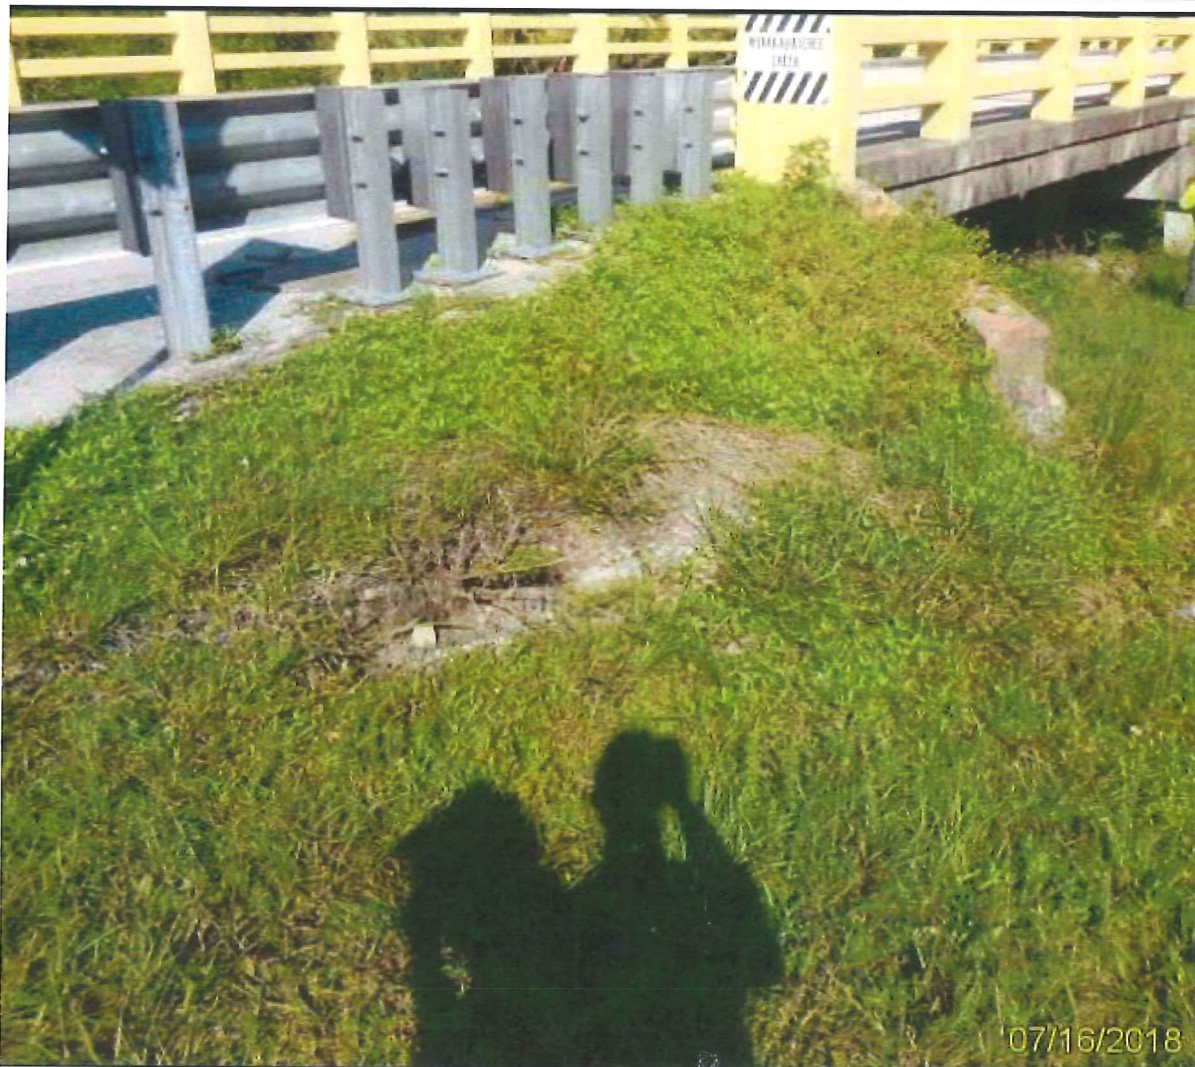
Photo 9 - Inspection Notes

Area of erosion at the northeast approach slope

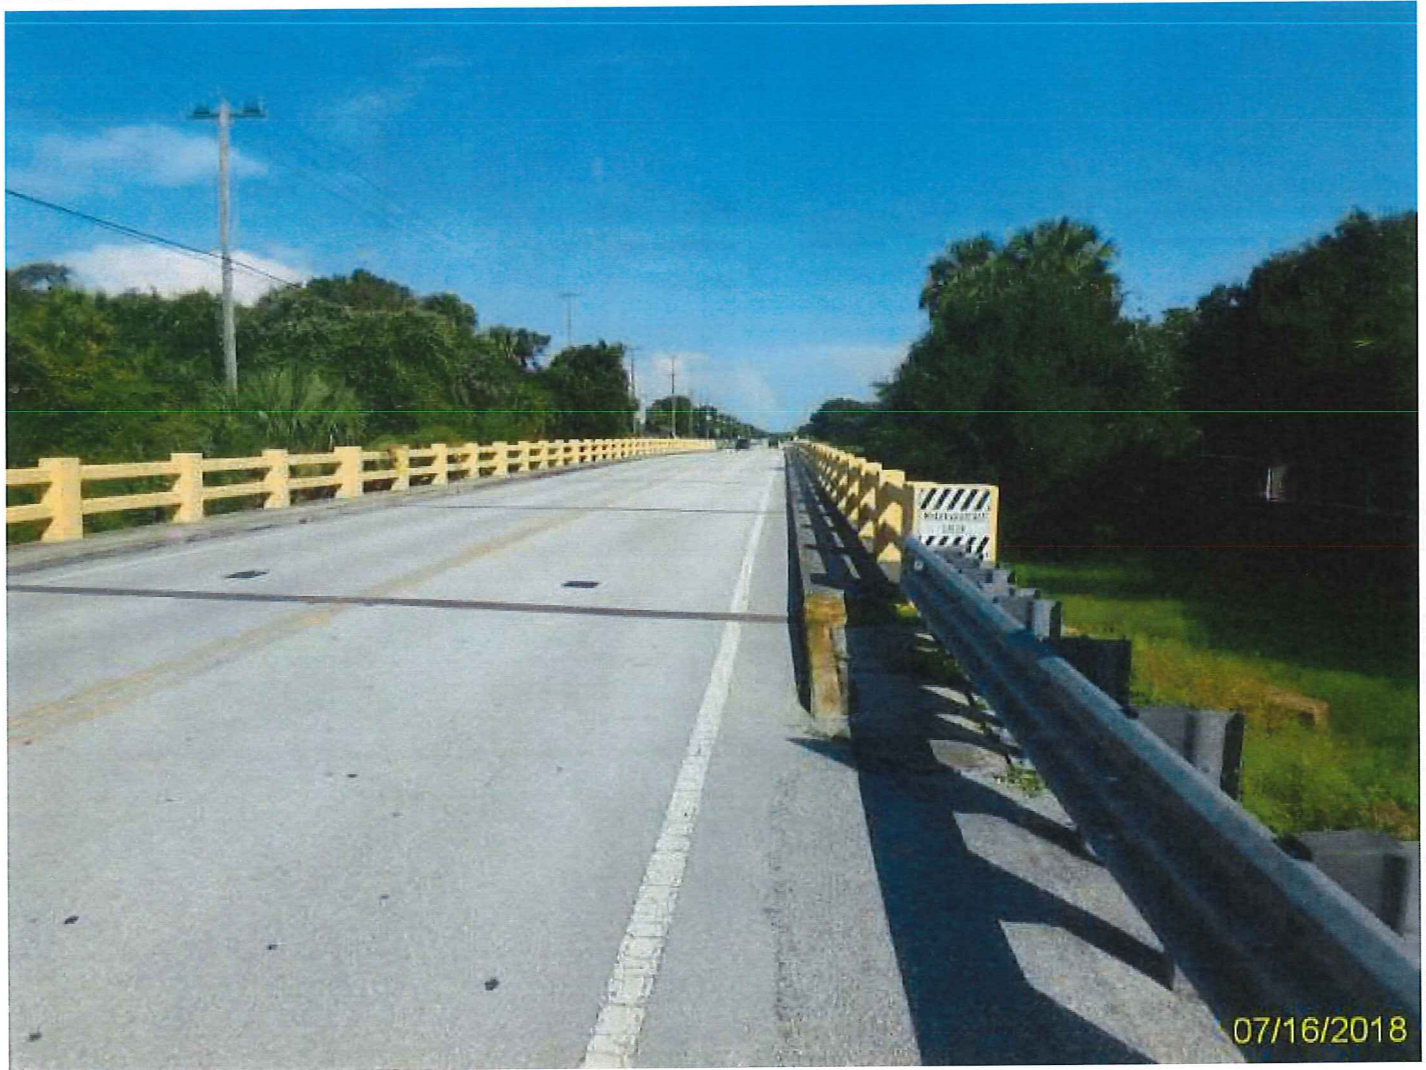
Photo 10 - Inspection Notes

Missing object markers at the southeast corner of the bridge
