MCEP BRIDGE AND OBSERVATION DECK Limited Structural Condition Assessment

6968 Reisterstown Road
North Port, FL 34291

NPORT22004

March 10, 2023

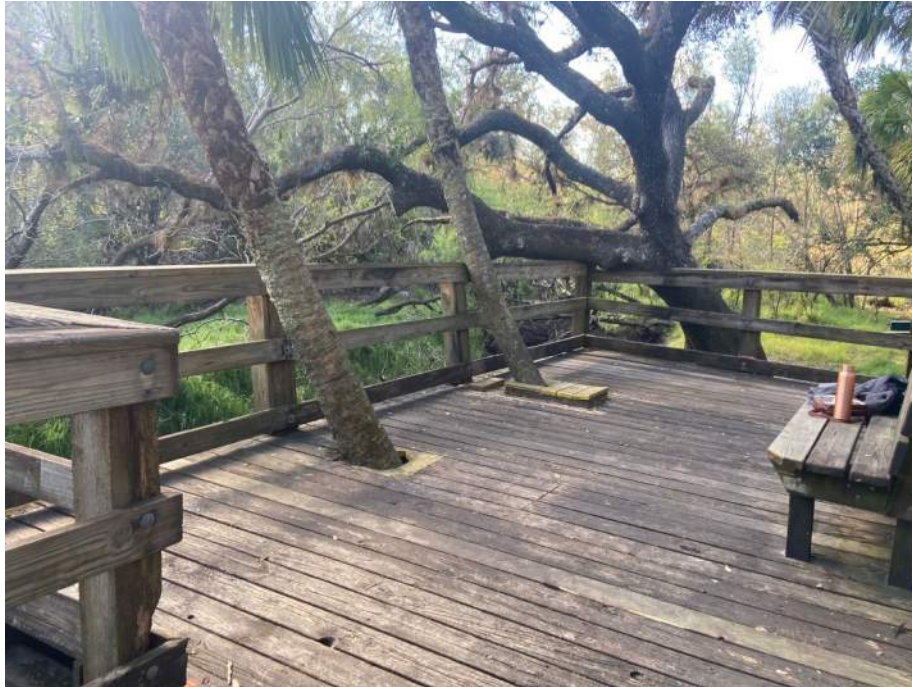
Photograph #11: Overall Observation Deck

- Four timber piles supporting the observation deck in direct contact with water have significant deterioration and loss of cross section.
- Deterioration and insect damage in several vertical post along the handrail.
- Deteriorating wood decking panels.

It is our understanding that the observation deck is being used for pedestrian traffic only. It does not appear the damaged piles in water can support full-service loads and should be considered a **Dangerous Condition** as defined by Section 202 of the 2020 Florida Existing Building Code.
