MA Architects

This document has been prepared by GAI Consultants, Inc. on behalf of the City of North Port, Florida.

01. Parks Today

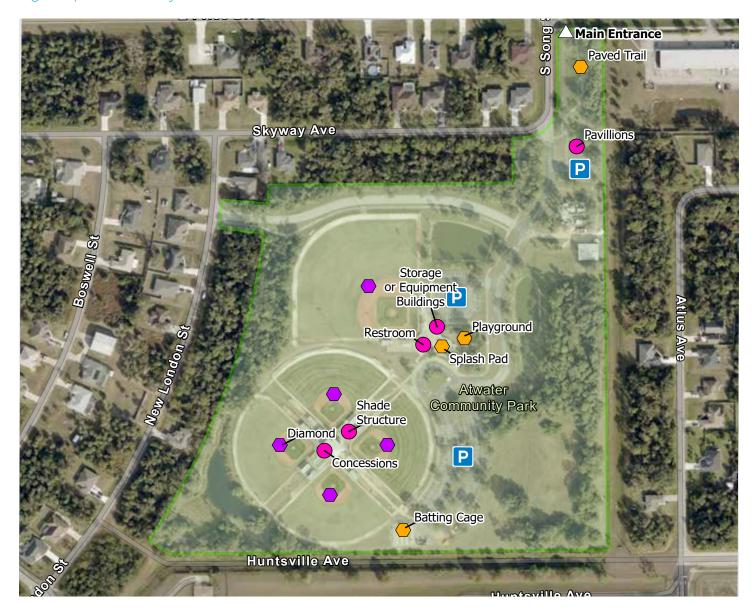
Figure 1 | Park Inventory

The amenities throughout the site are in good condition and are very well-maintained. The circulation and the spatial organization of the site make it easy to navigate through. There is an opportunity to add more seating within the playground area and improve existing seating with a bench pad and added walkway. There are potential CPTED issues near the playground; including firebush on the north side which may create blind spots. There is an opportunity to add low hedges along the playground to add a protective buffer between the parking lot and play area. Although the chalk wall may not be a major concern, it also creates blind corners due to its height. The Splash pad surfacing is a textured rubber, which children have been slipping on, and nearby water fountain may need to be replaced, due to clogs and rust.

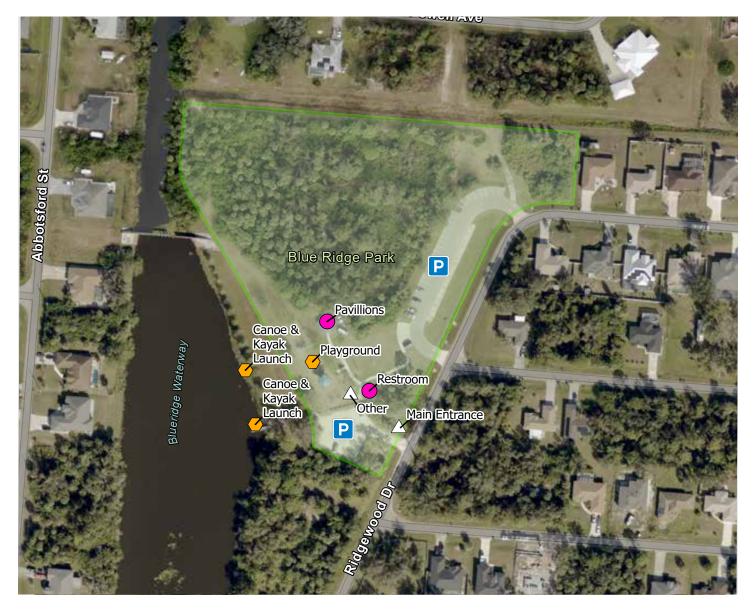
Figure 2 | Park Inventory

There is good circulation throughout the park, but the benches and kayak launch are not very accessible, with steep slopes and no path. The benches are starting to wear, and although they are in fair condition now, they will need to be replaced soon. A good portion of the site is a natural area with the potential to add a boardwalk or trail.

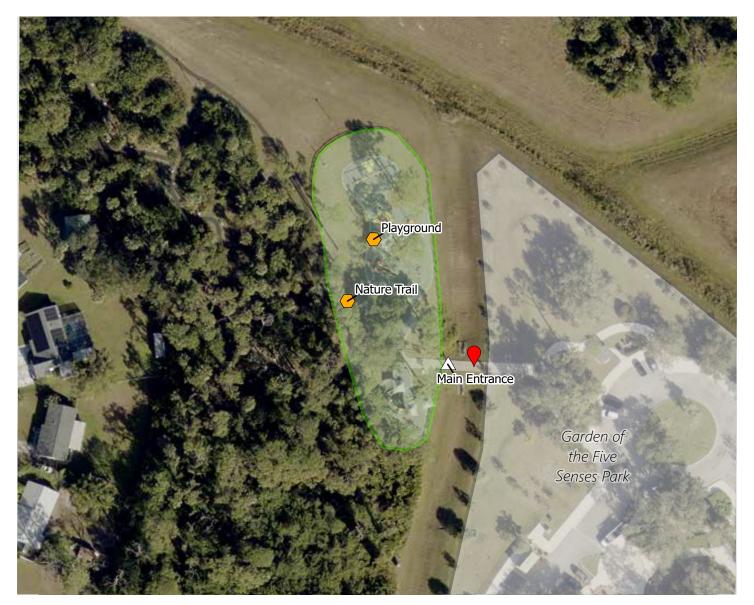
Figure 3 | Park Inventory

The playground is well-maintained and provides a welcoming environment for all children. However, enhancements such as additional trees along the entranceway and the outer edge of the Story Stroll would further improve the space. Widening the paved trail to five feet would accommodate two users walking side by side, enhancing accessibility.

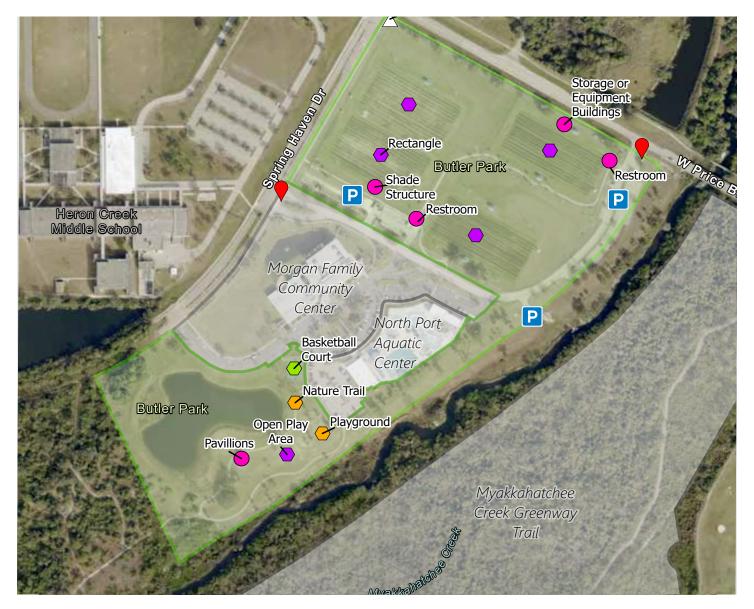
Figure 4 | Park Inventory

There is also a lack of accessibility to the playground and fields which could be improved with the addition of connecting sidewalks. Enhancing pedestrian safety is also a priority, as crossing signage and road markings are not present in the eastern parking lot.

Opportunities for improvement include enhancements to park user comfort and could include walking loops, and increased shade through tree canopy along the sidewalks and extending shade structures to the team benches and bleachers. As well as, adding in some shaded picnic tables areas for families to use in between games.

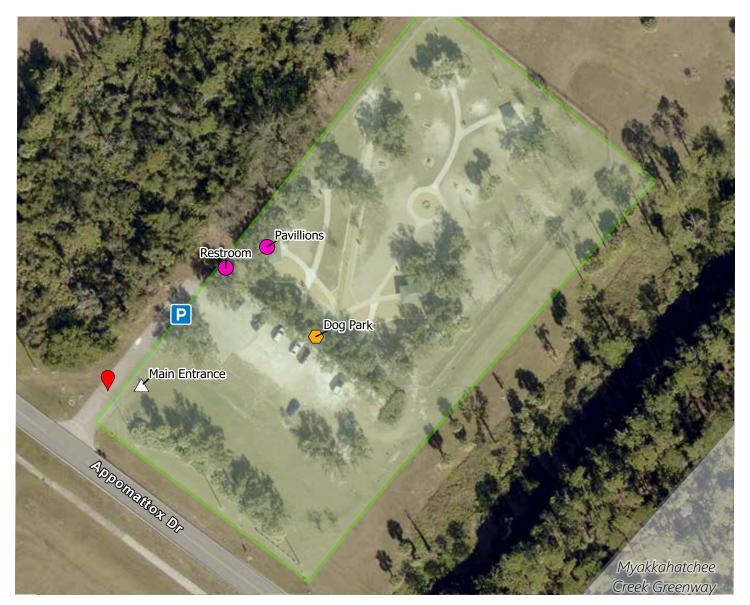
Figure 5 | Park Inventory

Canine Club Dog Park is well-maintained and regularly utilized, with a scheduled weekly closure for cleaning. However, the large dog area could benefit from additional shade trees to improve comfort. Some of the surfaces, such as the concrete walkway and rocked areas, retain excessive heat. Replacing the rocked sections with grass may enhance usability. Furthermore, installing a dog water fountain on each side would be a valuable amenity, ensuring convenient hydration for visiting pets.

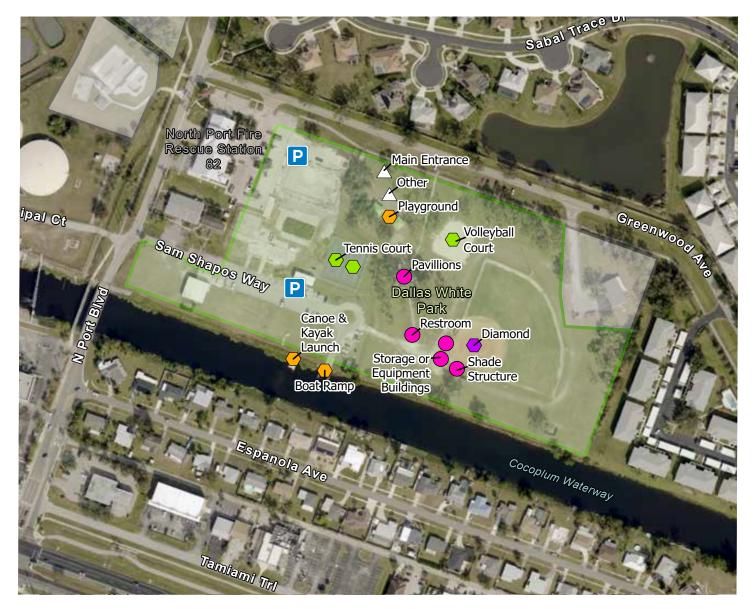
Figure 7 | Park Inventory

Located behind the Fire station, abutting the Cocoplum Waterway and the North Port Scout House, Dallas White Park consists of a baseball field, sand volleyball court, a playground, and a tennis court. The softball field is in good condition with shaded bleachers. However, the dugouts are missing fencing and shade structures. The dugouts' walls prevent visibility into both the dugouts and the fields creating a CPTED blind spot. The volleyball court is in need of repairs, specifically the posts and the net, which are currently being held up by adjacent light poles. The tennis courts are in good condition with a few minor cracks. The playground included ADA structures and overall is in good condition: however, the playground lacks ADA compliant access points. The park also has access into the waterway with a kayak/canoe launch and boat ramp that are currently non-functional. Although there is a clear vehicular access point into the park, there is no clear pedestrian circulation within the park, connecting the variety of amenities it offers. There are some signs of undesirable uses within the park which may be avoided by increasing regular park users and enhancing the park with CPTED strategies.

Future plans for the site include the replacement of the softball field with a multipurpose field as well as general ADA enhancements throughout the site.

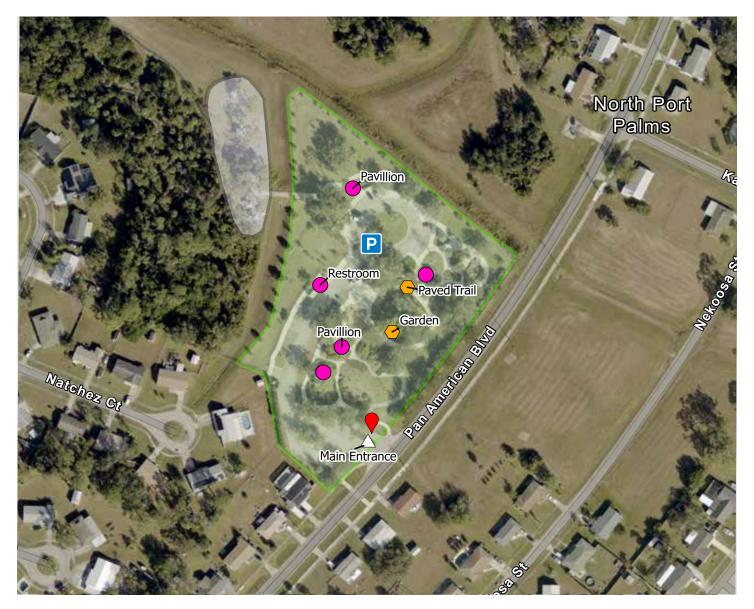
Figure 8 | Park Inventory

Overall, the park is well-maintained, and its amenities remain in good condition. However, some of the educational signage has experienced sun-related wear and would benefit from replacement. While the walking loop facilitates smooth circulation throughout the park, the southwest portion could benefit from additional shade trees. The entrance sidewalk integrates well with the gardens, but improved crosswalk signage across Pan American Boulevard and additional markings at the driveway entrance would enhance pedestrian safety. Additionally, the park's entrance signage differs from standard City of North Port Parks signs. Installing an additional standard park sign and with its current monument sign would help reinforce its identity as a city operated park.

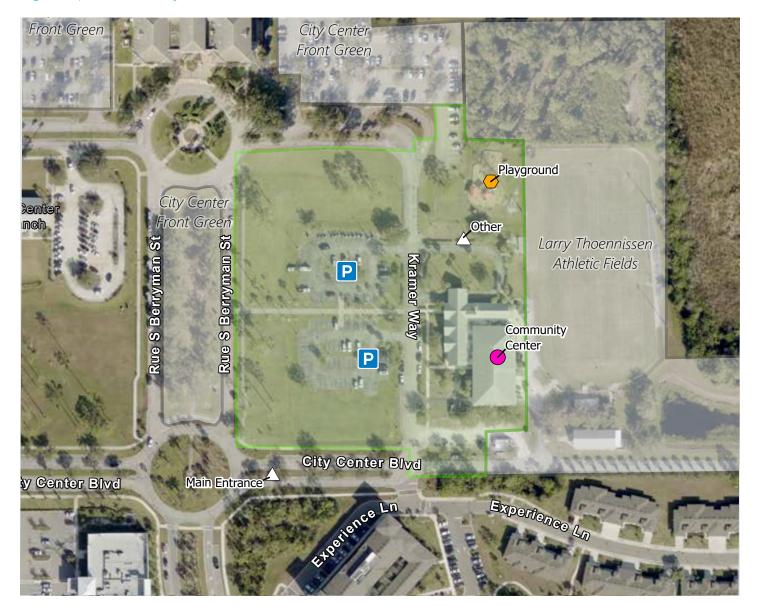
Figure 9 | Park Inventory

George Mullen Activity Center is located next to the City Hall and is connected to Larry Thoennissen Athletic Fields. The George Mullen Activity Center consists of the activity center building, a playground, and parking that serves both the activity center and Larry Thoennissen Athletic Fields. The playground is relatively new but lacks shade and an accessible entry point. There is an informal entry point for people to access the park if coming from the Activity Center, but there are no formal sidewalks or paths that lead to the playground.

There is an opportunity to integrate more shade throughout the site, including the parking lot. The site circulation can be improved with the addition of sidewalks or pathways connecting the playground to the parking lot and the Activity Center.

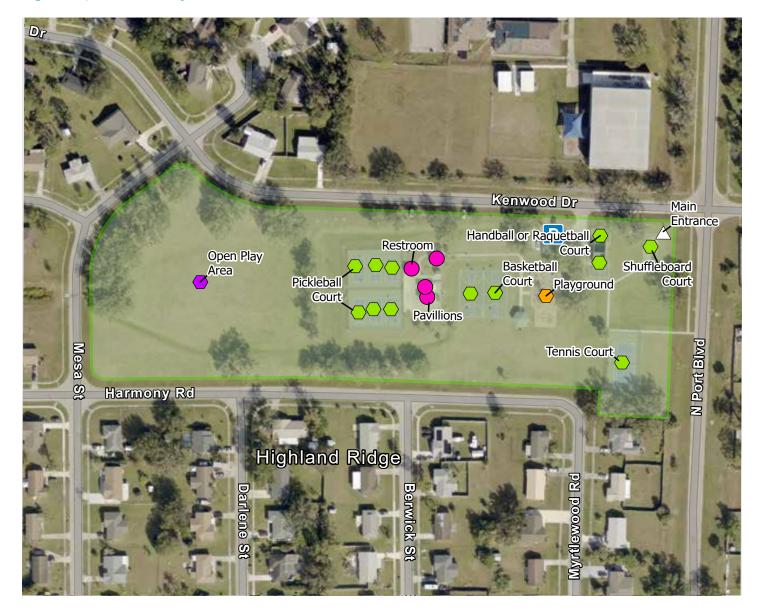
Figure 10 | Park Inventory

Enclosed by residential areas, Highland Ridge Park offers the residents a multitude of amenities. The site consists of well-maintained racquetball court, tennis court, and basketball courts, all of which have slight cracking on the surfacing. The basketball backboards may need to be replaced soon due to rust and wear. The shuffle ball court is in fair condition, but it is in the need of updates, including resurfacing and restriping. The playground on site is mainly in good condition, but is displaying some signs of rusting. The pickleball courts on site are in good condition and get lots of use on site. To account for its usage, there may be a need to integrate more parking. Court dividers may also need to be installed in the pickleball court to replace the existing PVC structures. The site also includes a considerable amount of open green space surrounded by seating under the perimeter canopy trees. The site includes 3 shade structures with picnic tables underneath, offering shaded seating with clear views into the playground, basketball court, and pickleball courts. There is also a restroom on site as well as a storage structure, both of which are in good condition.

The site has good circulation and is generally ADA accessible. Some of the site furnishings are worn out and in need of replacements, especially the benches and grills. There are opportunities to integrate a trail encompassing the entirety of the site as well as more canopy trees along internal sidewalks and near the playground. To encourage safe pedestrian access, there is an opportunity to include crosswalks at the main pedestrian entry points.

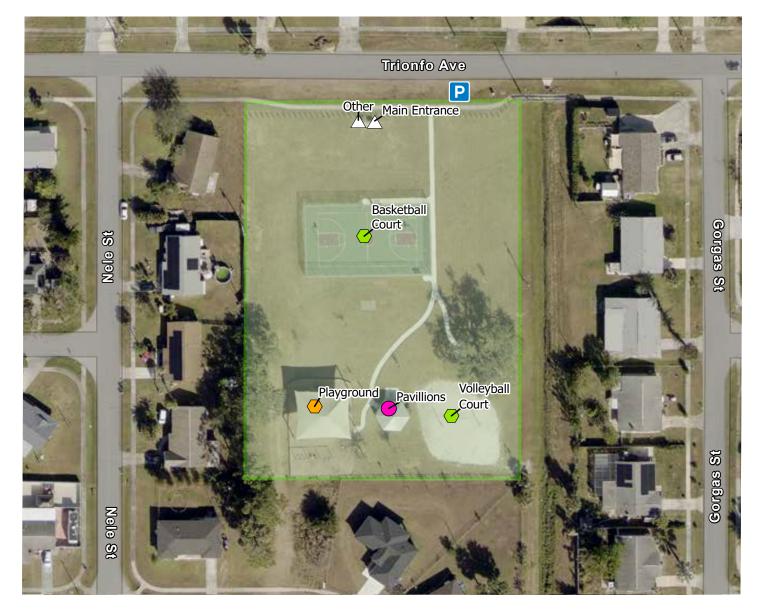
Figure 12 | Park Inventory

Opportunities for improvement include planting additional trees along the sidewalks to enhance shade and comfort. Extending the sidewalk to the volleyball court to improve accessibility, ensuring all amenities are easily reachable. Adding edging around the volleyball court would help maintain a cleaner and more defined playing area. Consideration could also be given to removing the fencing around the basketball court to create a more open layout, improving the overall flow of the park. The entrance to the playground area would be improved with the transition ramp from the sidewalk to the mulched area. Additionally, enhancing landscaping around the entrance sign would contribute to a more welcoming and aesthetically appealing entrance.

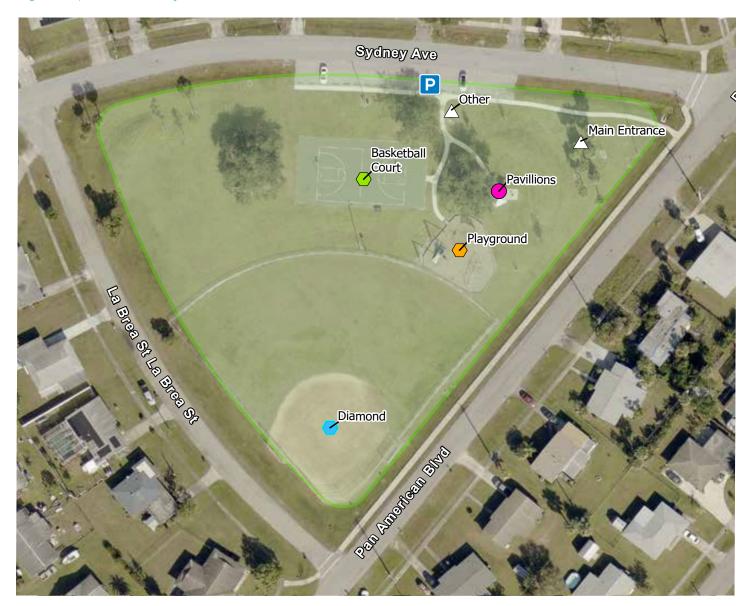
Figure 13 | Park Inventory

Opportunities for improvement include replacing the sunshade canopy over the playground to enhance protection from the elements and adding seating for guardians supervising children. Incorporating a sidewalk to the fields would improving accessibility, along with shaded bleachers on either side enhancing the spectator experience. Installing a split rail fence around the park perimeter would provide a safeguard against vehicles encroaching too far into the recreational areas. There is a need to improve accessibility in the parking lot as the scope is not up to ADA code, there are no handicapped parking space, and no accessible access point. The parking lot is also in need of restriping.

Additionally, the basketball court lights remain illuminated throughout the night, creating the impression that the park is open after designated hours. Implementing a timer system would help regulate lighting and discourage latenight occupancy. Lastly, addressing traffic concerns along Sydney Avenue by introducing traffic-calming measures would improve pedestrian safety and create a more secure environment for park visitors.

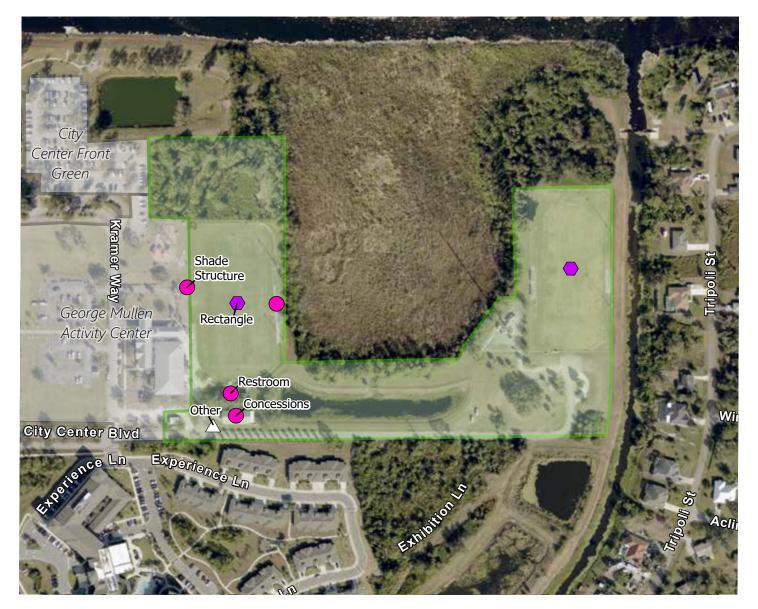
Figure 14 | Park Inventory

Larry Thoennissen Athletic Fields is located adjacent to George Mullen Activity Center, near the City Hall. The facilities this park offers, includes fields for football and soccer, with bleachers that are in good condition. The main field is located more central to the George Mullen Activity Center and is in good condition. The shaded bleachers for the fields need replacements. Of the three, two structures are broken and the third has broken shade fabric. There are also storage structures and restrooms on site.

The second field, the practice field, is in the northern part of the site and has no signage or defined formal parking. The practice field is also in good condition and is currently going through renovations for the goal posts. There is opportunity to formalize the parking space for the practice field, as well as seating and shade near the field. There is currently no pedestrian connection between the two fields, the site can benefit from a path or trail connecting the two fields unifying the space.

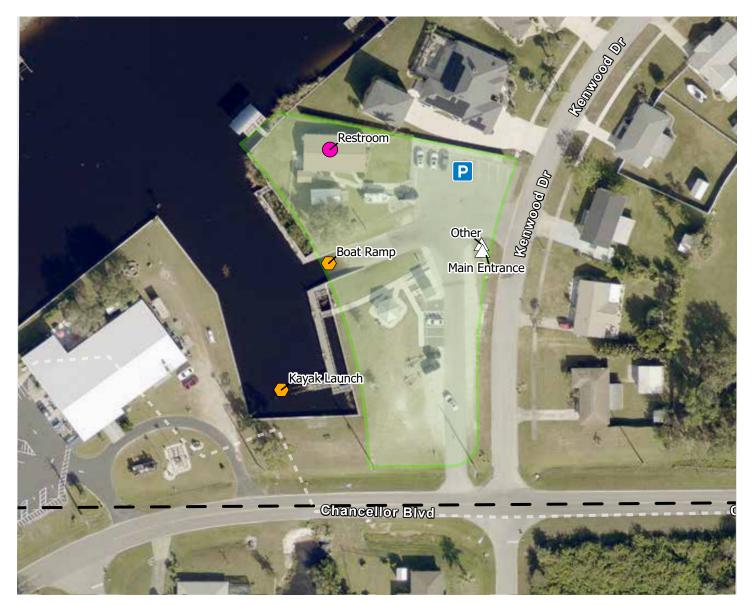
Figure 15 | Park Inventory

Located in a residential area, abutting the Myakkahatchee Creek, Marina Park consists of a boardwalk with integrated kayak launches, a boat ramp, restrooms, a pavilion with picnic tables, and on-site parking. The site includes the coast guard facility, which includes a dock and a building. Overall, the site is in good condition and the boardwalks seem to be new additions. With the lack of shade within the park, there is an opportunity to integrate additional tree canopy into the site.

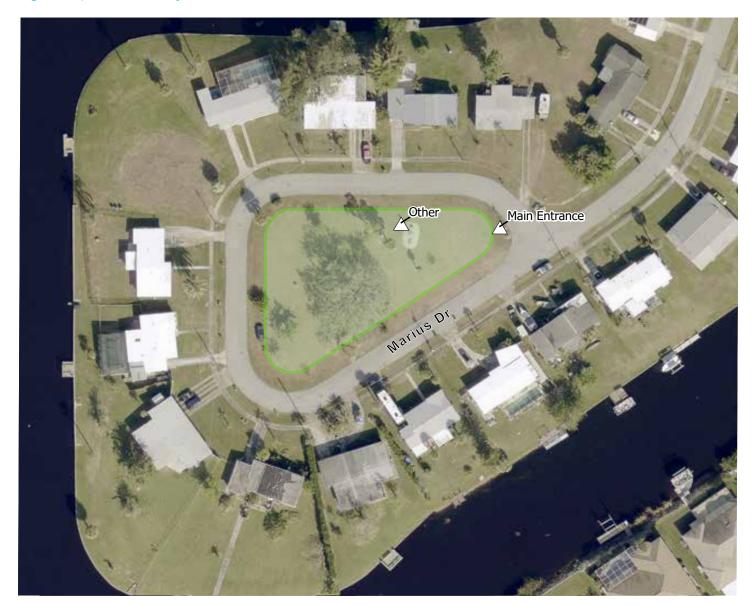
Figure 16 | Park Inventory

There are opportunities to enhance the park by introducing additional amenities. Installing a small playground or a fitness equipment loop would provide recreational options for residents and promote community engagement. To improve safety and organization, a split-rail fence or low-level plantings around the perimeter would help prevent vehicles from encroaching into the recreational space while better defining parking areas. Additionally, updating the park sign and complementing it with landscaping would enhance visibility and contribute to the park's overall aesthetic appeal.

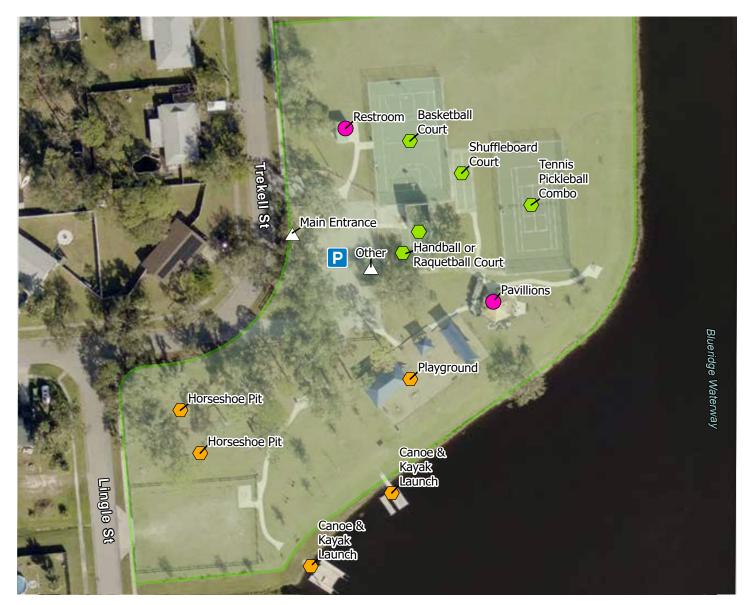
Figure 17 | Park Inventory

McKibben Park caters to all ages with a variety of amenities, including a racquetball court, basketball court, tennis courts, shuffleboard courts, playground, open green space, and kayak/canoe launches. The sport courts surfacing is in good condition, although the basketball nets and backboards will need replacements soon. The playground, with integrated shade, includes ADA compliant access points. A nearby pavilion with picnic tables allows parents a clear view of their children in both the sport courts and the playground. The site includes ADA kayak/canoe launches with supporting facilities like a kayak stand and designated parking area for visitors specifically seeking water access. The primary parking lot for the park is in good condition but will need to be restriped soon.

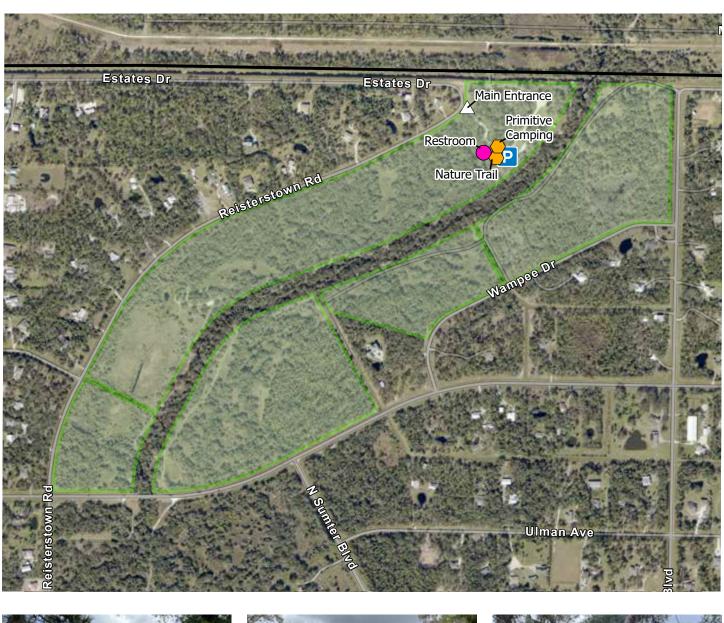
Figure 18 | Park Inventory

The park is well-maintained, ensuring a high-quality experience for all visitors. However, there are opportunities to further enhance accessibility and educational engagement. Additional trail maps placed throughout the site would improve navigation, helping visitors explore more confidently. Furthermore, the addition of interpretive signage highlighting the local wildlife and native flora would enrich the visitor experience, providing educational insights into the park's unique ecosystem.

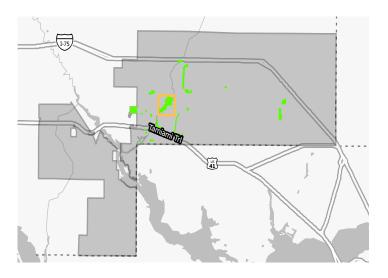
Location	Myakkahatchee Creek Greenway
Туре	Greenway
Acreage	105.05 AC
Inventory Rating	2.1 - Exceeds Expectations

The Myakkahatchee Creek Greenway Trail is a newly established one-mile passive walking path that offers an accessible route through natural surroundings for visitors of all abilities. Carefully designed to minimize environmental disturbance, the trail preserves native vegetation and provides scenic views of local wildlife and landscapes. In addition to the paved walking path, the site also includes a primitive bike trail.

While the trail represents a valuable addition to the City's park system, there remain opportunities for improvement. The absence of designated parking currently limits access for individuals with disabilities. Establishing formal parking facilities would significantly enhance accessibility. Moreover, expanding the trail network to connect with additional parks would contribute to greater system-wide connectivity. Lastly, installing clear signage identifying the park as a City facility would improve visibility and reinforce its role within the City park system.

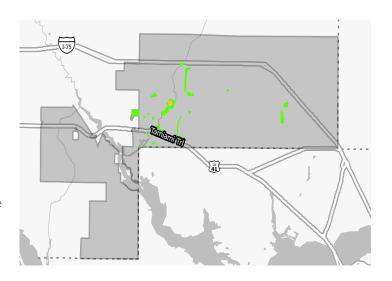
Location	6205 West Price Blvd
Туре	Special Use Facility
Acreage	2.85 AC
Inventory Rating	2.6 - Exceeds Expectations

Designed with both functionality and aesthetics in mind, the center features a well-organized layout with ample seating options, both shaded and unshaded, ensuring comfort for all visitors. The facility is meticulously maintained, providing excellent circulation throughout the space. Its vibrant and inviting theme enhances the overall experience, making it a standout attraction for the community.

The North Port Aquatic Center serves as an asset, offering residents and visitors a dynamic space for recreation, fitness, and leisure.

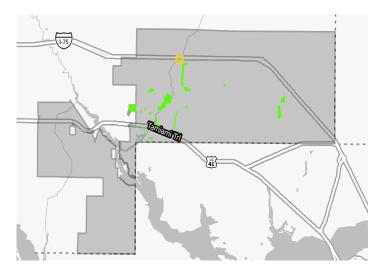
Location	5430 Mandrake Terrace
Туре	Neighborhood Park
Acreage	11.75 AC
Inventory Rating	2.0 - Meets Expectations

Oaks Park is a natural preserve situated along the Myakkahatchee Creek, offering visitors a serene environment with scenic trails that weave throughout the landscape. The trail system is suitable for both hiking and mountain biking. At the entrance, a few picnic tables are available, shaded naturally by the surrounding trees, providing a tranquil spot for relaxation and outdoor gatherings.

Enhancements to the park could include the addition of wayfinding signage to improve navigation, ensuring visitors can explore the trails with ease. As well as additional signage about the mountain biking offerings at the trailhead. Incorporating educational signage that highlights the local wildlife, and native flora would enrich the experience and foster a deeper appreciation for the park's ecological diversity.

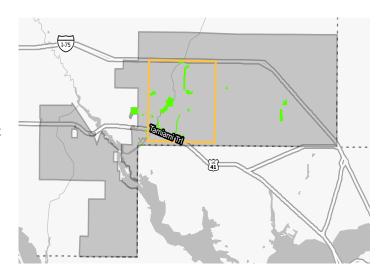
Location	Sumter Blvd
Туре	Recreational/Sports Facility
Acreage	56.82 AC
Inventory Rating	2.0 - Meets Expectations

Sumter Boulevard Linear Park is a picturesque addition to the suburban landscape, offering a wide, winding bicycle and pedestrian paved trail along Sumter Boulevard. The park is thoughtfully designed, featuring several pavilions with benches along the trail, providing users with convenient rest stops. Well-maintained landscaping creates an attractive environment while serving as a buffer from road traffic, enhancing the park's appeal. The trail includes lighting, making it a safe and accessible option for those who wish to walk or cycle, whether during the day or in the evening. The park concludes at Cocoplum Waterway, where a scenic bridge and pavilion provide a peaceful retreat for visitors. Some sections of the park benefit from natural shade, further improving comfort for parkgoers.

Opportunities for enhancement include the addition of more shade trees in areas that lack sun protection, improving overall usability. Parking at the trailhead could be reorganized to ensure better safety and functionality, making it easier for visitors to leave their vehicles while enjoying the trail. Consideration should also be given to adding additional trailheads, which would increase accessibility for those who do not live near the park but wish to use its amenities. Lastly, installing signage to highlight the park's identity as part of the North Port Park system would improve visibility and recognition.

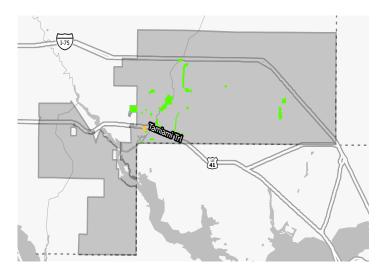
Location	13750 S Tamiami Trl
Туре	Neighborhood Park
Acreage	1.59 AC
Inventory Rating	2.2 - Exceeds Expectations

Veterans Memorial Park is a small, yet meaningful space dedicated to honoring the veterans in the community. Located adjacent to the public library, the park provides shaded benches where visitors can relax, read, or reflect. The beautifully landscaped areas enhance its tranquil atmosphere, making it a welcoming place for residents and library patrons alike.

Opportunities for improvement include adding additional shaded seating near the monument, allowing visitors a more comfortable space to sit and reflect. Enhancing connectivity to adjacent parking, particularly for ADA accessibility, would ensure greater ease of access for all visitors. Additionally, installing a pedestrian crosswalk for those parking across the road would improve safety and provide a secure route to the park.

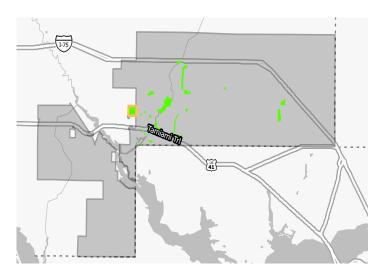
Location	12200 San Servando Ave
Туре	Special Use Facility
Acreage	81.57 AC
Inventory Rating	2.0 - Meets Expectations

Located at the edge of the City, Warm Mineral Springs Park consists of natural, vegetated area, a parking lot, structures, open green space, and the warm mineral spring. The Park creates a glimpse back into time to Old Florida from back in the 1950's. Surrounding the mineral spring is open green space sloping down towards the spring, with ample seating dispersed throughout. There is a lack of connectivity from the entry point of the site to the other side of the springs, as the walkways only lead to the nearest access point to the spring and the nearest lifeguard tower. Seating consists of lounge chairs placed throughout the open lawn. Lawn chairs were often clustered in areas that were shaded, illustrating the need for additional shade throughout the site. The site also includes historical buildings that are currently being renovated.

The incorporation of walkways around the springs will benefit the site by increasing accessibility and improving circulation. To improve user comfort and experience in the site, there is an opportunity to integrate planting beds and overall shaded seating. To account for larger groups of visitors, the site could also incorporate gathering nodes sparsely dispersed in the green space.

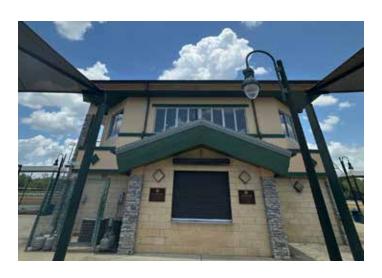
Building Envelope & Structural Systems

The building is constructed out of 8 inch CMU block and supported on a spread foundation. The exterior walls are finished with stone veneer and painted stucco. The roof structure is protected by a standing seam metal roofing system installed over structural steel framing. The building includes both non-conditioned and conditioned areas, with mechanical systems provided by a split-system HVAC with interior air handlers and wall louvers and ventilation.

The exterior envelope shows minor signs of wear, particularly at the roof fascia, but remains in overall good condition. Concrete sidewalks are properly sloped away from the building, helping to prevent water intrusion and maintain site drainage.

The interior of the ground floor is clean and wellmaintained and in good condition. The concessions area is in good condition, and overhead rolling doors are operational and well-kept. Restroom fixtures and finishes exhibit typical wear but remain fully functional, visibly maintained and in good condition. The second floor is in good condition exhibiting consistent upkeep and adequate natural light throughout.

Overall, the building appears to be well-maintained, with no major deficiencies observed in the exterior or interior systems.

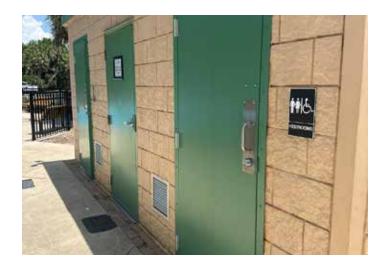
Restrooms Building

The building is a prefabricated structure with a concrete slab. Exterior walls are composed of concrete precast panels. The roof assembly consists of a painted precast concrete. The building is non-conditioned with wall louvers and ventilation.

The exterior envelope is in good condition and shows no signs of physical damage or moisture intrusion, with the exception of graffiti on one overhead rolling window. Concrete sidewalks are properly sloped away from the building to direct water away from the foundation and reduce the risk of water infiltration.

The interior is in good condition, with adequate ventilation provided. Restroom fixtures, including toilets, lavatories, and accessories, exhibit typical wear but remain fully functional and in good condition. Wall and floor finishes show no signs of water damage or deterioration.

Overall, the building is well-maintained, with no significant deficiencies observed in the exterior or interior systems.

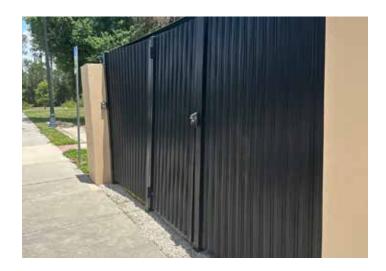
Trash Enclosure

Trash enclosure is constructed of CMU block on spread foundations. The block is finished w/ stucco that's been painted. The gates for the trash enclosure are aluminum. The enclosure sits on a concrete slab.

The trash enclosure is well maintained and functioning as designed.

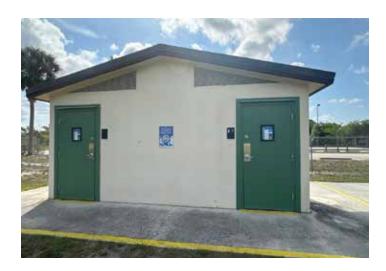
Restrooms Building

The building is a prefabricated structure with a concrete slab. Exterior walls are composed of concrete precast panels. The roof assembly consists of a painted precast concrete. The building is non-conditioned with wall louvers and ventilation.

The exterior envelope is in good condition. It shows no signs of physical damage or moisture intrusion. Concrete sidewalks are properly sloped away from the building to direct water away from the foundation and minimize the risk of infiltration.

The interior is in good condition, with adequate ventilation provided. Restroom fixtures, including toilets, lavatories, and accessories, exhibit typical wear but remain fully functional and in acceptable condition. Wall and floor finishes are intact, with no signs of water damage or deterioration.

Overall, the building is well-maintained, with no significant deficiencies observed in the exterior or interior systems.

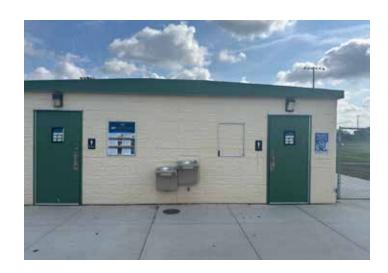
Restrooms Bldg

The building is a prefabricated structure with a concrete slab. Exterior walls are composed of concrete precast panels. The roof assembly consists of a painted precast concrete. The building is non-conditioned with wall louvers and ventilation.

The exterior envelope is in good condition. It shows no signs of physical damage or moisture intrusion. Concrete sidewalks are properly sloped away from the building to direct water away from the foundation and minimize the risk of infiltration.

The interior is in good condition, with adequate ventilation provided. Restroom fixtures, including toilets, lavatories, and accessories, exhibit typical wear but remain fully functional and in acceptable condition. Wall and floor finishes show no signs of water damage or deterioration

Overall, the building is well-maintained, with no significant deficiencies observed in the exterior or interior systems.

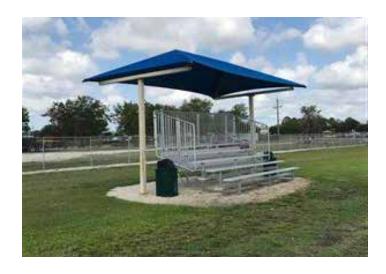
Shade Structure

The exterior structural components of the fabric shade structure are in good condition, with some rust and minor wear observed on steel framing elements. The sloping of concrete pad appears effective, with no evidence of standing water, and walking surface are in sound condition. Overall, the structure appears to be well-maintained, with no significant deficiencies noted.

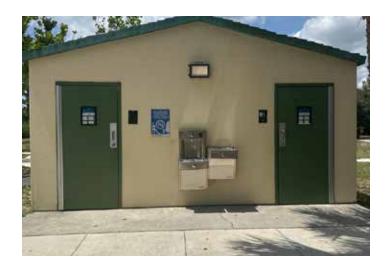
Restrooms Bldg

The building is a prefabricated structure with a concrete slab. Exterior walls are composed of concrete precast panels. The roof assembly consists of a painted precast concrete. The building is non-conditioned with wall louvers and ventilation.

The exterior envelope is in good condition. It shows no signs of physical damage or moisture intrusion. Concrete sidewalks are properly sloped away from the building to direct water away from the foundation and minimize the risk of infiltration.

The interior is in good condition, with adequate ventilation provided. Restroom fixtures, including toilets, lavatories, and accessories, exhibit typical wear but remain fully functional and in good condition. Wall and floor finishes show no signs of water damage or deterioration.

Overall, the building is well-maintained, with no significant deficiencies observed in the exterior or interior systems.

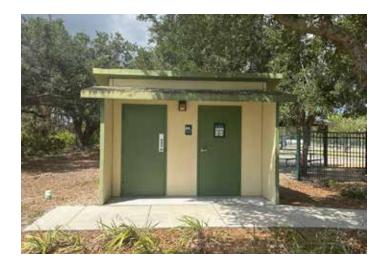
Restrooms Bldg

The exterior envelope is in good condition. It shows no signs of physical damage or moisture intrusion. Concrete sidewalks are properly sloped away from the building to direct water away from the foundation and minimize the risk of infiltration.

The interior is in good condition, with adequate ventilation. Restroom fixtures and finishes show typical wear but remain functional and in acceptable condition.

Overall, the building appears to be well-maintained, with no significant deficiencies observed in either the exterior or interior systems.

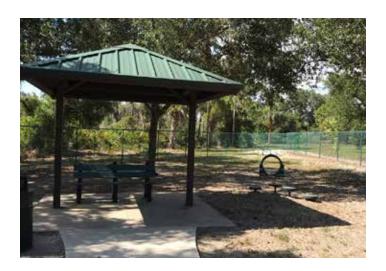
Shade Pavilions

The exterior structural components of the picnic pavilion is in good shape, with minor rust and wear visible on exposed framing and connections. Concrete pads and sidewalks surrounding the pavilion are properly sloped, promoting effective drainage, and are free of cracking or ponding. The structure is considered to be in good overall condition, with no major issues affecting performance or safety.

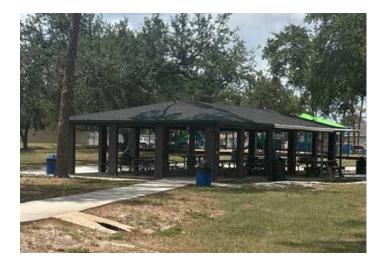
Picnic Pavilion

The exterior structural components of the picnic pavilion is in good shape, with minor abrasions and there is typical wear visible on exposed framing. Concrete pads and sidewalks surrounding the pavilion are properly sloped, promoting effective drainage, and are free of cracking or ponding.

The structure is considered to be in good overall condition, with no major issues affecting performance or safety.

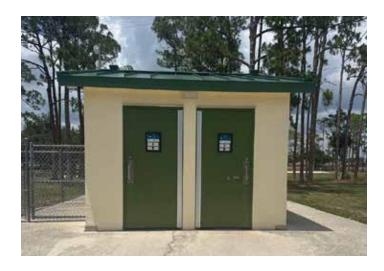
Restrooms Bldg

The exterior envelope is in good condition. It shows no signs of physical damage or moisture intrusion. Concrete sidewalks are properly sloped away from the building to direct water away from the foundation and minimize the risk of infiltration.

The interior is in good condition, with adequate ventilation provided. Restroom fixtures, including toilets, lavatories, and accessories, exhibit typical wear but remain fully functional and in acceptable condition. Wall and floor finishes are intact, with no signs of water damage or deterioration.

Overall, the building is well-maintained, with no significant deficiencies observed in the exterior or interior systems.

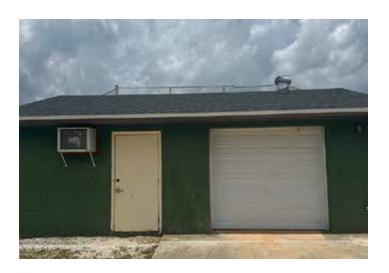
Storage Bldg

The exterior envelope is in poor condition. There is structural damage of stepped cracking in multiple locations, no recent paint or maintenance. Exterior door is rusted and worn. The sloping of concrete drive appears to be effective, with no evidence of standing water, and surfaces are in fair condition. The building is non-conditioned with wall unit (undetermined if it is in working condition).

Overall, the building appears to be under-maintained, with minor deficiencies observed in either the exterior or interior systems. There is noticeable stepped cracking along the north wall and interior repairs needed.

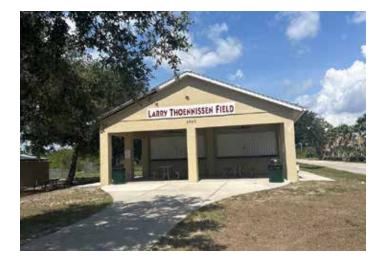
Concessions & Restrooms

The exterior envelope is in poor condition. The exterior envelope shows major signs of damage at the roof fascia. There is structural damage to the exterior CMU partial wall in the rear as well as damage to the concrete slab. . Concrete sidewalks are properly sloped away from the building to direct water away from the foundation and minimize the risk of infiltration. The sloping of concrete sidewalks and pads appears to be effective, with no evidence of standing water, and surfaces are in good condition with the exception of the back patio.

The interior is in fair condition, with inadequate ventilation. Restroom fixtures and finishes show moderate wear and/or cosmetic damage but remain functional and in acceptable condition.

Overall, the building appears to be approaching the end of its useful life, with significant deterioration, damage, and/or material failure of the exterior or interior systems.

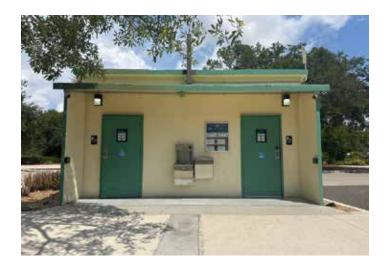
Restrooms Bldg

The exterior envelope is in good condition. It shows no signs of physical damage or moisture intrusion. Concrete sidewalks are properly sloped away from the building to direct water away from the foundation and minimize the risk of infiltration.

The interior is in good condition, with adequate ventilation provided. Restroom fixtures, including toilets, lavatories, and accessories, exhibit typical wear but remain fully functional and in acceptable condition. Wall and floor finishes are intact, with no signs of water damage or deterioration.

Overall, the building is well-maintained, with no significant deficiencies observed in the exterior or interior systems.

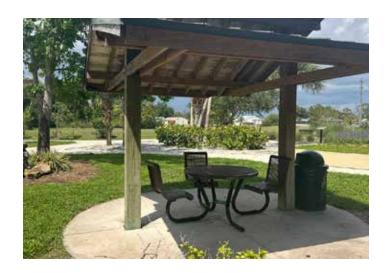
Picnic Pavilions

The exterior structural components of the picnic pavilion is in great condition. Concrete pads and sidewalks surrounding the pavilion are properly sloped, promoting effective drainage, and are free of cracking or ponding. The structure is considered to be in good overall condition, with no major issues affecting performance or safety.

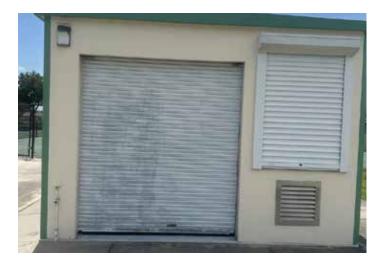
Storage Bldg

The exterior envelope is in good condition. It shows no signs of physical damage or moisture intrusion. Concrete sidewalks are properly sloped away from the building to direct water away from the foundation and minimize the risk of infiltration.

Overall, the building appears to be well-maintained, with no significant deficiencies observed in either the exterior or interior systems.

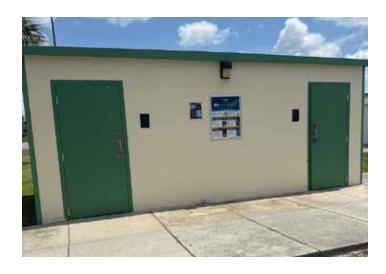
Restrooms Bldg

The exterior envelope is in good condition. It shows no signs of physical damage or moisture intrusion. Concrete sidewalks are properly sloped away from the building to direct water away from the foundation and minimize the risk of infiltration.

The interior is in good condition, with adequate ventilation provided. Restroom fixtures, including toilets, lavatories, and accessories, exhibit typical wear but remain fully functional and in acceptable condition. Wall and floor finishes are intact, with no signs of water damage or deterioration.

Overall, the building is well-maintained, with no significant deficiencies observed in the exterior or interior systems.

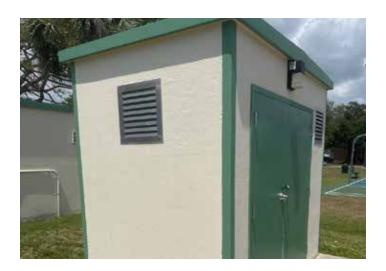
Utility Bldg

The exterior envelope is in great condition. It shows no signs of physical damage or moisture intrusion. Concrete sidewalks are properly sloped away from the building to direct water away from the foundation and minimize the risk of infiltration.

Overall, the building appears to be well-maintained, with no significant deficiencies observed on the exterior. **Overall Building Condition Grade: 2**

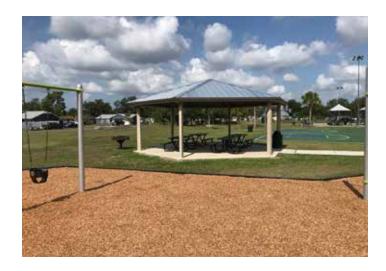
Picnic Pavilion

The exterior structural components of the picnic pavilion is in good shape, with minor rust and wear visible on exposed framing and connections. Concrete pads and sidewalks surrounding the pavilion are properly sloped, promoting effective drainage, and are free of cracking or ponding. The structure is considered to be in good overall condition, with no major issues affecting performance or safety.

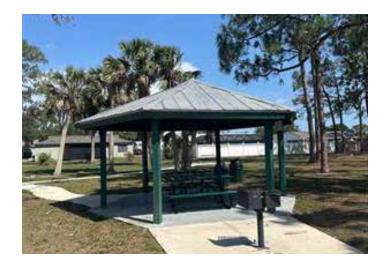
Picnic Pavilion

The exterior structural components of the picnic pavilion is in good shape. Concrete pads and sidewalks surrounding the pavilion are properly sloped, promoting effective drainage, and are free of cracking or ponding. The structure is considered to be in good overall condition, with no major issues affecting performance or safety.

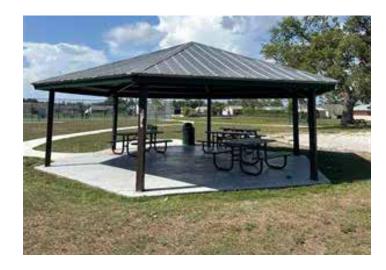
Picnic Pavilion

The exterior structural components of the picnic pavilion are in good shape. Concrete pads and sidewalks surrounding the pavilion are properly sloped, promoting effective drainage, and are free of cracking or ponding. The structure is considered to be in good overall condition, with no major issues affecting performance or safety.

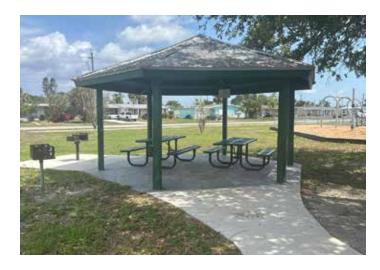
Picnic Pavilion

The exterior structural components of the picnic pavilion are in good shape. Concrete pads and sidewalks surrounding the pavilion are properly sloped, promoting effective drainage, and are free of cracking or ponding. The structure is considered to be in good overall condition, with no major issues affecting performance or safety.

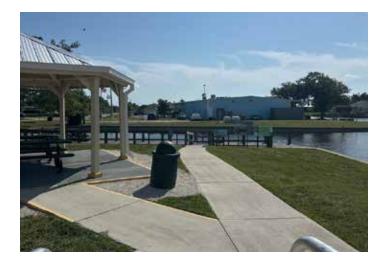
Picnic Pavilion

The exterior structural components of the picnic pavilion are in great shape, with no visible wear or damage on the exposed framing and connections. Concrete pads and sidewalks surrounding the pavilion are properly sloped, promoting effective drainage, and are free of cracking or ponding.

The structure is in great overall condition, with no major issues affecting performance or safety.

Overall, the building appears to be well-maintained, with no significant deficiencies observed.

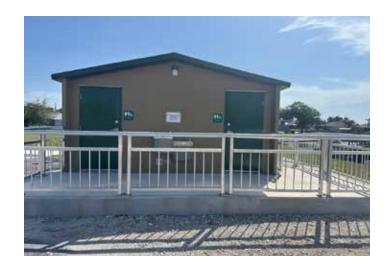
Restrooms / Mechanical Bldg

The exterior envelope is in great condition. Shows no signs of physical damage or moisture intrusion. Concrete sidewalks are properly sloped away from the building to direct water away from the foundation and minimize the risk of infiltration.

The interior is in great condition, with adequate ventilation provided. Restroom fixtures, including toilets, lavatories, and accessories, exhibit no wear and are fully functional and in acceptable condition. Wall and floor finishes are intact, with no signs of water damage or deterioration.

Overall, the building is very well-maintained, with no significant deficiencies observed in the exterior or interior systems.

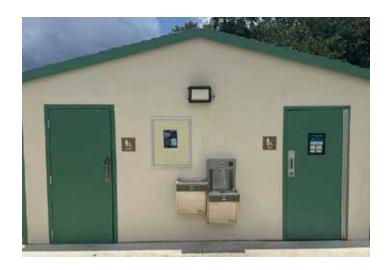
Restrooms Bldg

The exterior envelope is in good condition. It shows no signs of physical damage or moisture intrusion. Concrete sidewalks are properly sloped away from the building to direct water away from the foundation and minimize the risk of infiltration.

The interior is in good condition, with adequate ventilation provided. Restroom fixtures, including toilets, lavatories, and accessories, exhibit typical wear but remain fully functional and in acceptable condition. Wall and floor finishes are intact, with no signs of water damage or deterioration.

Overall, the building is well-maintained, with no significant deficiencies observed in the exterior or interior systems.

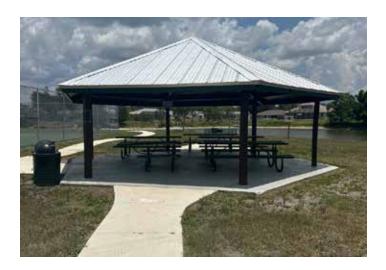
Picnic Pavilion

The exterior structural components of the picnic pavilion are in good shape. Concrete pads and sidewalks surrounding the pavilion are properly sloped, promoting effective drainage, and are free of cracking or ponding. The structure is considered to be in good overall condition, with no major issues affecting performance or safety.

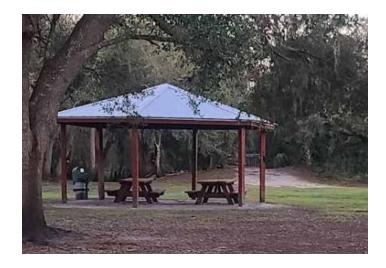
Picnic Pavilion

The exterior structural components of the picnic pavilion are in good shape. Concrete pads and sidewalks surrounding the pavilion are properly sloped, promoting effective drainage, and are free of cracking or ponding. The structure is considered to be in good overall condition, with no major issues affecting performance or safety.

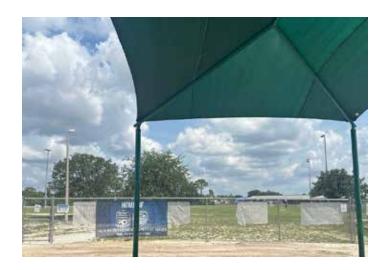
Shade Structure

Overall, the structure appears to be maintained, with no significant deficiencies noted.

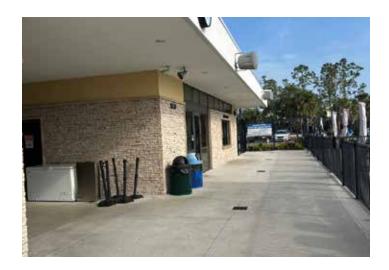
Main Bldg

Overall, the building is very well-maintained, with no significant deficiencies observed in the exterior or interior systems.

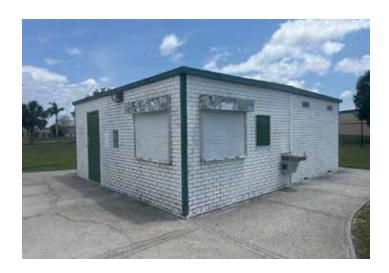
Restroom and Concessions

The interior is in good condition, with adequate ventilation provided. Restroom fixtures, including toilets, lavatories, and accessories, exhibit no wear and are fully functional and in acceptable condition. Wall and floor finishes are intact, with no signs of water damage or deterioration.

Overall, the building appears to be maintained, with no significant deficiencies observed in either the exterior or interior systems.
