MEMORANDUM

Department of Public Works

SUBJECT: Community Services Facility - 4940 Pan American Boulevard

North Port Senior Center Site Observations from 8-13-2025 Field Visit

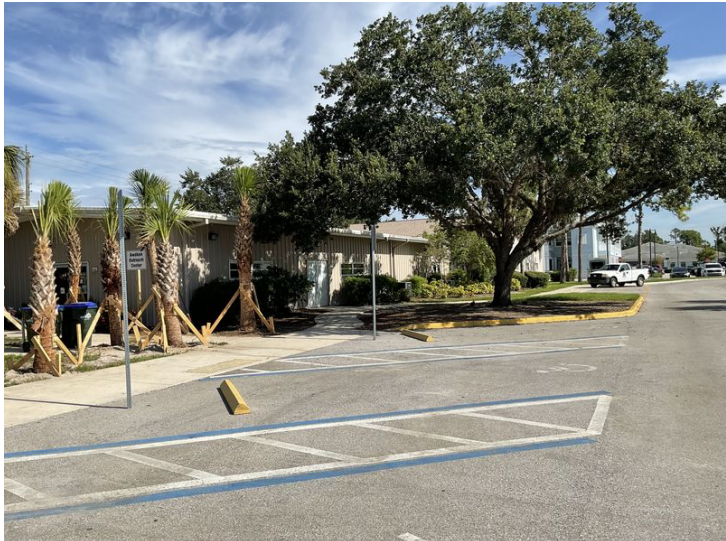
Table 6: Facility Description: AWAKEN CHURCH - AWAKEN CHURCH

General Observations:

- The ductwork system is beyond its recommended useful life.

The fluorescent lighting was in good condition. The electrical branch wiring is within its recommended useful life. The service and distribution system was in good condition.

The glazed doors were in good condition. The single-pane windows were in good condition. The metal paneling walls were in fair condition due to observed faded finishes. The metal panel roof covering was within its recommended useful life.

The painted wall finishes were in good condition. The vinyl tile floor finishes were in fair condition. The suspended acoustical tile ceiling finishes were in good condition.

The porcelain and manual plumbing fixtures were in fair condition due to observed mineral build-up. The domestic water distribution system is beyond its recommended useful life. The sanitary waste system is beyond its recommended useful life.

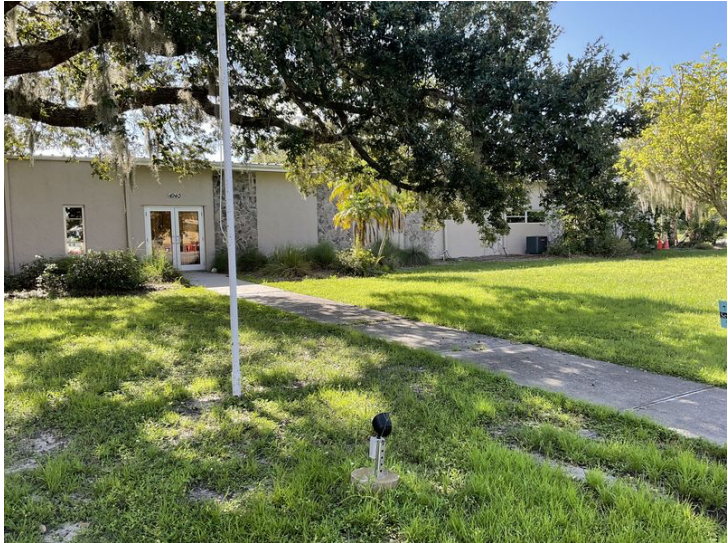
Table 6: Facility Description: COMMUNITY EDUCATION CTR - COMMUNITY EDUCATION CTR

General Observations:
