**Proposed Mosaic DeSoto
County Mine and Potential
Impacts on Surface Waters
Flowing to the City of North
Port**

City of North Port Literature and
Data Review

Prepared by:
Stantec Consulting Services Inc.
6900 Professional Parkway East
Sarasota, FL 34240
941.907.6900

January 30, 2018

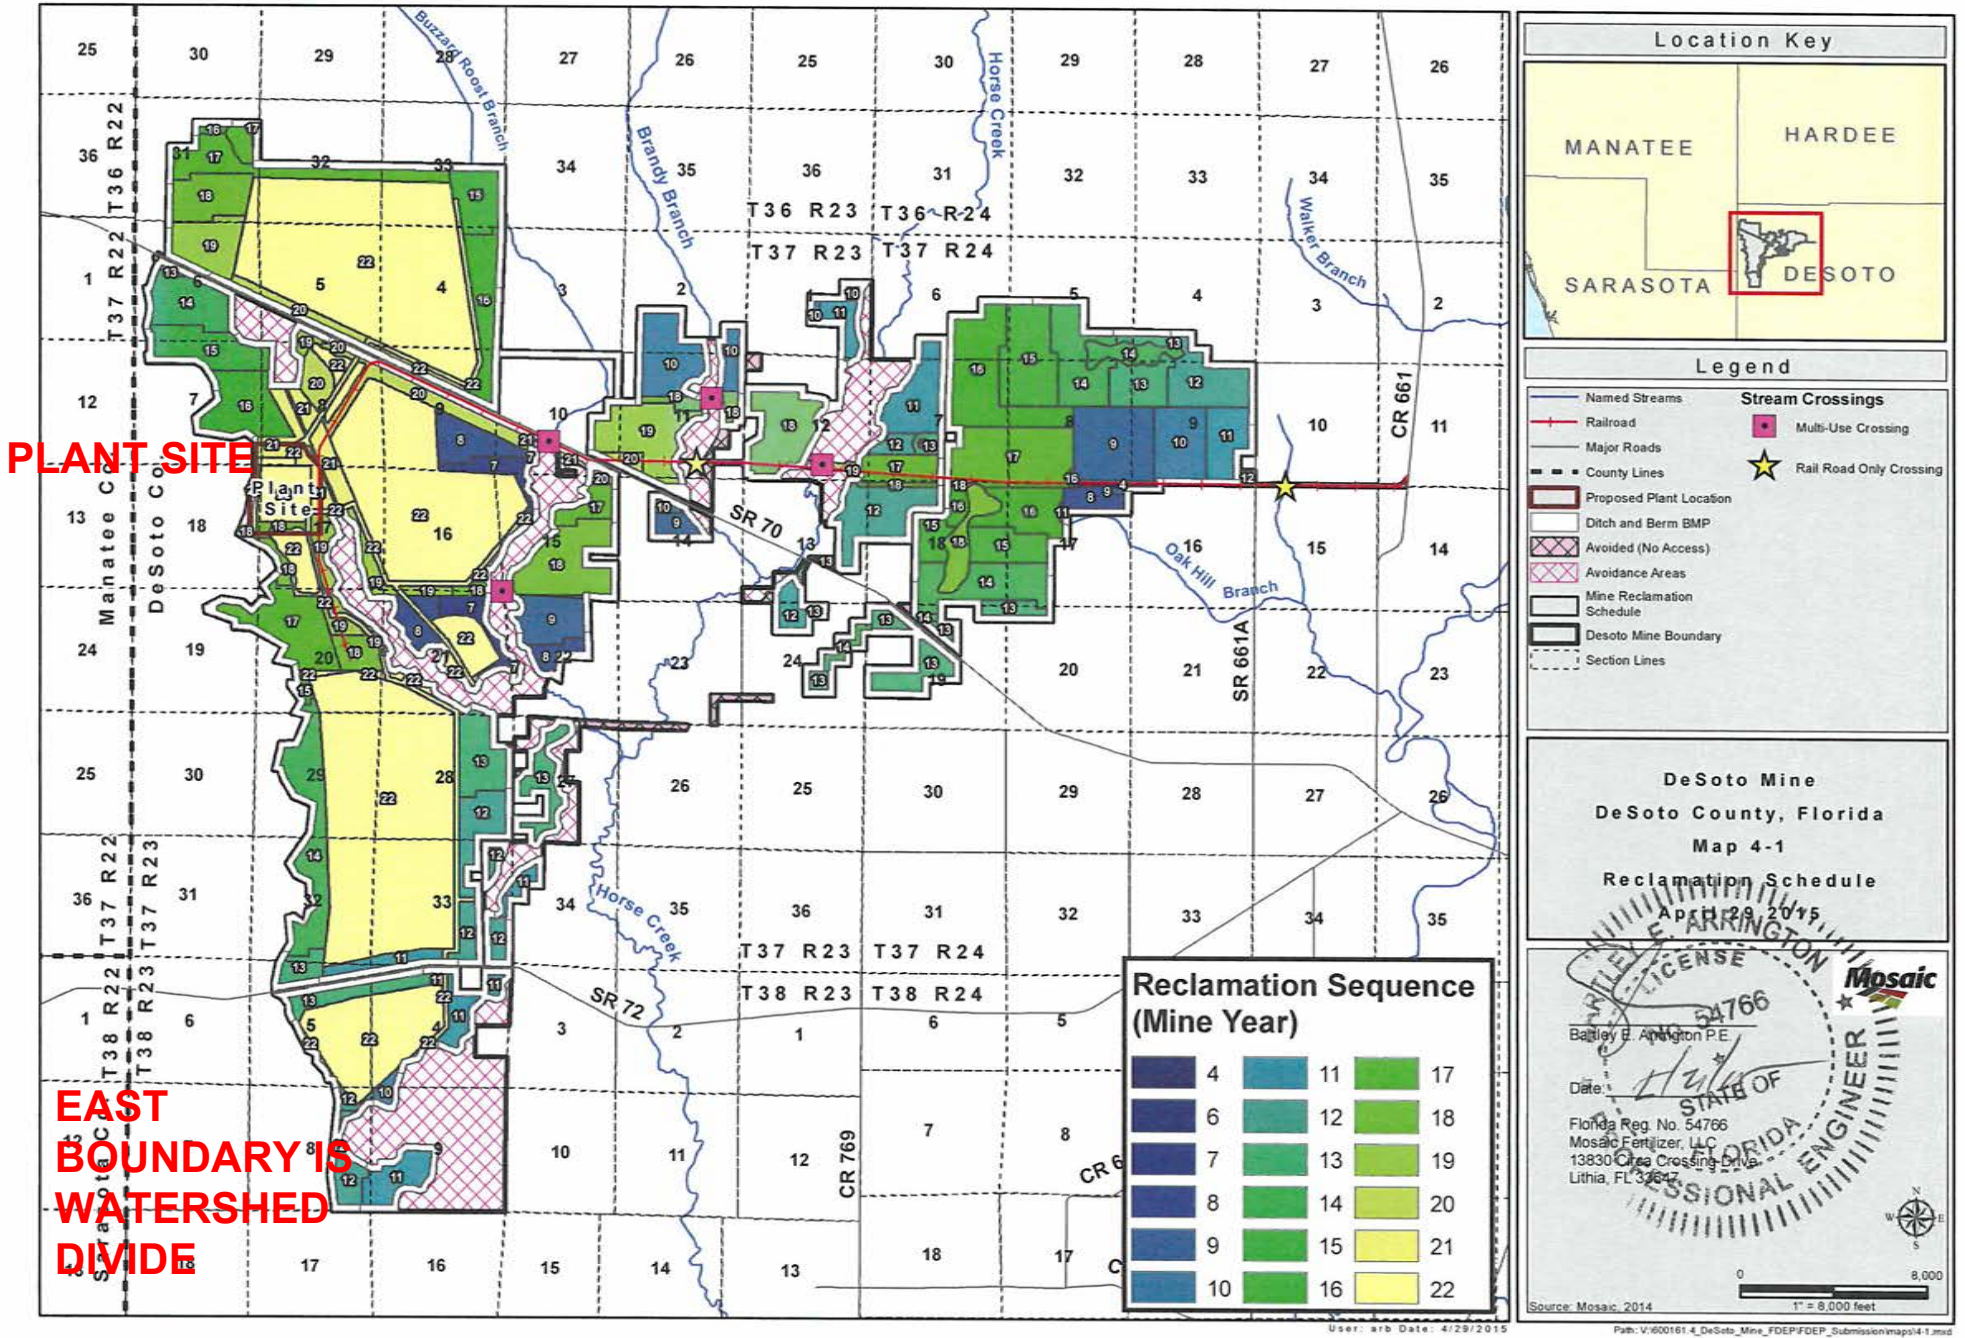
Figure ES-3: DeSoto East Mine Site Facilities (FDEP) (shaded areas). Note the beneficiation "Plant Site" shown in the west-central portion of the site.

While the proposed beneficiation plant is to be located outside the Big Slough watershed, it is proposed approximately 100 ft or so from the watershed divide, which is located in an area with just a one to three feet high barrier. The proposed clay settling areas associated with the DeSoto East Mine are also located outside but adjacent to the watershed divide (see **Figure ES-3**). In addition, it is expected that if the west mine site is developed, clay settling areas on the east side of the watershed divide will be used initially, but eventually they will reach capacity and clay settling areas will need to be developed in the Big Slough watershed.

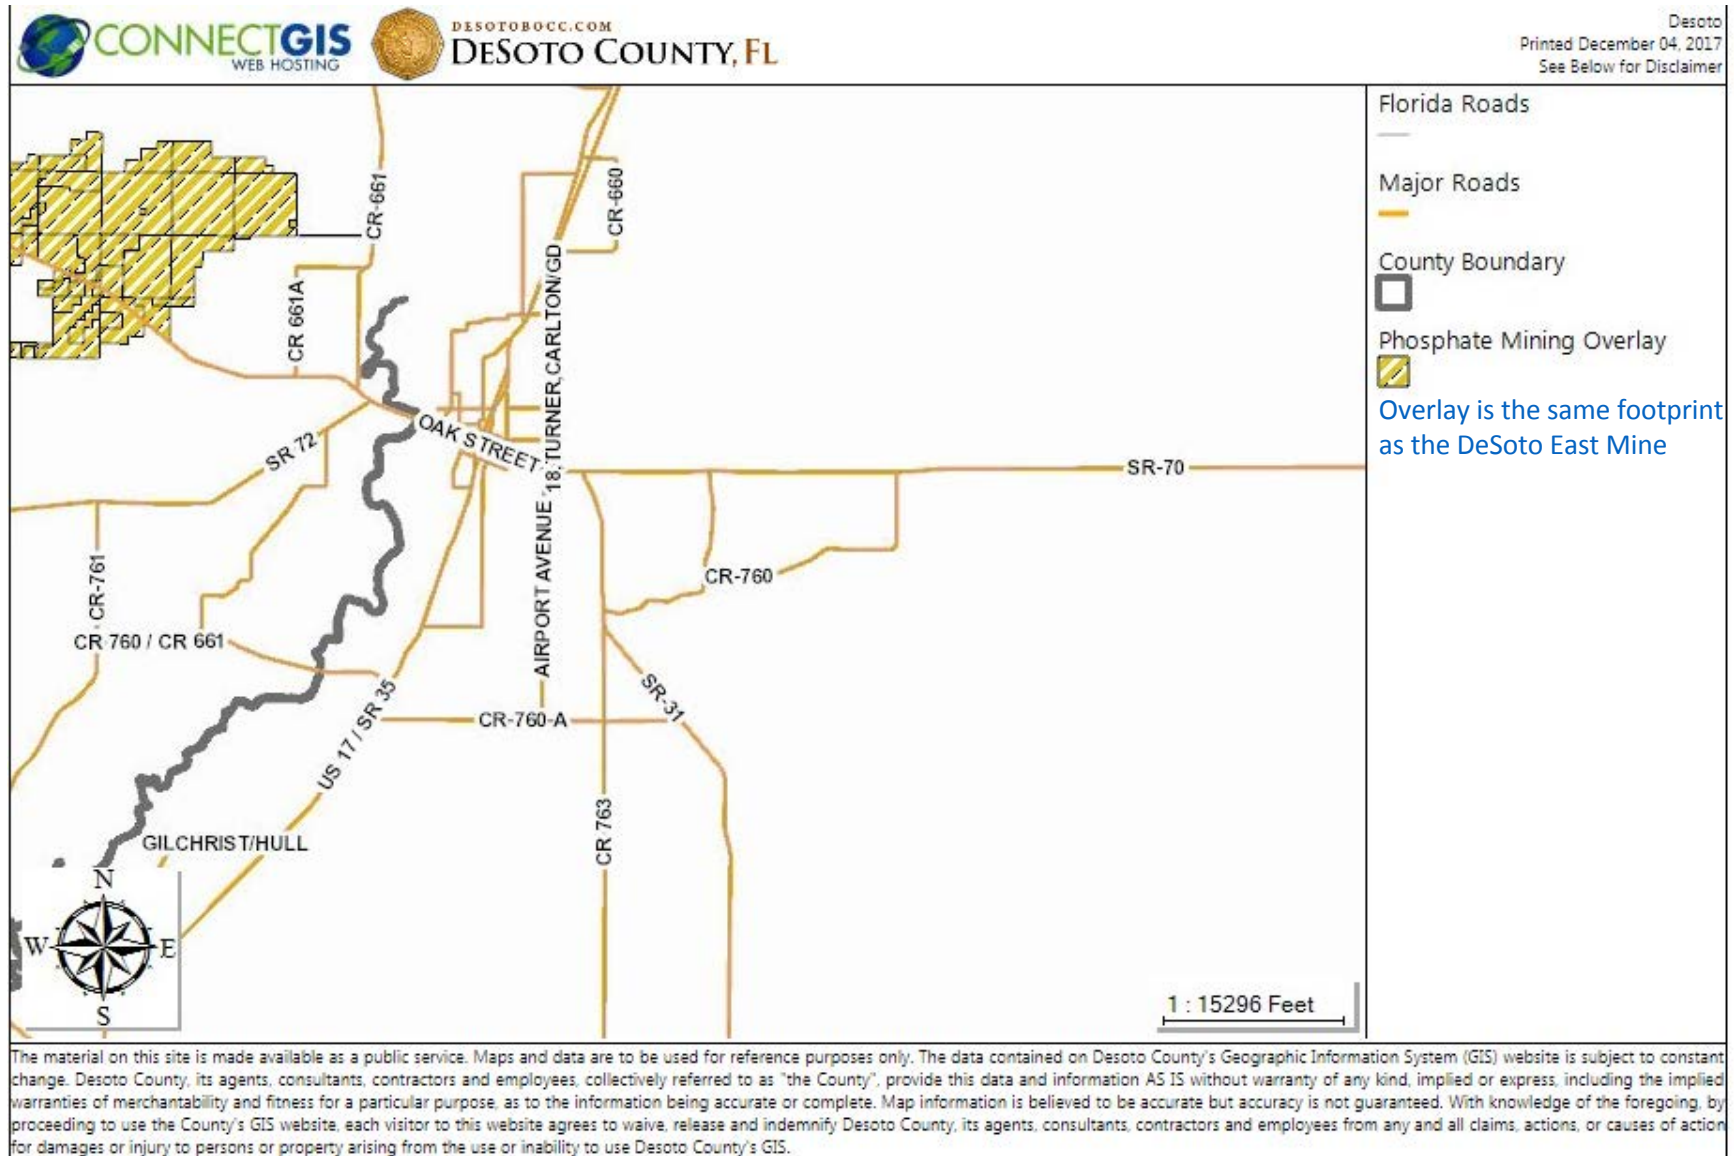
Figure 3-1: DeSoto County Phosphate Mining Overlay boundary. (Source: <https://desoto.connectgis.com/Map.aspx>)

DeSoto County's Future Land Use map includes a Phosphate Overlay (**Figure 3-1**) that covers the area proposed for the Desoto East Mine.

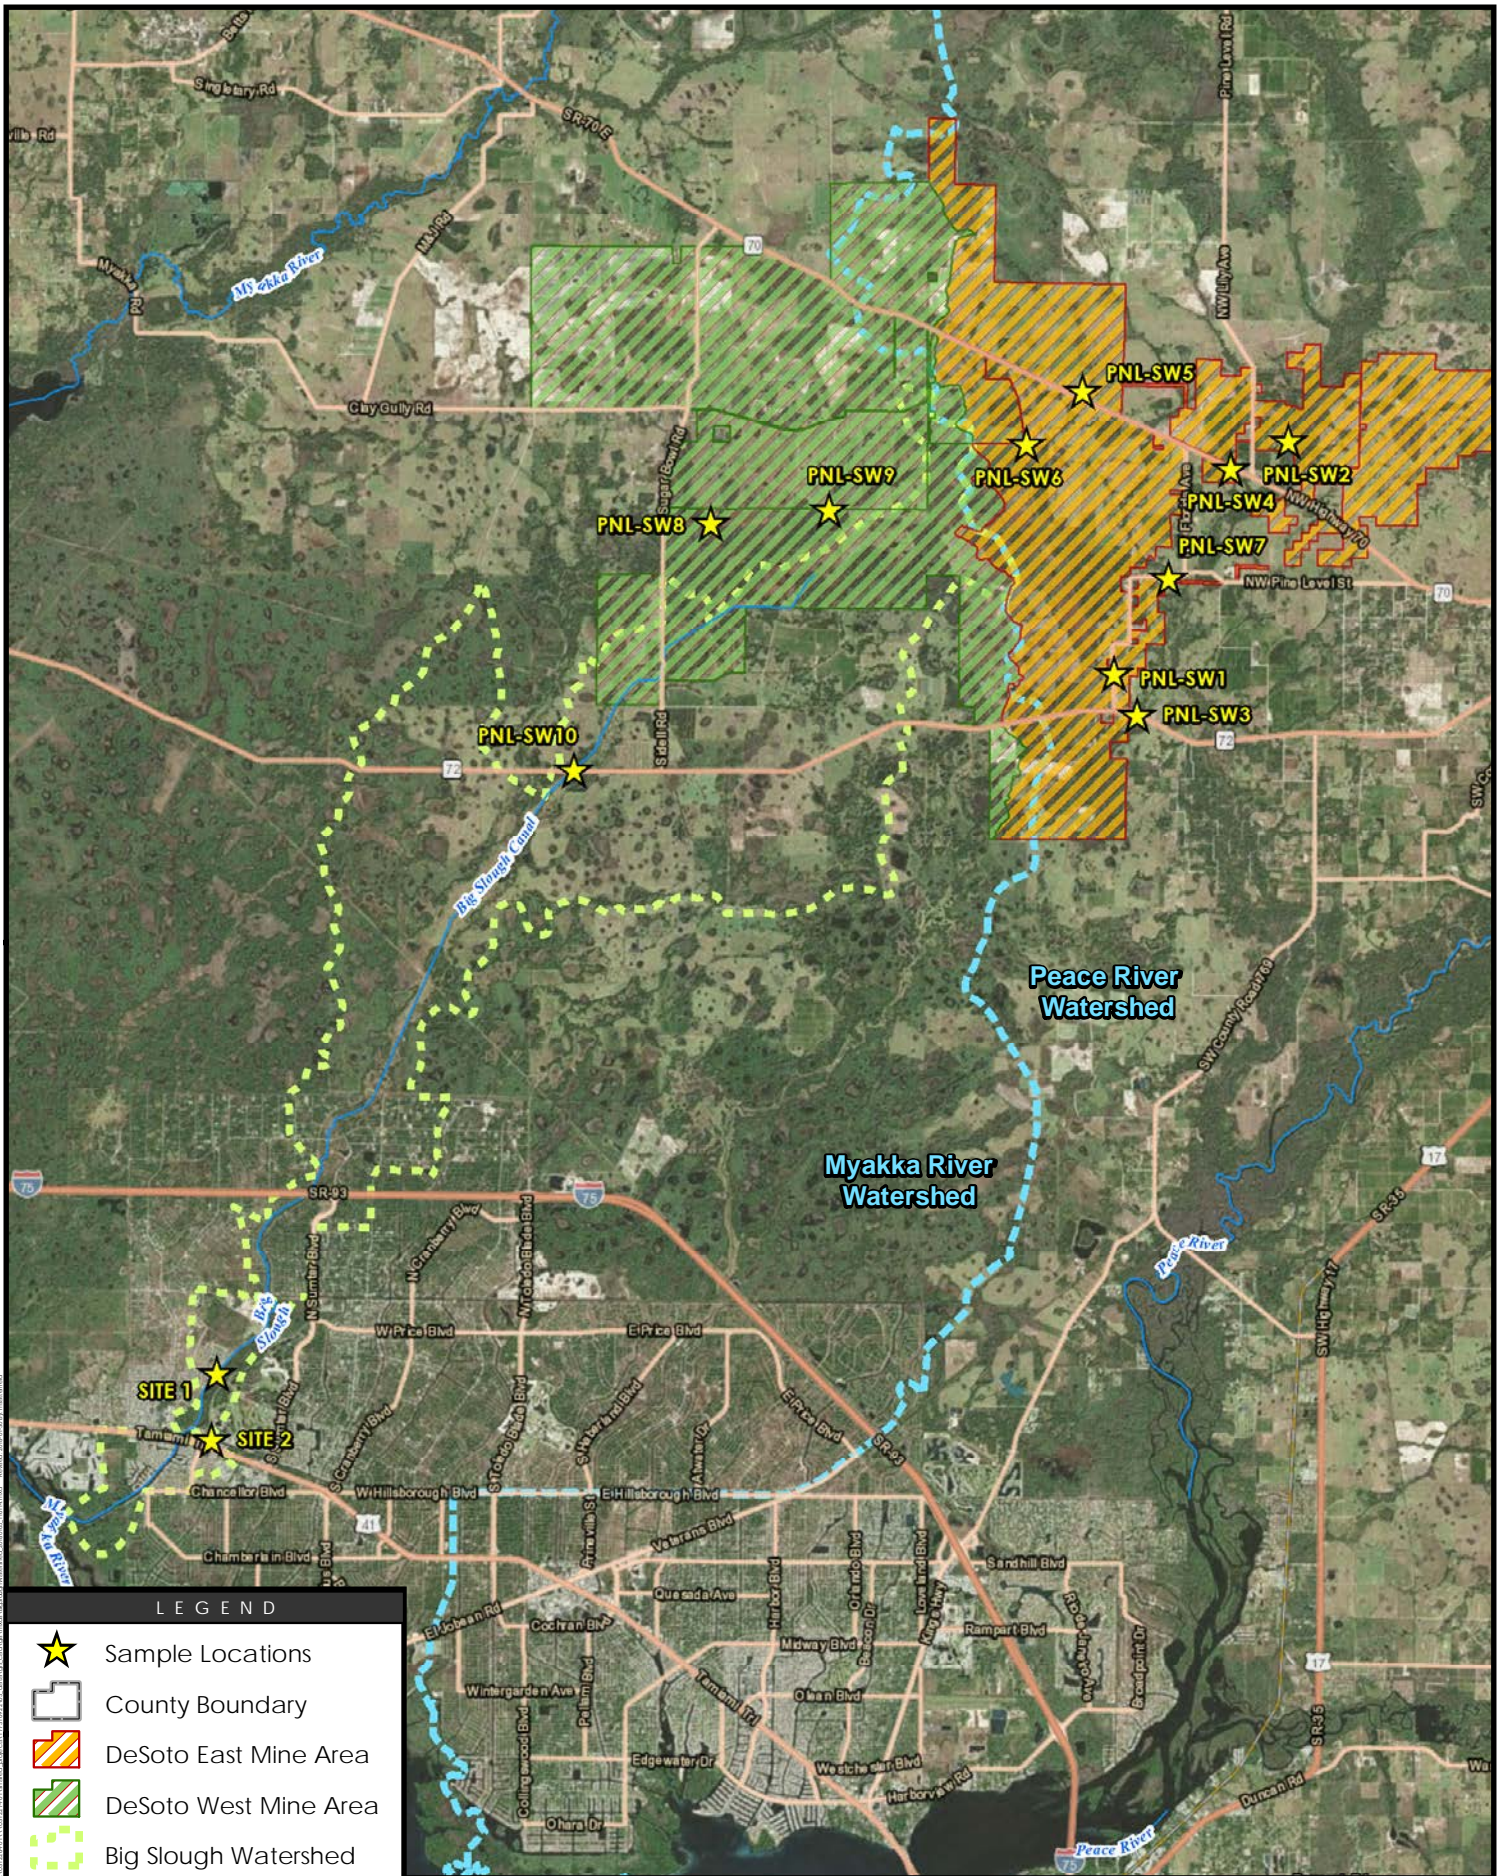
Figure 5-1: Surface Water Quality Sample Locations

Yellow highlight indicates Big Slough/Myakkahatchee Creek sites
